**Docket No. 272 – Development and Management Plan Inspection**

**East Devon Substation Inspection**

**Date:** June 7, 2007

**Location:** East Devon Substation

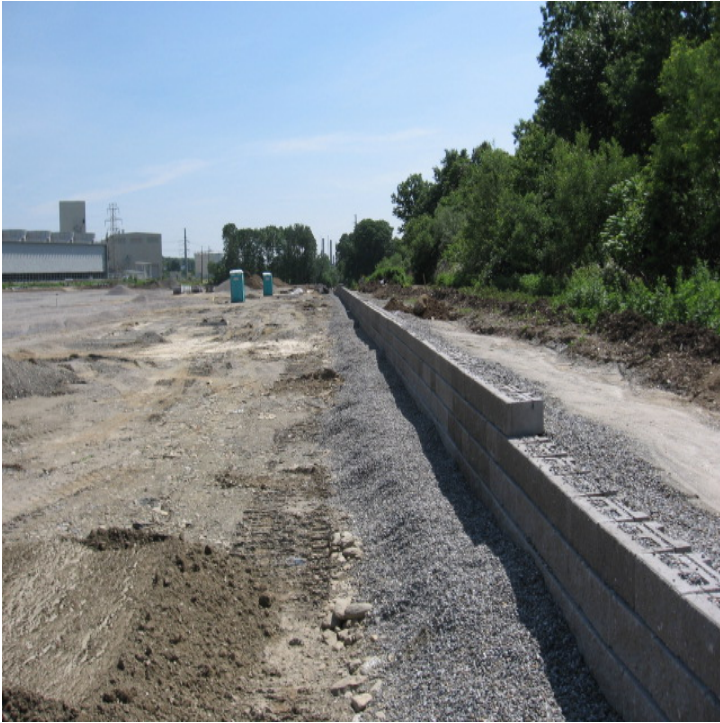
View of the perimeter/retaining wall along the western site boundary. Jersey barriers have been removed but wood chips remain.

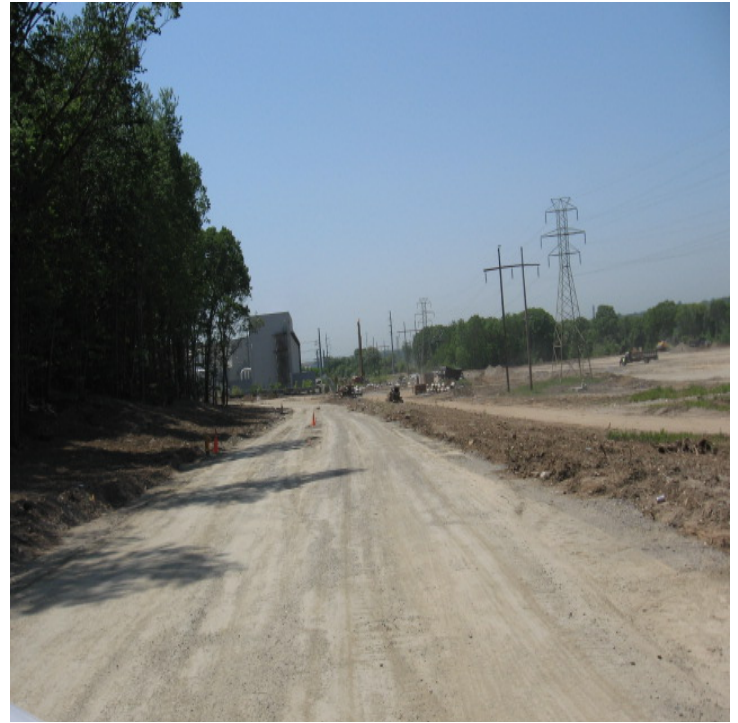
A view of the substation site from Shelland Street.

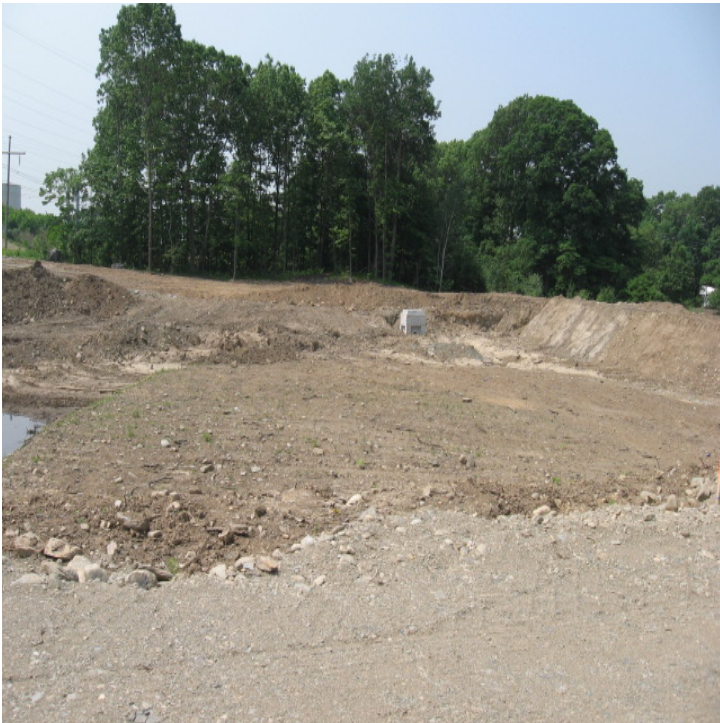
Detention basin construction continues at the southeastern portion of the site.

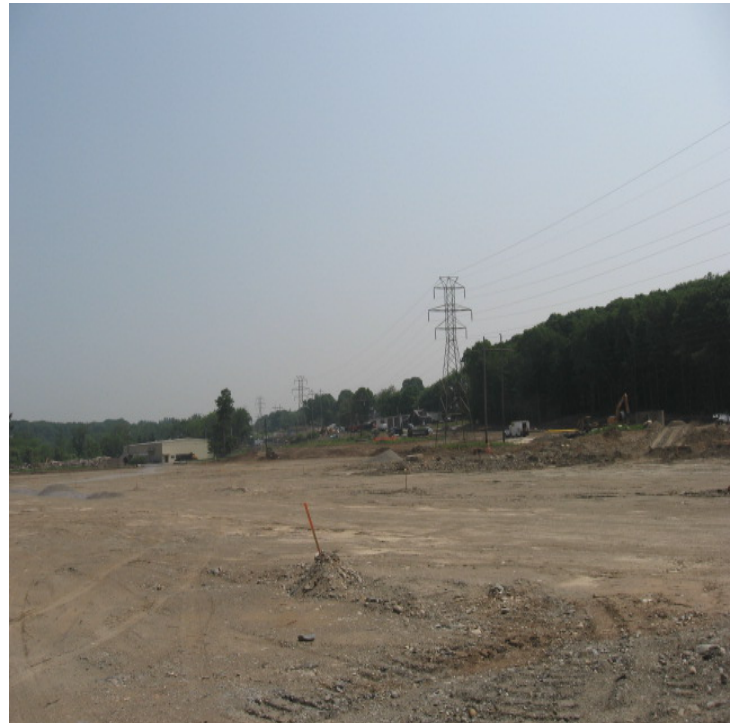
Overall view of the substation site. Grading and foundation construction continues.
