Docket No. 272 – Development and Management Plan Inspection

East Devon Substation Inspection

Date: June 29, 2007

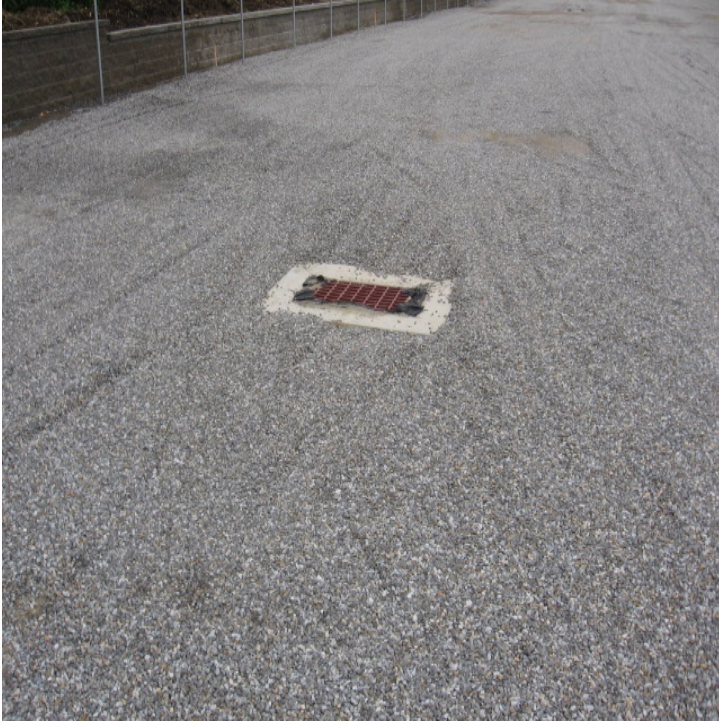
The catch basins along the western site boundary are now operational and "Silt saks" remain intact.

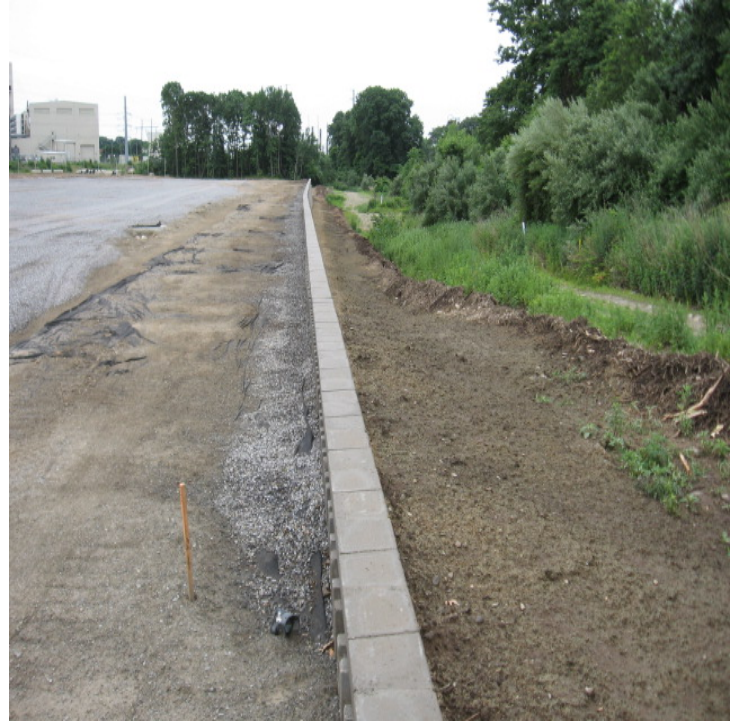
View of the completed retaining wall along the western boundary. Disturbed soils to the west of the retaining wall have been seeded. The mulch berm remains as a perimeter control here.

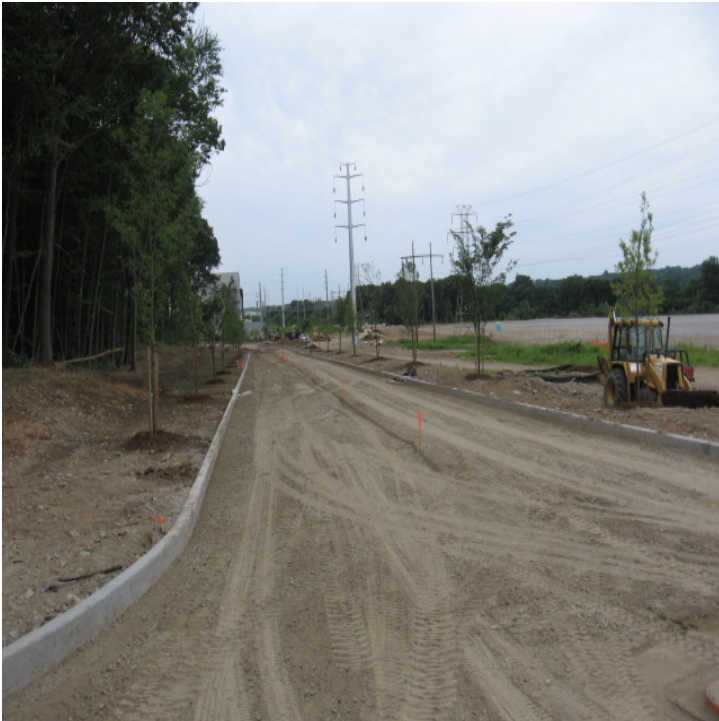
Overall view of Shelland Street. Street grading continues and tree plantings appear to be complete.

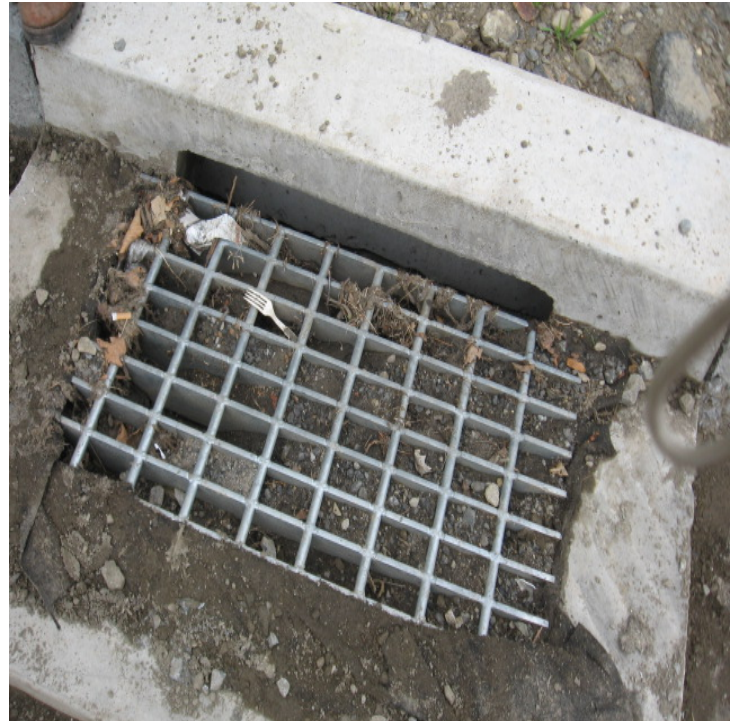
The "Silt sak" remains intact at the catch basin located at the corner of Shelland St. and Plains Rd, but curb inlet protection has not been provided.
