Docket No. 272 – Development and Management Plan Inspection

Segment 1a Inspection

Date: April 30, 2007

Location: Segment 1a – Scovill Rock Switching Station to Chestnut Junction, Oxbow Junction to Beseck Switching Station (excluding Royal Oak Bypass), and Black Pond Junction to Beseck Switching Station

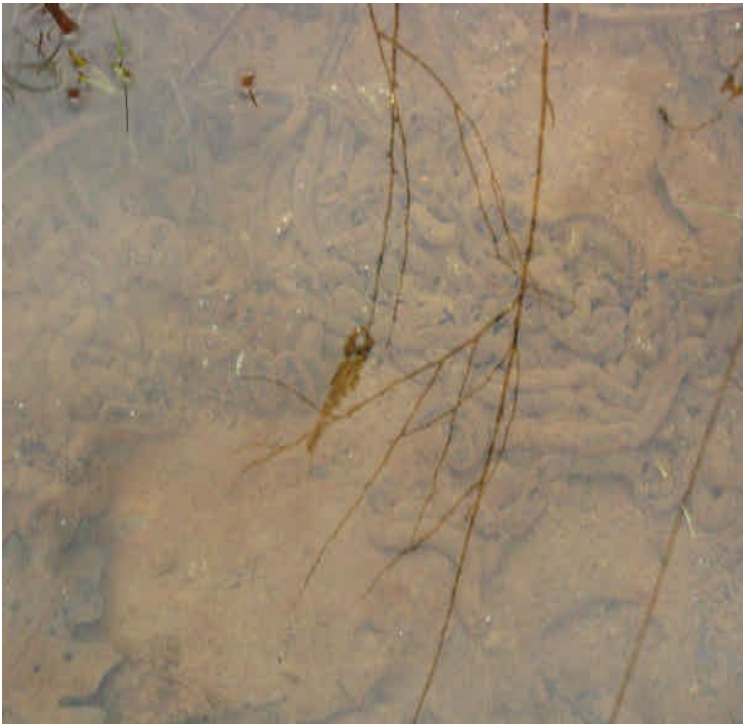
American toad eggs noted in standing water at the access road off Freeman Road.

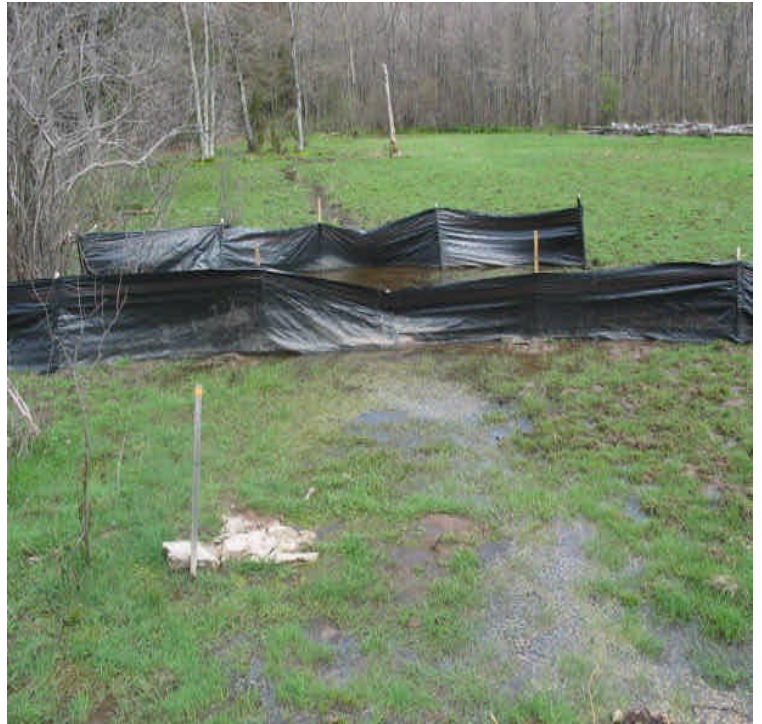
Area near the wetland crossing off Little Ln. Clear water was flowing through several lines of controls and off site.

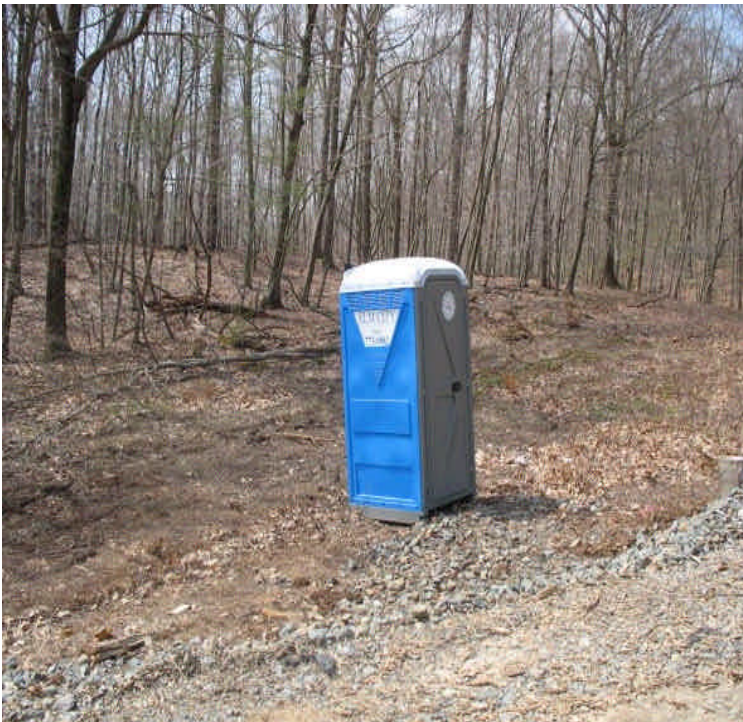
The portable sanitary facility off Black Walnut Dr. was picked up and righted.

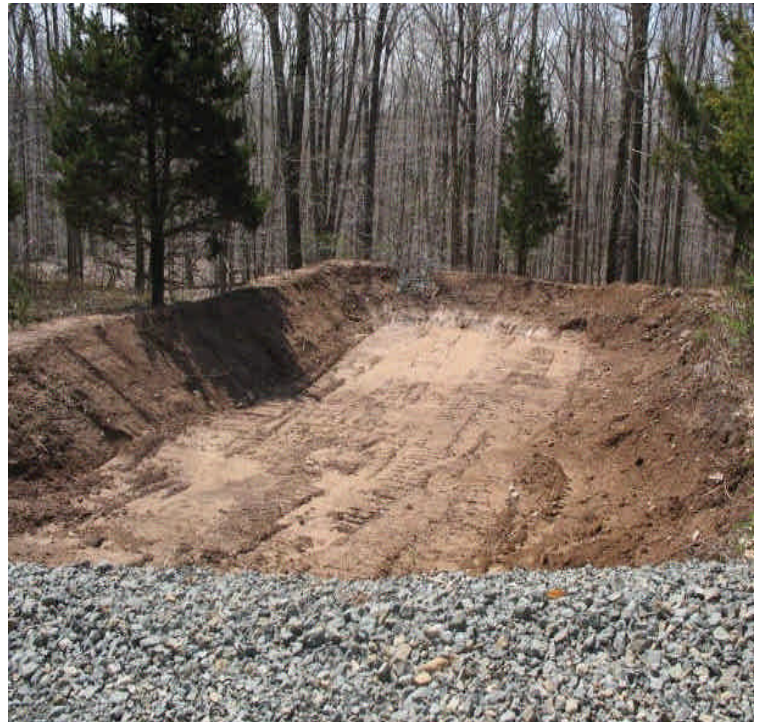
Detention basin in place off Black Walnut Drive upgradient of Ball Brook.

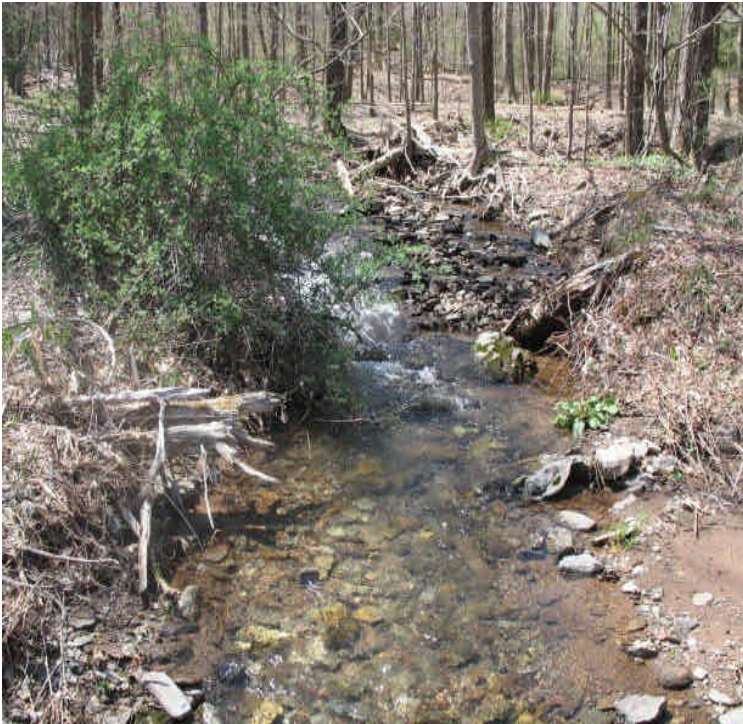
Wetland and stream crossing off Foot Hills Rd. Mats were in place and turbid run-off was not noted.

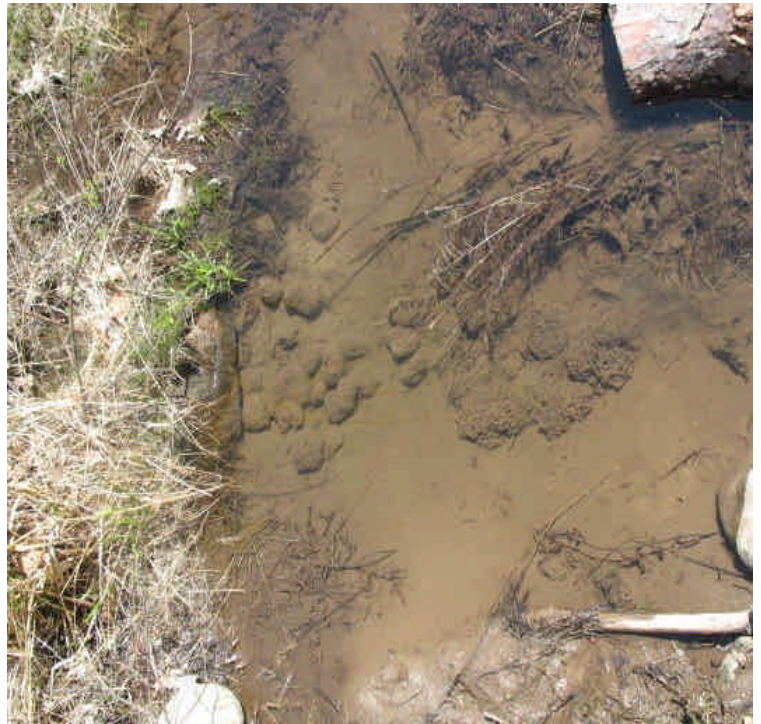
Amphibian egg masses were noted in the ponded water adjacent to a timber mat crossing off Johnson Ln. Slight sedimentation resulted from recent heavy rain. Continue to prevent turbidity and sedimentation here to the extent possible.

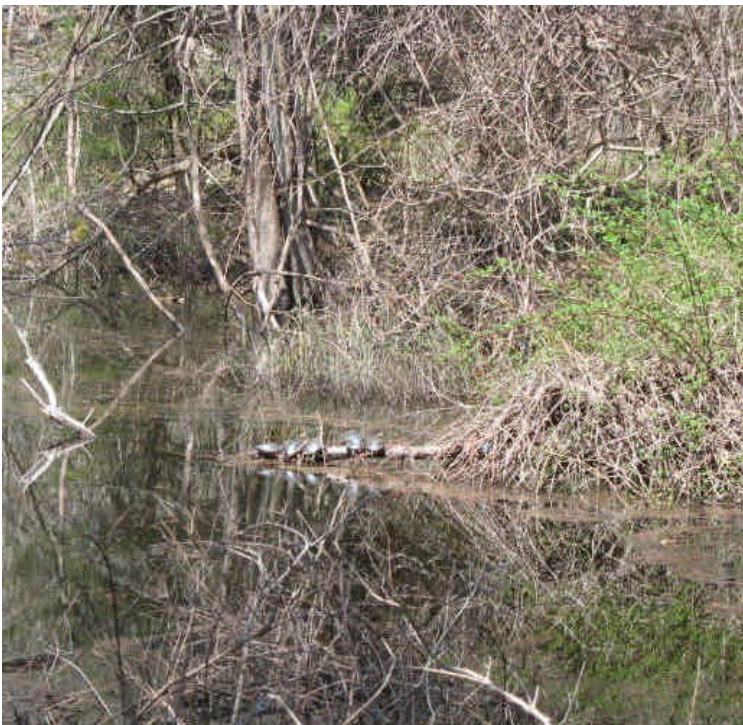
Painted turtles noted basking within the pond off Haddam Quarter Rd.

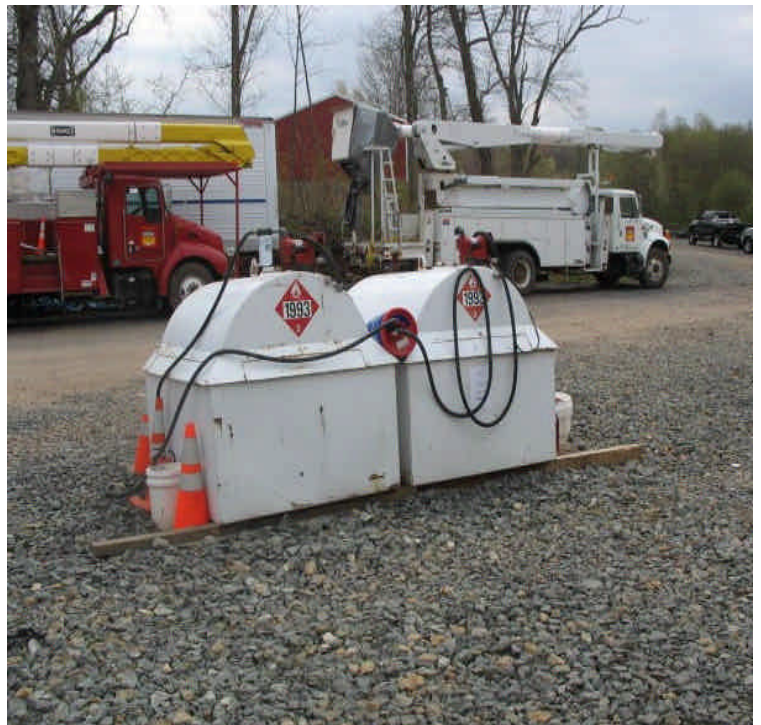
Both nozzles were well contained in a 5-gallon bucket within the contractor receiving yard.

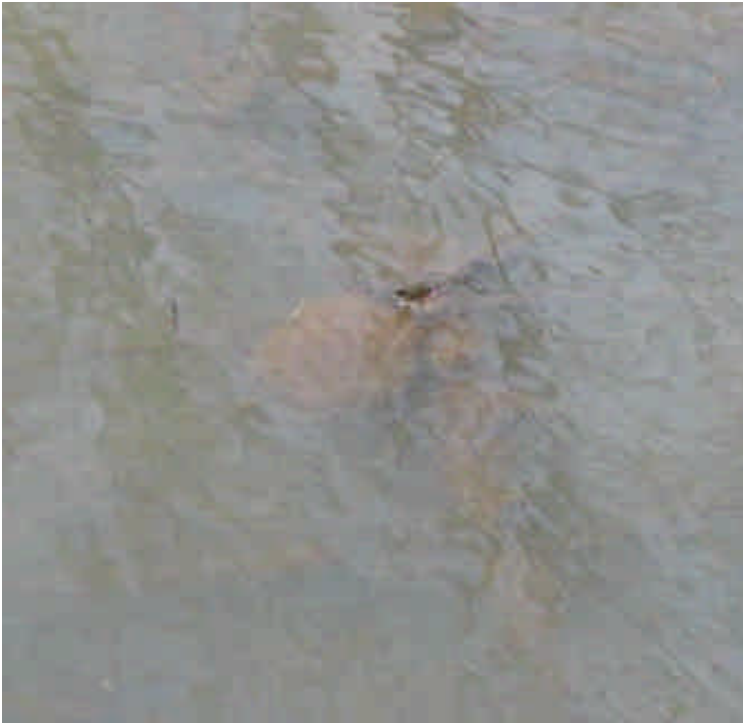
Pond adjacent to the contractor receiving yard also provides good amphibian breeding habitat based on the presence of egg masses, tadpoles and frogs.

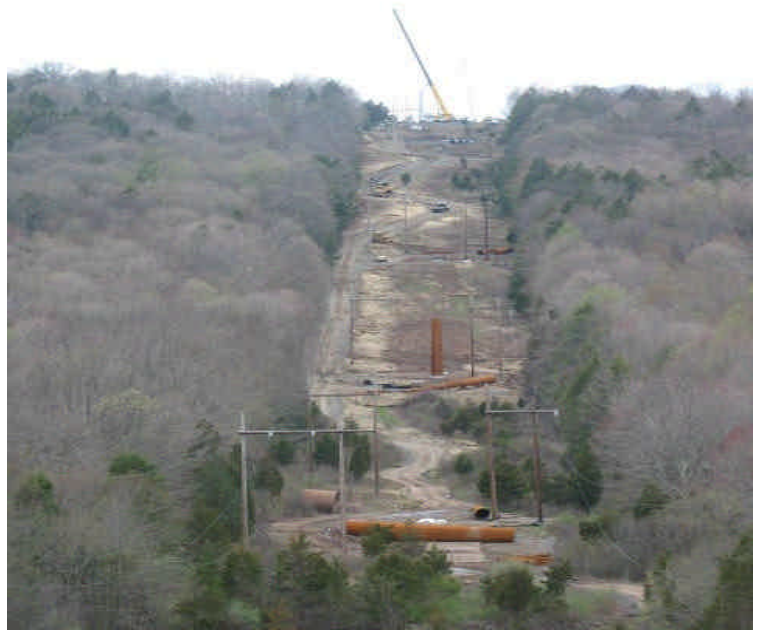
Looking west from Powder Hill Road. Pole installation is underway.

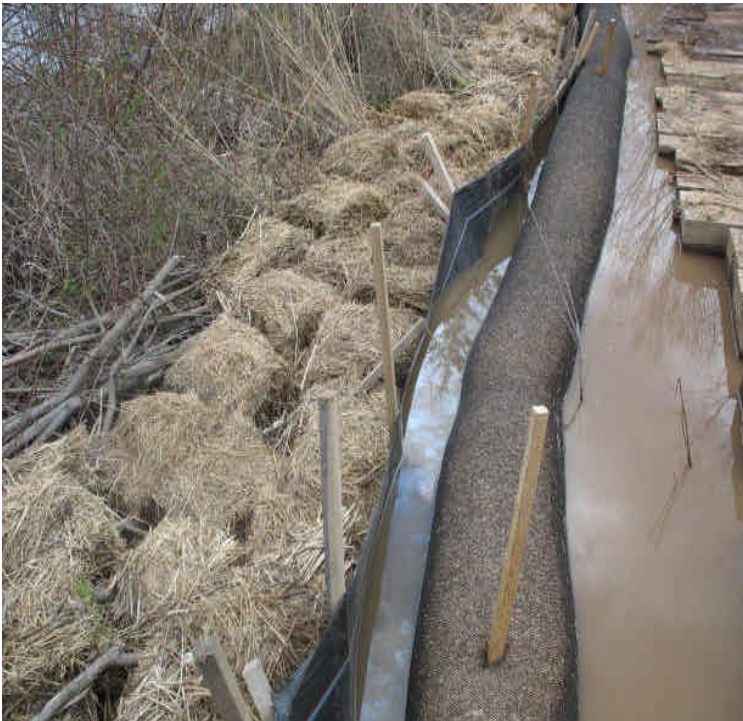
View of well installed haybales and fiber rolls at the timber mat crossing off Powder Hill Rd. Sediment is filtered from the run-off before it flows off-site in this area. A large amount of turbid water is being retained.

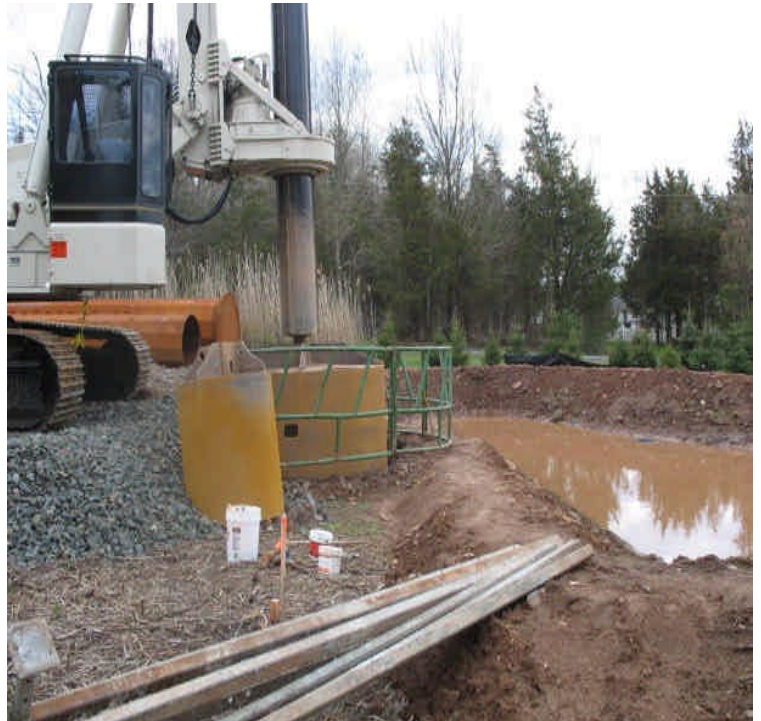
View of drilling east of Powder Hill Road. Detention basin in place to retain and settle run-off from the site.

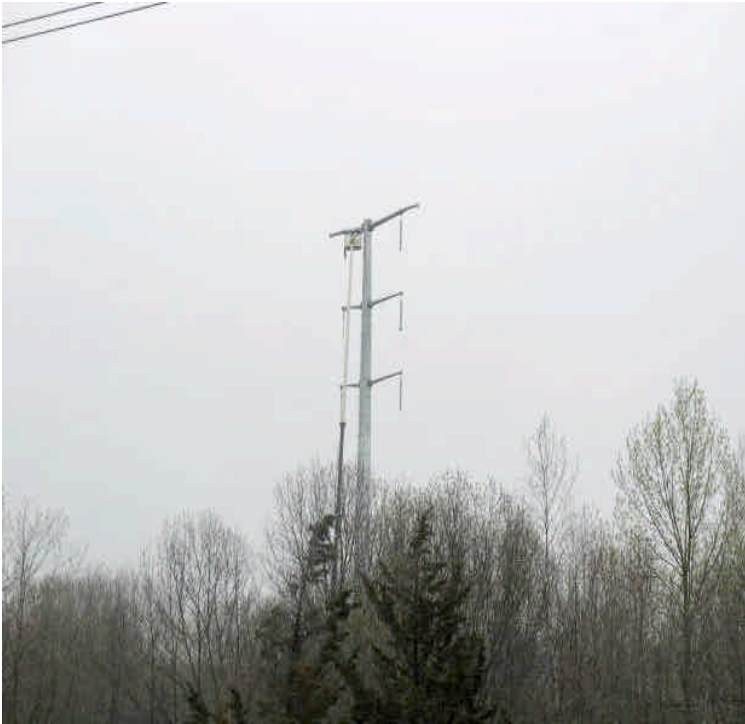
Pole work east of Beseck SS. off Valley View Drive.

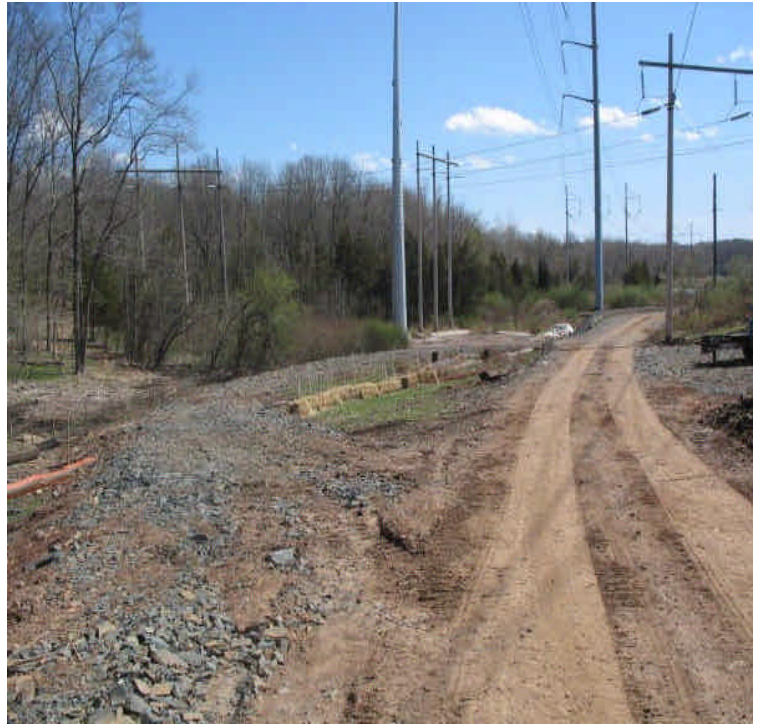
Access road north of Beseck SS is well controlled with stone in place to stabilize the soils and reduce run-off. Haybale and filter sock barriers are in place for additional control.

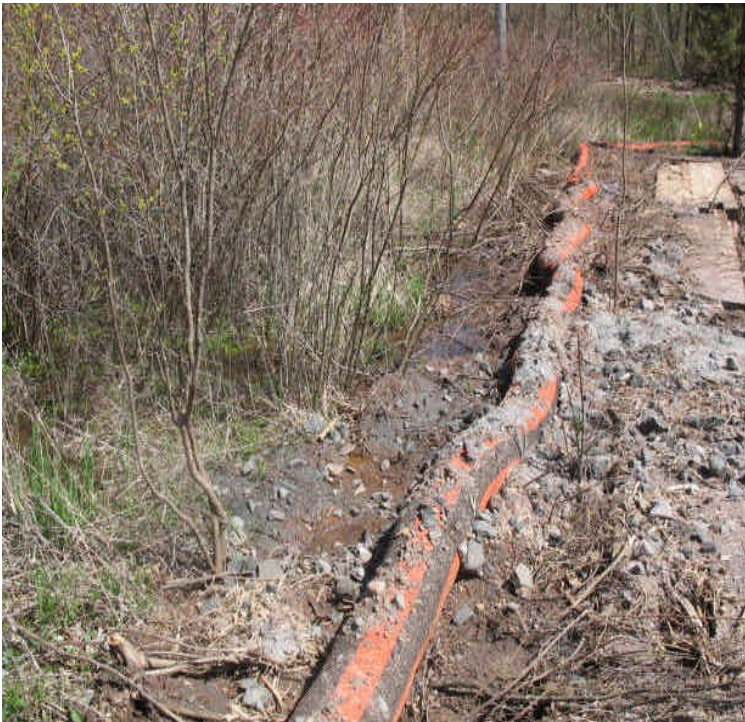
East of Beseck SS	Timber mat staging areas are in and adjacent to wetlands. Sediment was noted on and beyond the filter sock at the wetland's edge. 4/2-4/30/07	Adequately contain all sediment; the soil in the wetland will have to be removed carefully by hand. 4/30/07	Needs attention
Black Pond Junction to Beseck SS Fleming Rd.	Pole installation is complete adjacent to the edge of the pond. Sediment accumulation is at the capacity of the controls. 4/30/07	Remove sediment from controls. See erosion control section. 4/30/07	Needs attention.
High Hill Rd. South to East Meriden Substation and north to Black Pond	Pad site/work area is in place in several locations in or adjacent to the wetlands and streams. The flow is being re-routed through a riprap channel and culvert at one location. Erosion control mats are in place at the top of bank. 4/30/07	Continue to stabilize soils and adjust controls as necessary to protect wetlands and filter turbid run-off. See erosion control section for more details. 4/30/07	NA

Sediment (likely from snow clearing) was noted on and beyond the filter sock at the matted pad near Beseck SS. Sediment in the wetland needs to be carefully removed by hand.

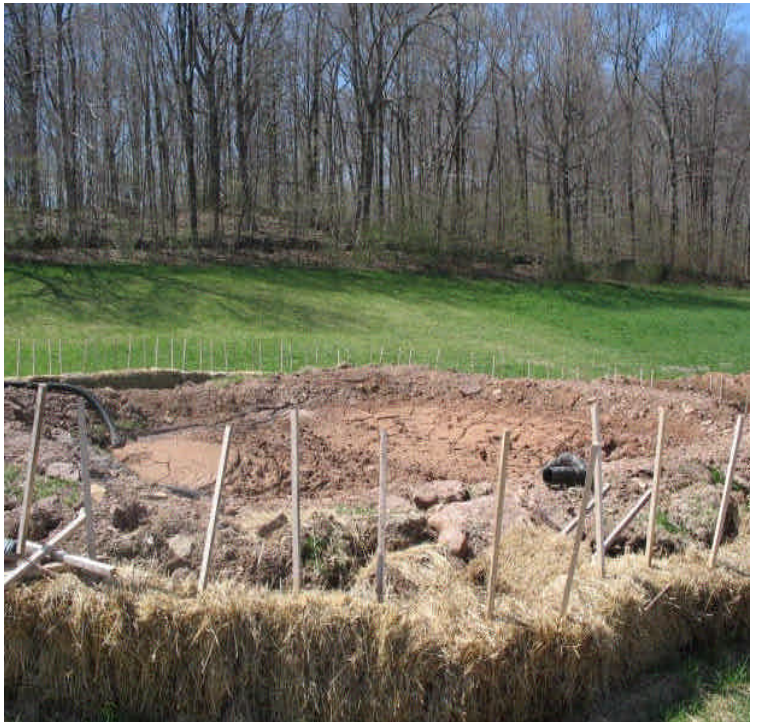
Slurry/dewatering containment area in place just north of Beseck SS.

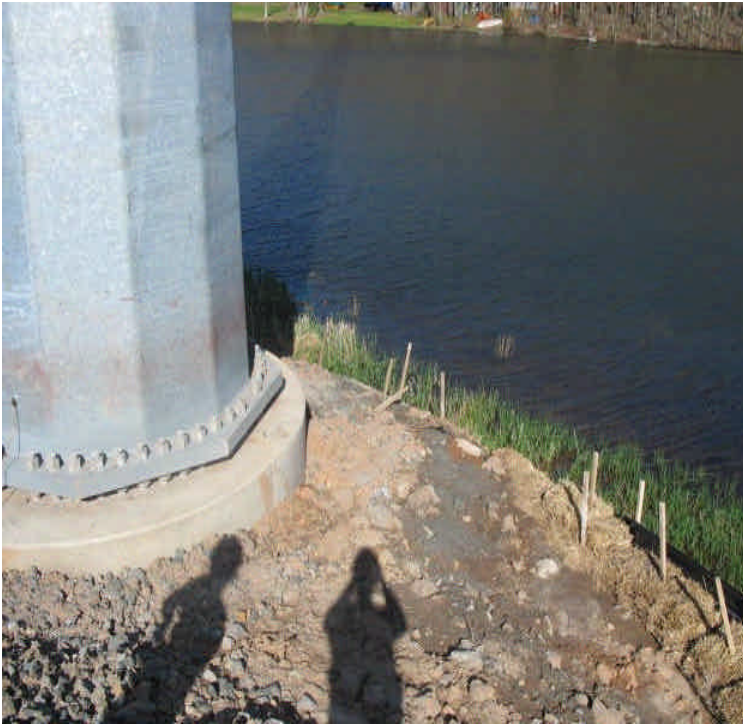
<p>Fleming Road</p>	<p>Pole installation is complete but sediment accumulation was noted and controls adjacent to the pond are at capacity. Mulch covers adjacent disturbed areas 4/30/07</p>	<p>Remove accumulated sediment from controls and adjust/repair controls as needed. 4/30/07</p>	<p>Needs attention.</p>
<p>South of High Hill Rd. (vicinity of East Meriden Substation)</p>	<p>Filter socks are in place along the edge of wetland areas. Stream banks remain mulched with hay and partial bales. 4/30/07</p> <p>Area north of E. Meriden SS has reinforced controls to prevent turbid water from entering the nearby pond but filter socks are still not fully in place. 4/23-4/30/07</p>	<p>Ensure the controls are adequate for run-off in this area. 4/30/07</p> <p>Ensure the controls are adequate for run-off in this area. Toe-in fiber rolls to ensure water doesn't channel underneath. 4/23-4/30/07</p>	<p>NA</p> <p>Controls were reinforced but needs some attention.</p>

Controls remain in place along the pond north of Beseck SS to E. Meriden SS off Fleming Rd where pole installation is complete. However, sediment has filled controls to capacity and needs to be removed.

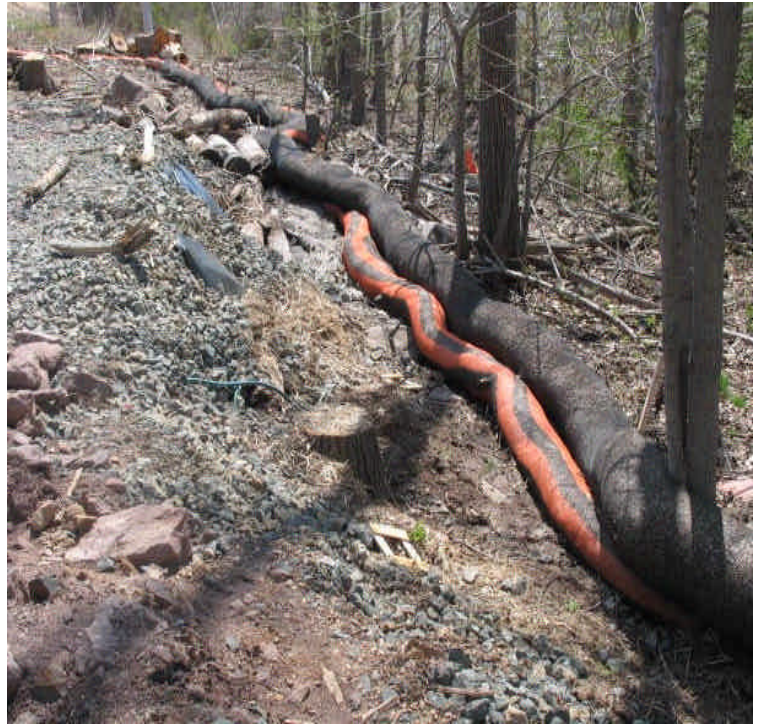
Filter socks just north of E. Meriden SS controls need to be toed in in order to work effectively. Haybales are in place at erosion prone areas for additional control.

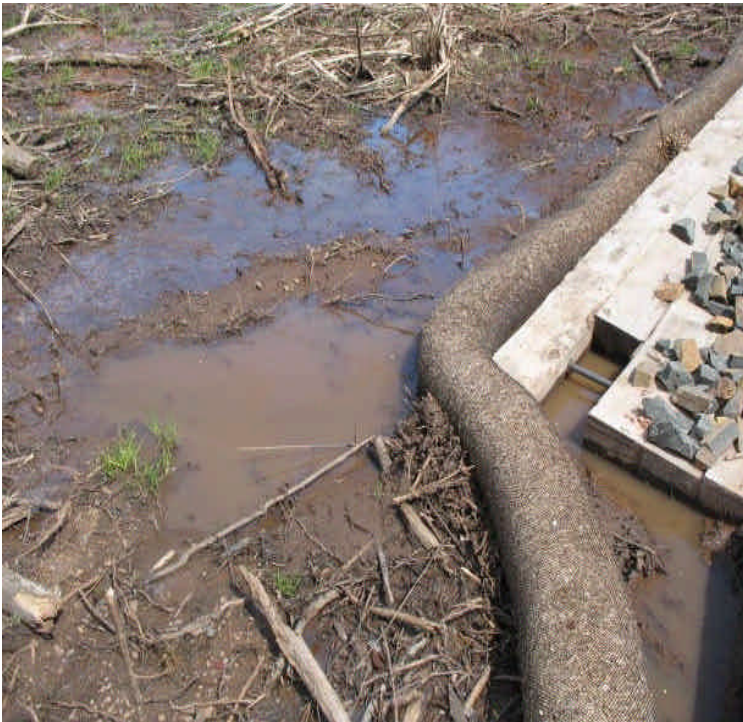
Foundation installed within the wetlands just south of High Hill Road. Slightly turbid run-off was noted leaving the timber mats under the filter socks but remained in the immediate area.

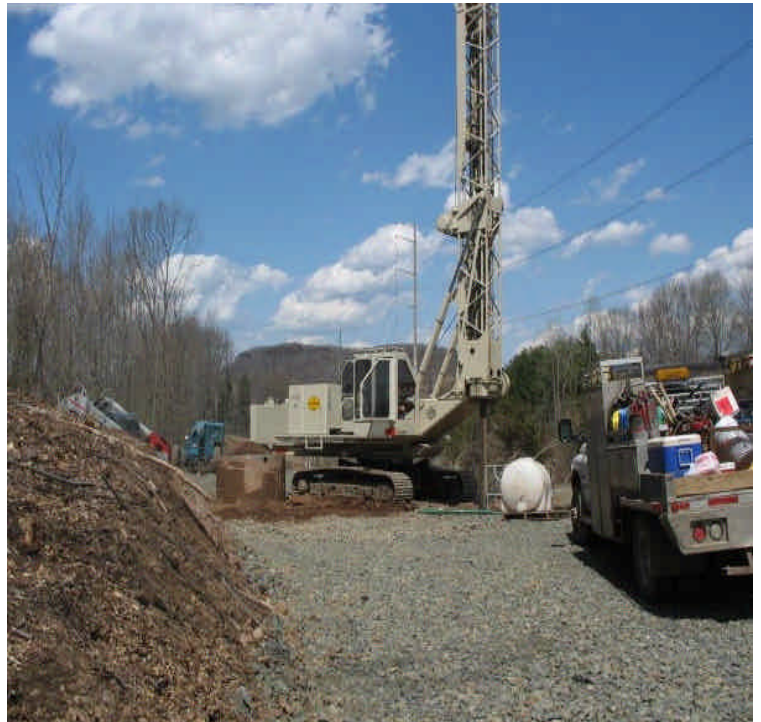
Foundation drilling north of High Hill Rd. near Black Pond. No sediment was noted entering the wetlands.
