Docket No. 272 – Development and Management Plan Inspection

Segment 1a Inspection

Date: May 7, 2007

Location: Segment 1a – Scovill Rock Switching Station to Chestnut Junction, Oxbow Junction to Beseck Switching Station (excluding Royal Oak Bypass), and Black Pond Junction to Beseck Switching Station

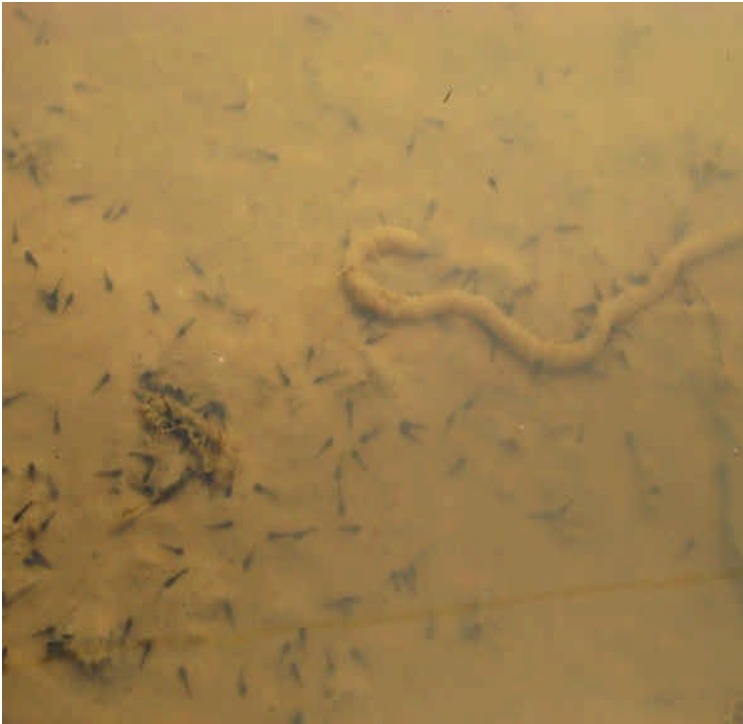
American Toad eggs/tadpoles noted in standing water at the access road off Freeman Rd.

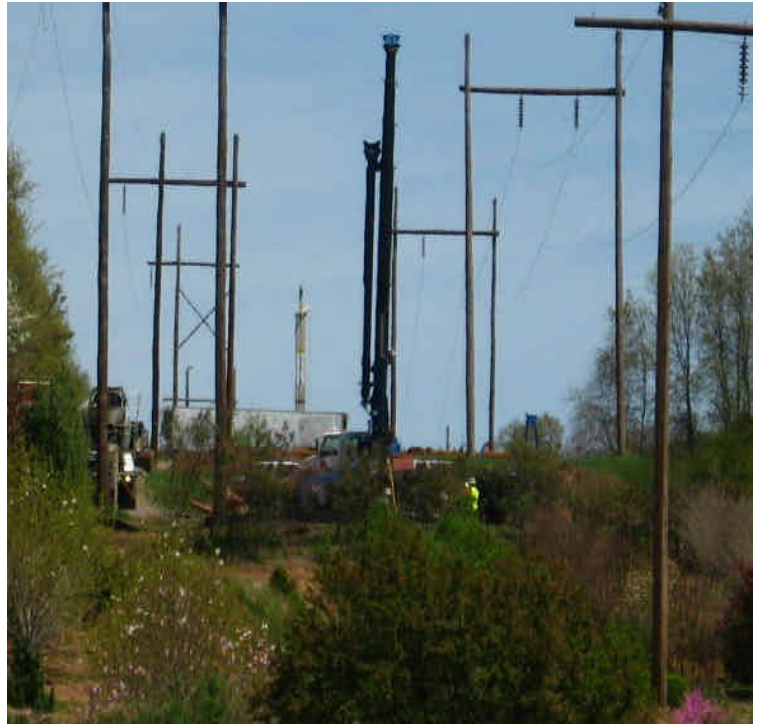
View of foundation drilling off Little Lane.

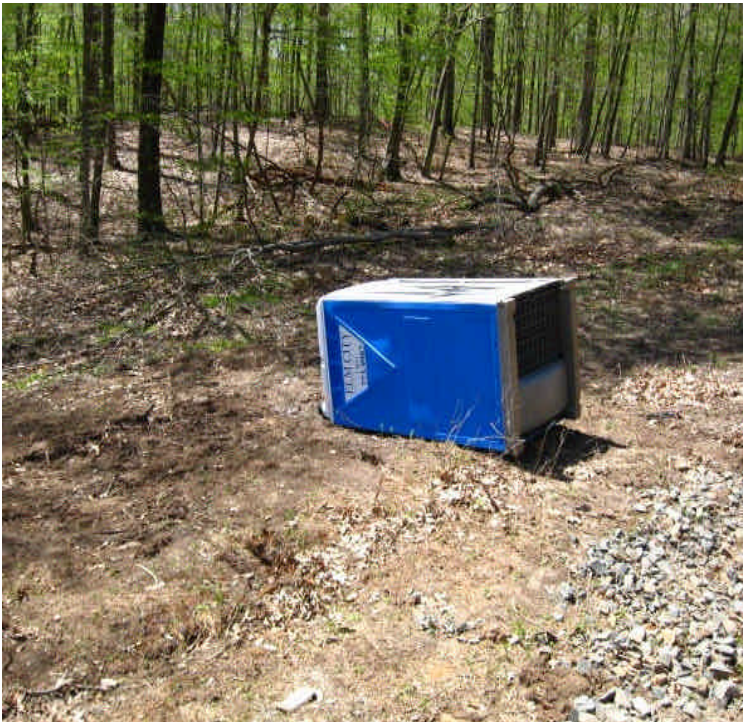
Portable Sanitary Facility off Black Walnut Dr. has tipped over again. Wetlands are not located in the vicinity but it should be righted and relocated if necessary.

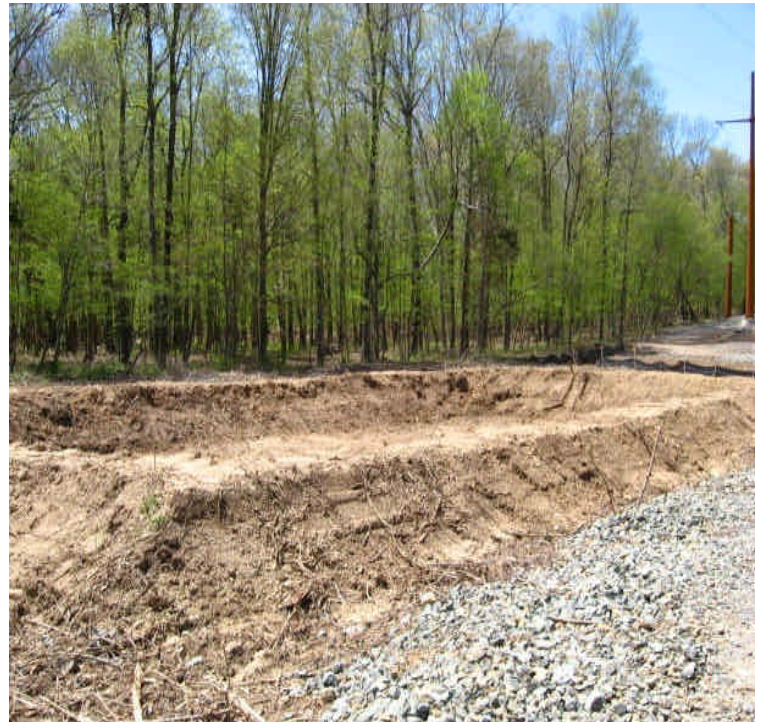
View of the basin in place off Black Walnut Drive upgradient from Ball Brook.

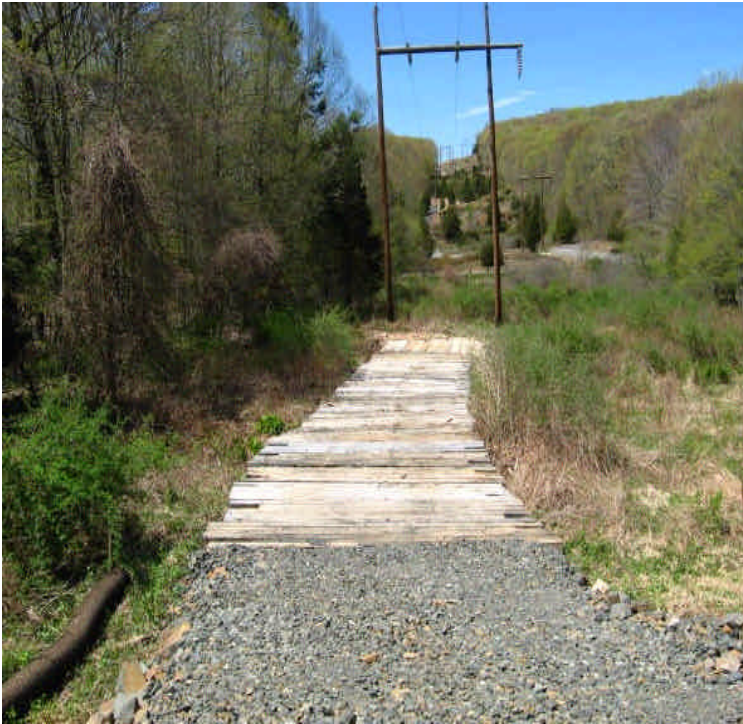
Wetland crossing off Foot Hills Rd. No turbid run-off was noted.

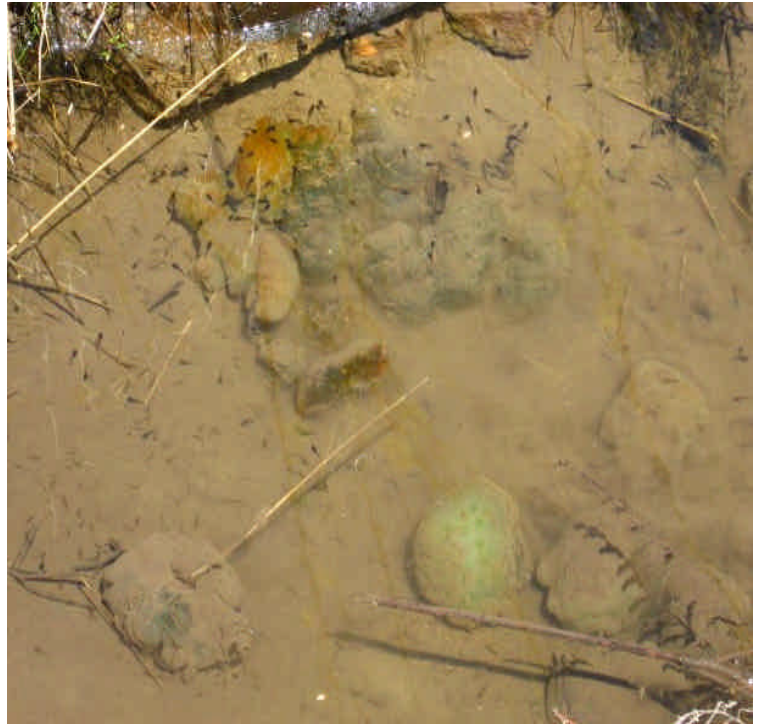
Amphibian egg masses and tadpoles were noted in the ponded water adjacent to a timber mat crossing off Johnson Ln. Slight sedimentation was noted. Continue to prevent turbidity and sedimentation here to the extent possible.

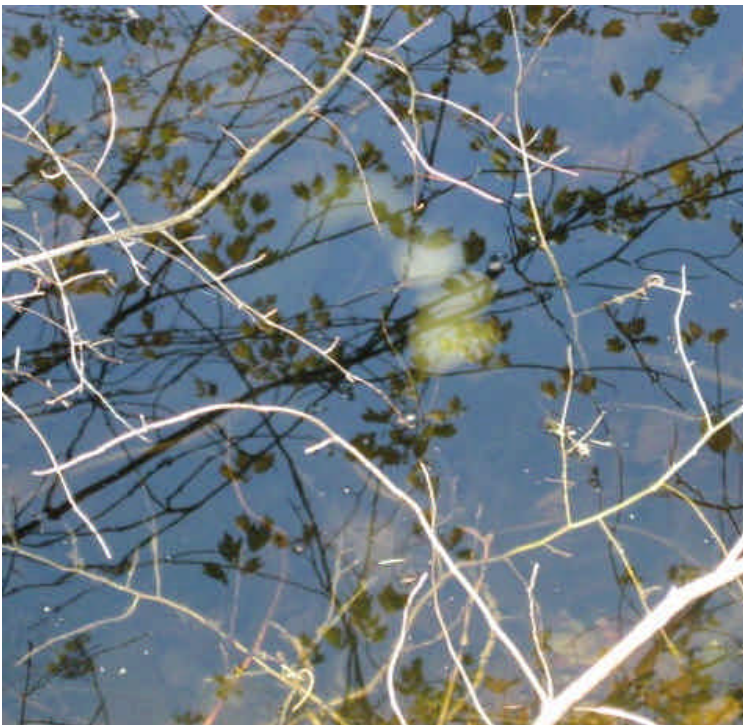
Egg masses noted within the pond off Haddam Quarter Rd.

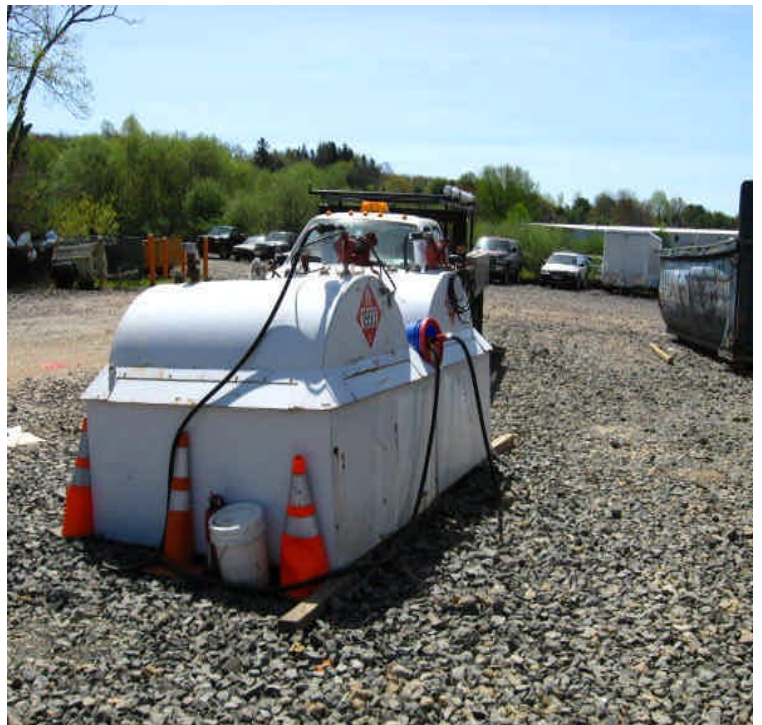
Both nozzles were well contained in a 5-gallon bucket within the contractor receiving yard.

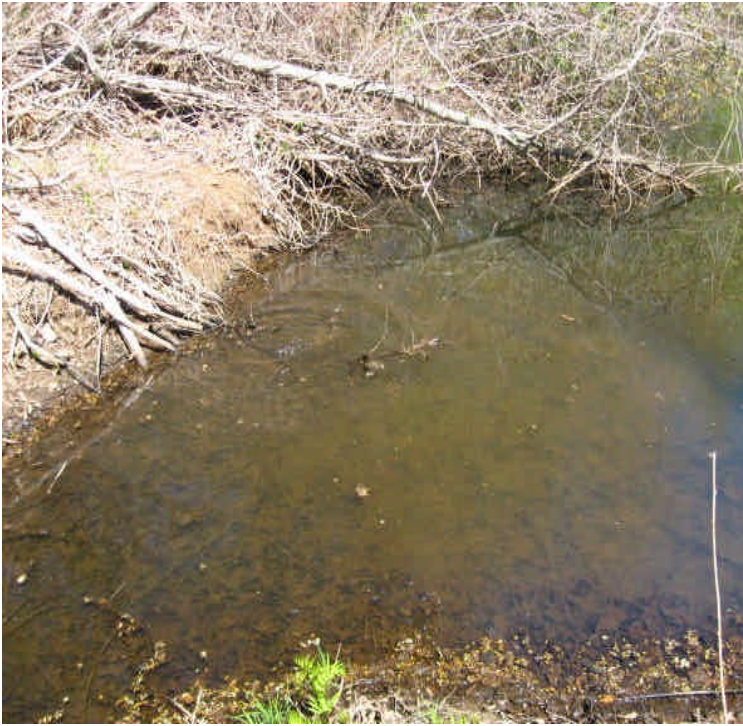
View of the pond adjacent to the contractor receiving yard. A snapping turtle had just entered the water.

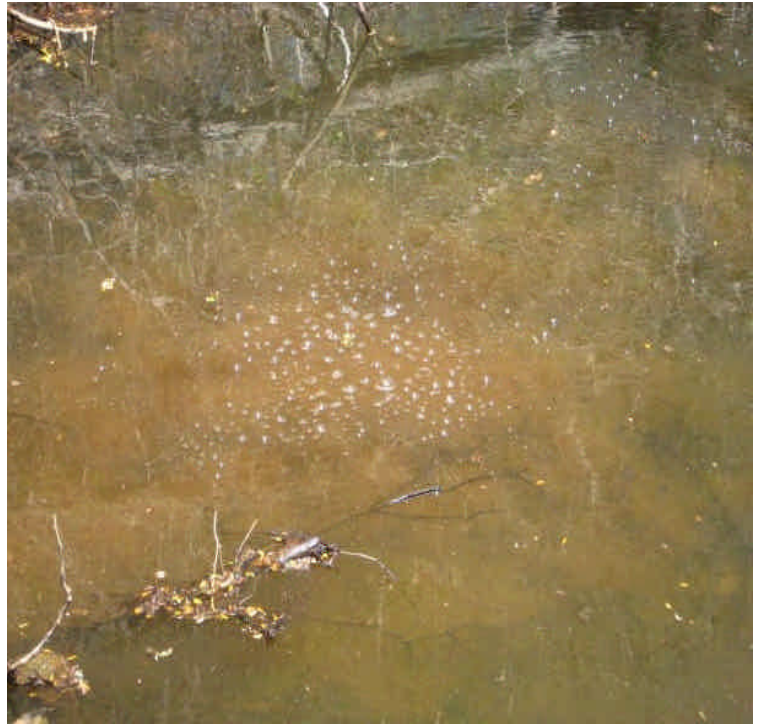
View of the turbidity generated as the snapping turtle buried itself in the substrate. Sediment appears to be fine and easily disturbed.

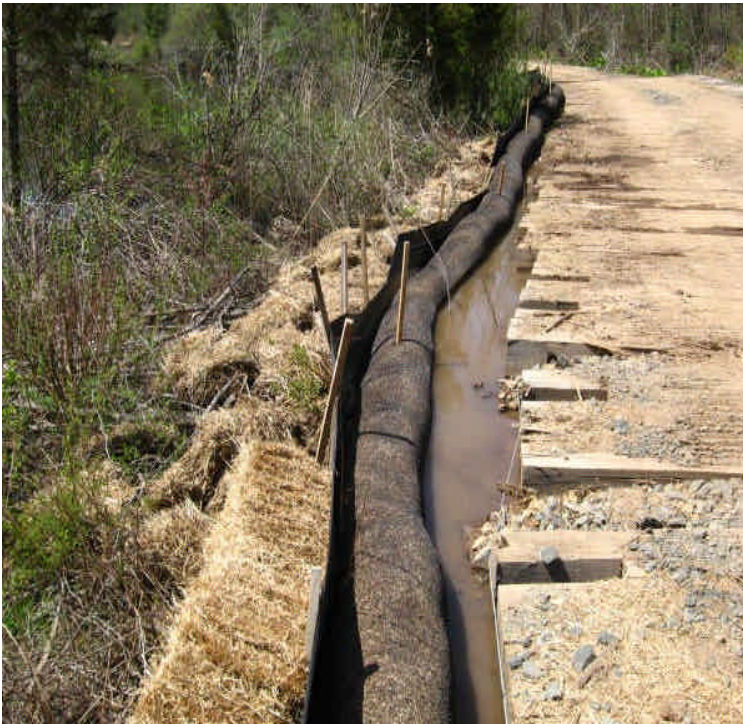
View of well installed haybales and fiber rolls at the timber mat crossing off Powder Hill Rd. Sediment is filtered from the run-off before it flows off-site in this area. A large amount of turbid water is still being retained here but is starting to recede.

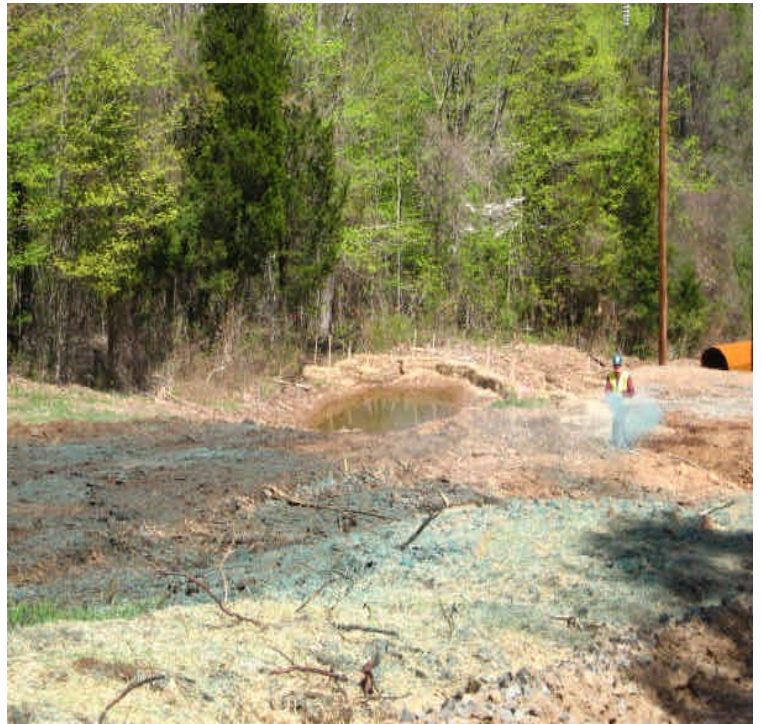
Hydroseeding was noted west of Powder Hill in an effort to restore the area.

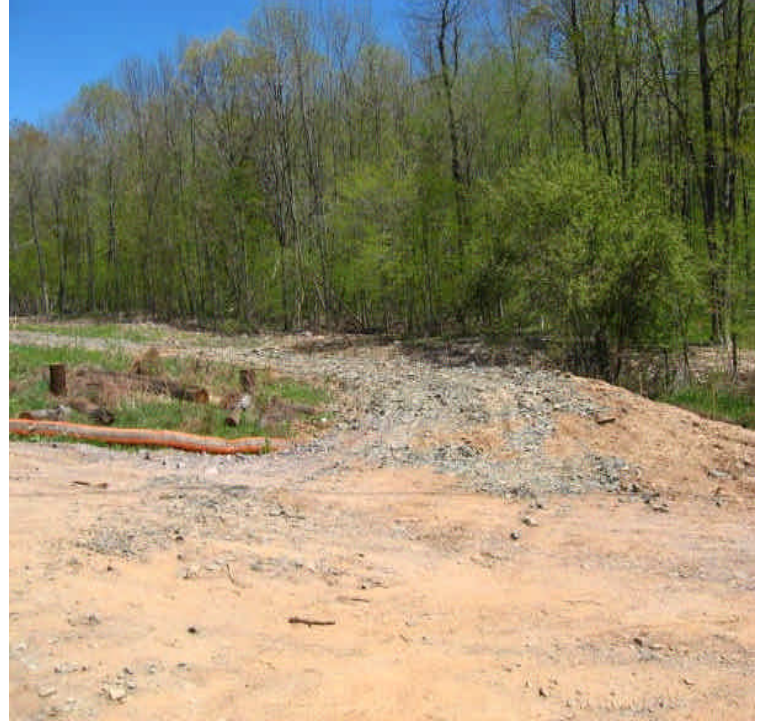
A line-pulling area north of Beseck SS has been graded and stone is in place to stabilize the area and reduce run-off. Haybales and filter sock barriers are in place for additional control.

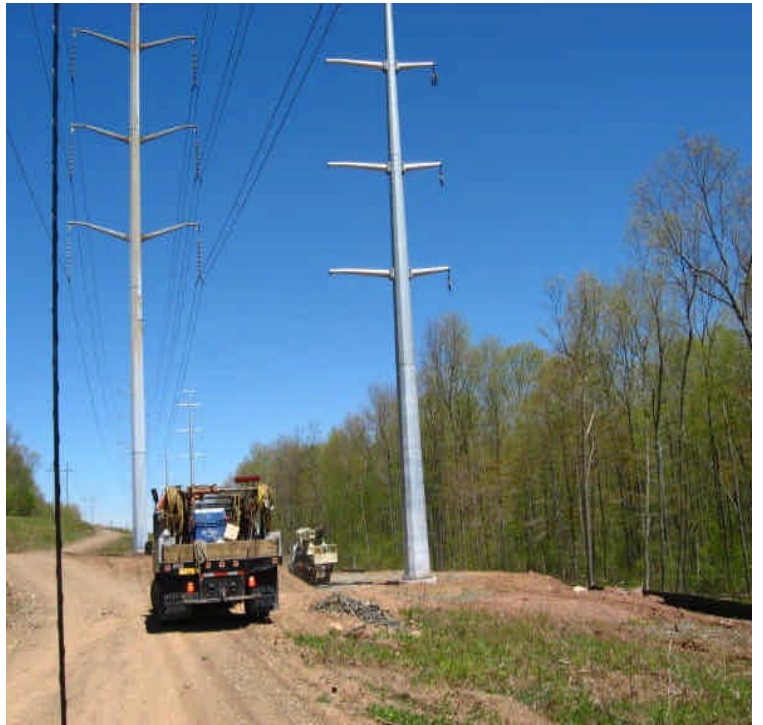
Crews were placing pulleys for wire/line installation north of Beseck SS.

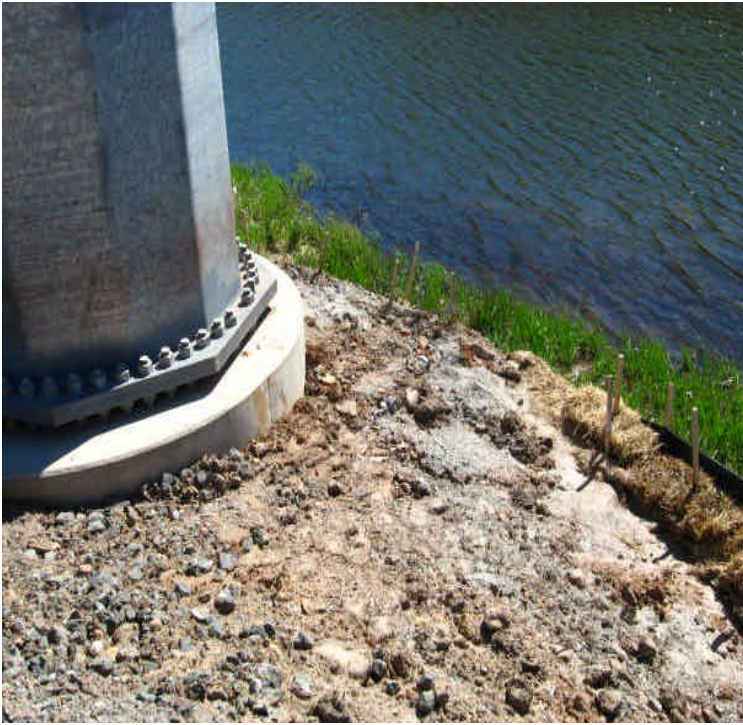
Controls remain in place along the pond north of Beseck SS to E. Meriden SS off Fleming Rd where pole installation is complete. However, sediment has filled controls to capacity and needs to be removed.

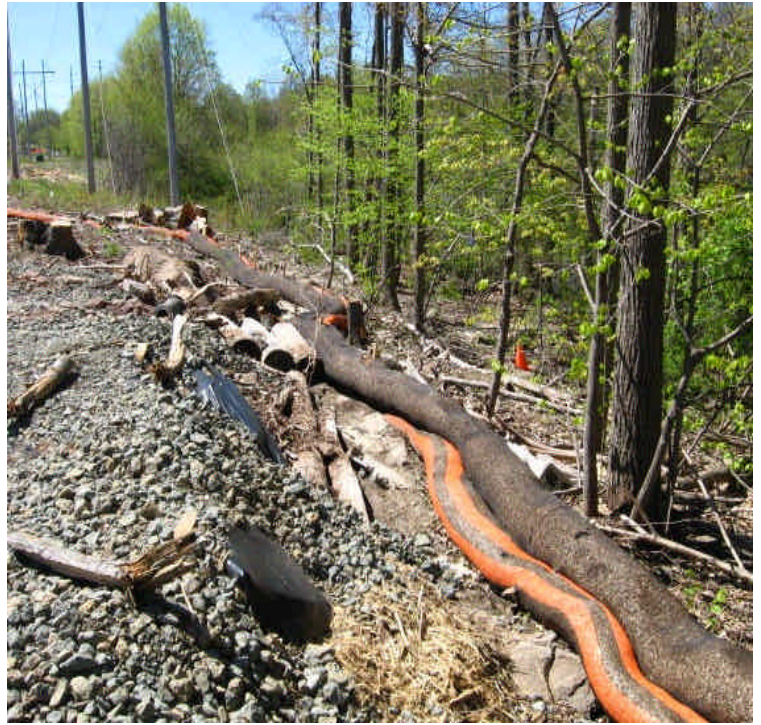
Filter socks just north of E. Meriden SS controls need to be toed in in order to work effectively. Haybales are in place at erosion prone areas for additional control.

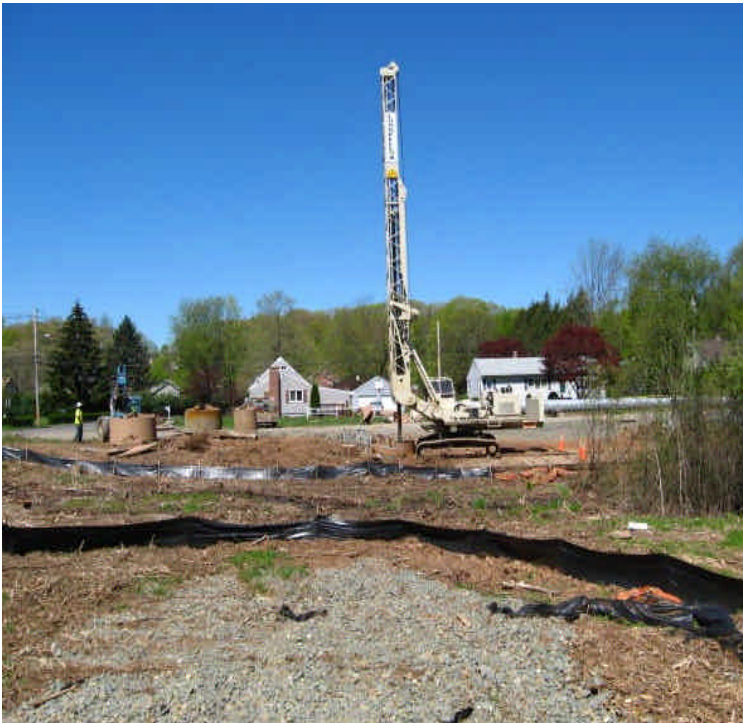
Foundation drilling upgradient from the wetlands just north of High Hill Rd. No sedimentation issues were noted; controls were in place.

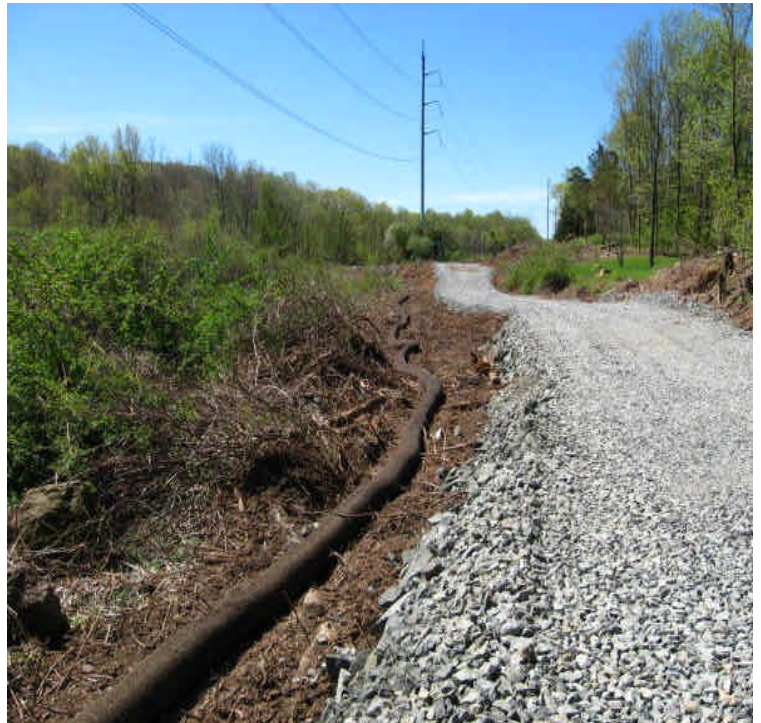
New access road and controls off East Main Street looking south.
