**Docket No. 272 – Development and Management Plan Inspection**

**Segment 1a Inspection**

**Date:** May 21, 2007

**Location:** Segment 1a – Scovill Rock Switching Station to Chestnut Junction, Oxbow Junction to Beseck Switching Station (excluding Royal Oak Bypass), and Black Pond Junction to Beseck Switching Station

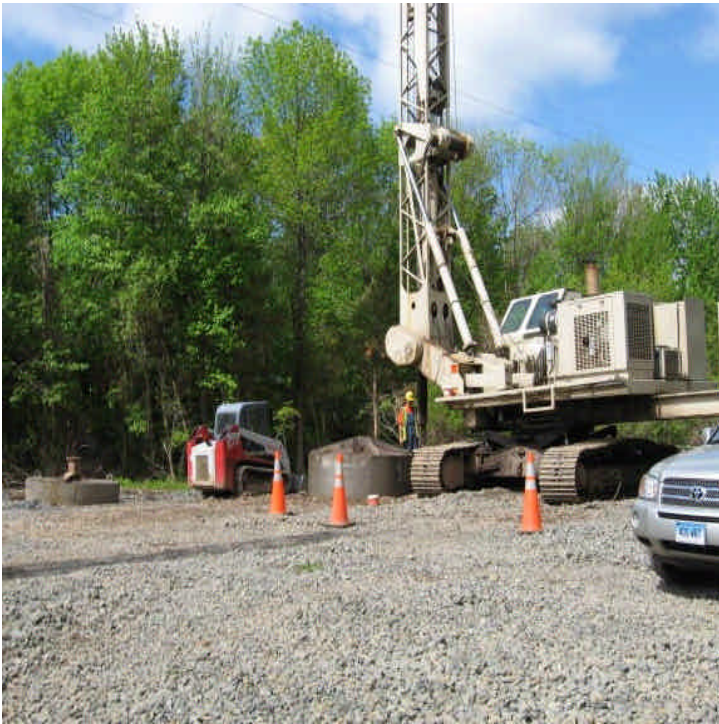
**View of foundation drilling off Haddam Quarter Road.**

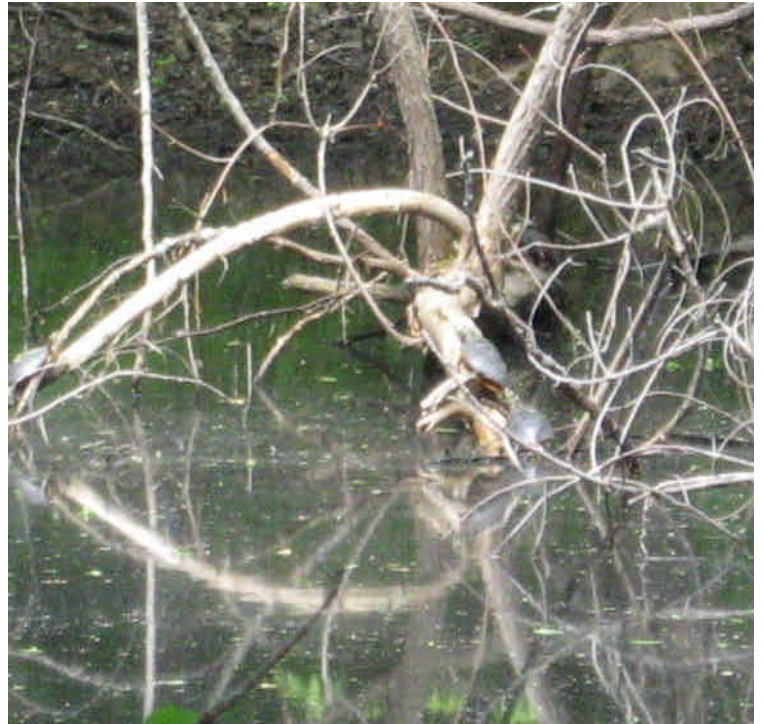
**Numerous painted turtles basing within the pond off Haddam Quarter Rd. Although not a state listed species, be mindful during equipment movement in this area.**

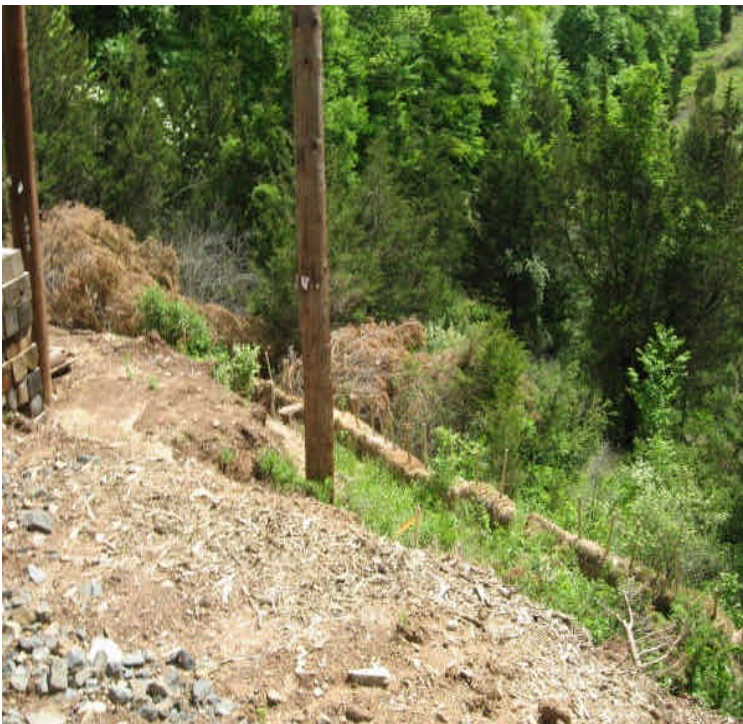
**Haybale line at the final pad upgradient from Ball Brook off Black Walnut Dr.**

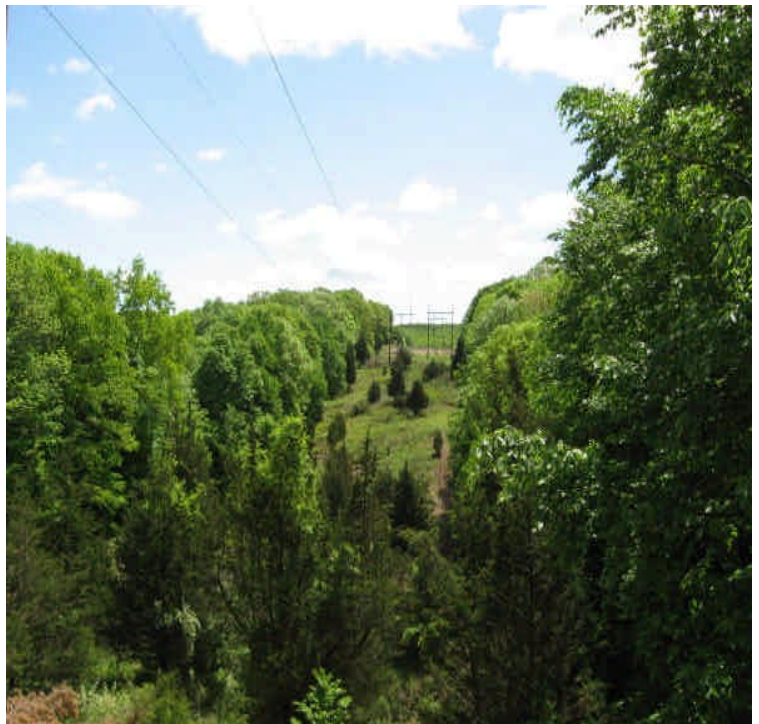
**View looking across Ball Brook off Black Walnut Dr. towards Arbutus St.**

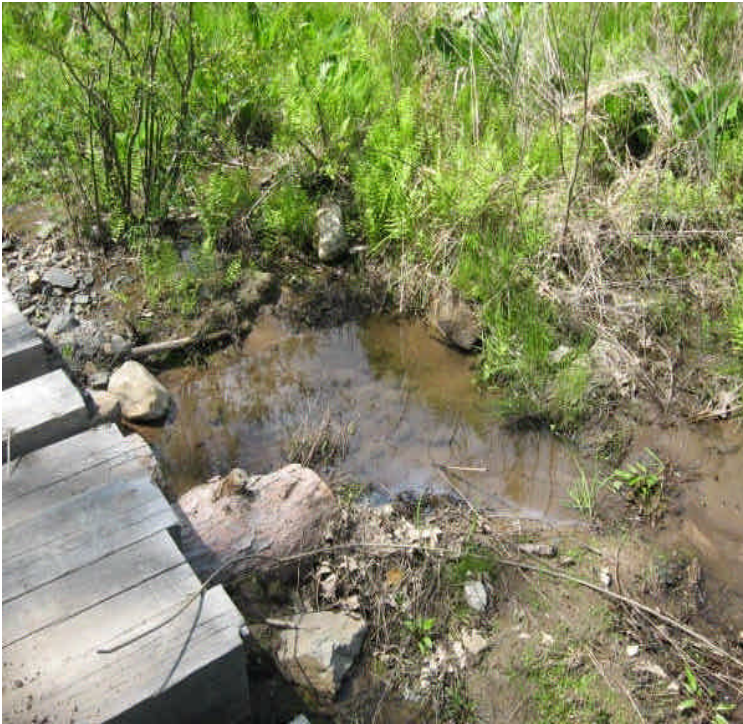
**Wetland crossing off Foot Hills Rd. No turbid run-off was noted.**

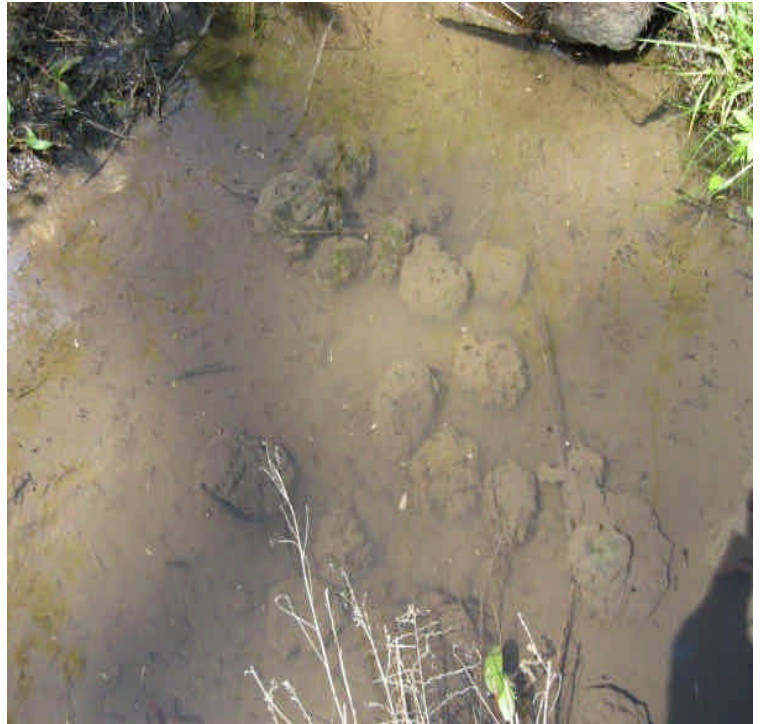
**Amphibian egg masses and tadpoles were noted in the ponded water adjacent to a timber mat crossing off Johnson Ln. Slight sedimentation was noted. Continue to prevent turbidity and sedimentation here to the extent possible.**

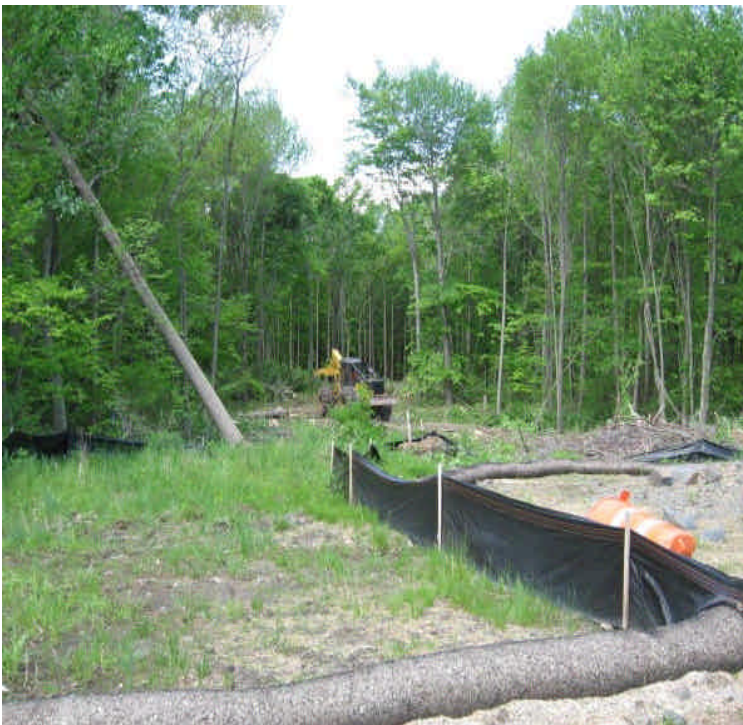
**View of the controls and clearing at 1B from the contractor receiving yard.**

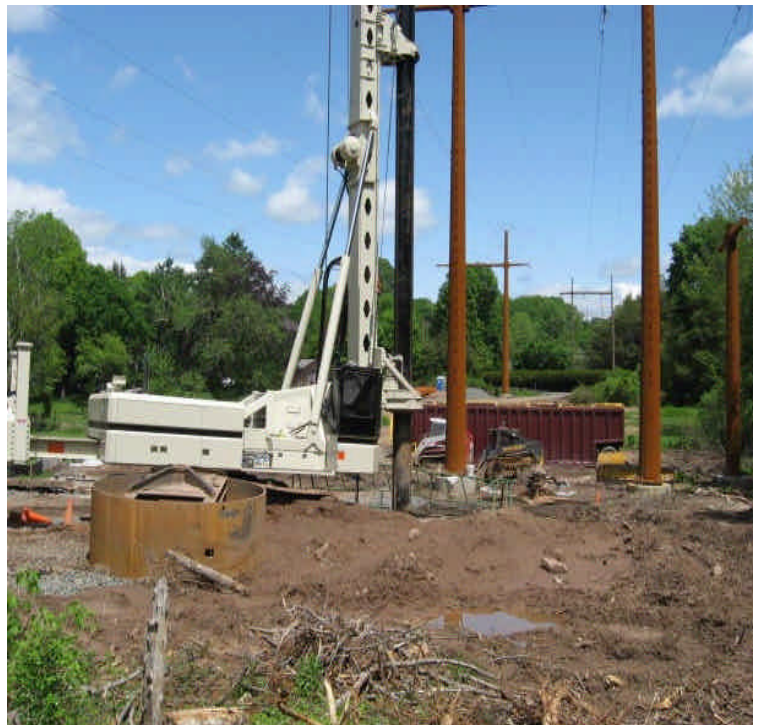
**Permitted drilling was occurring within wetlands off Little Lane. A settling tank was in place for any slurry containment.**

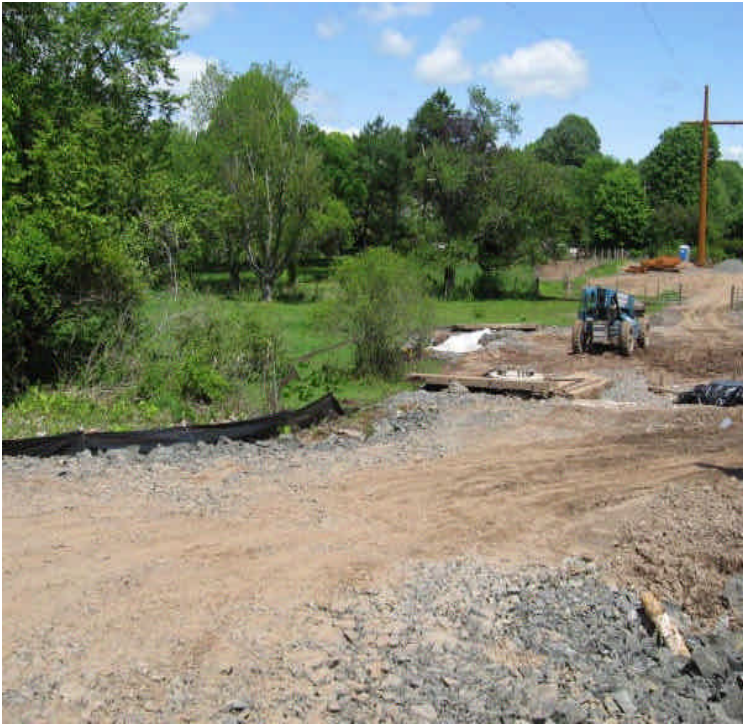
**View of the controls at the wetland crossing off Little Lane.**

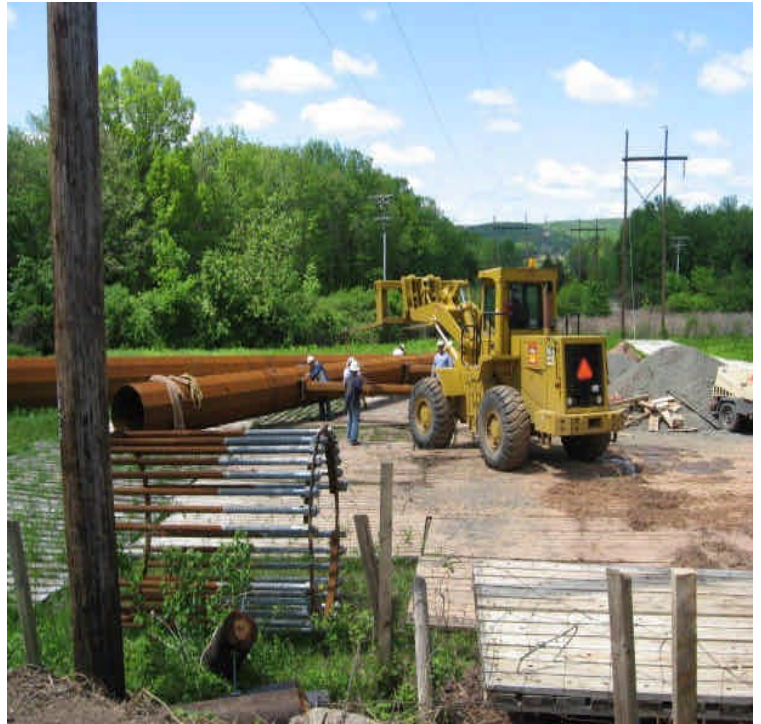
**Structure work noted off Cherry Hill Rd.**

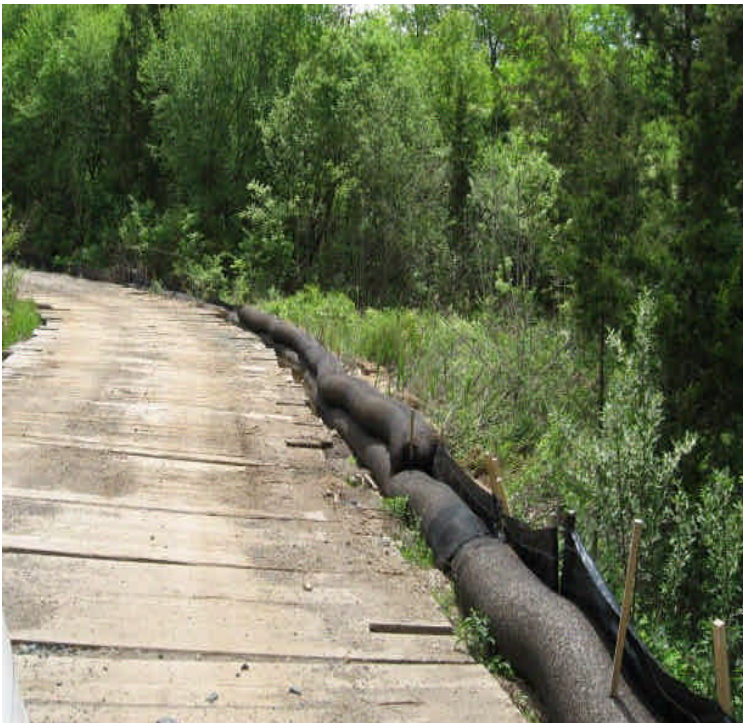
**View of well installed haybales and fiber rolls at the timber mat crossing off Powder Hill Rd. Sediment is filtered from the run-off before it flows off-site in this area. Turbid water previously retained here has fully receded.**

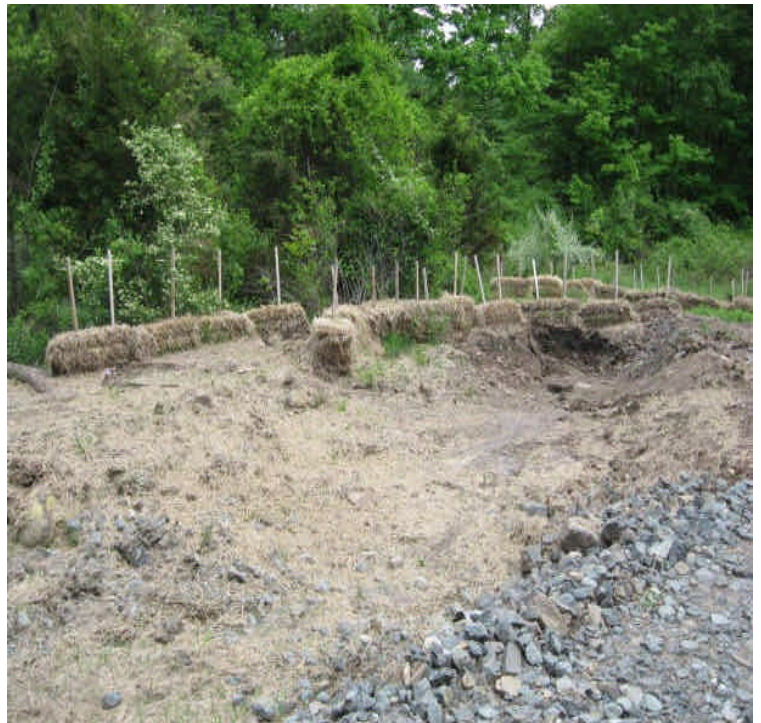
**Hydroseed and haybales remain in work areas west of Powder Hill in an effort to restore the area.**

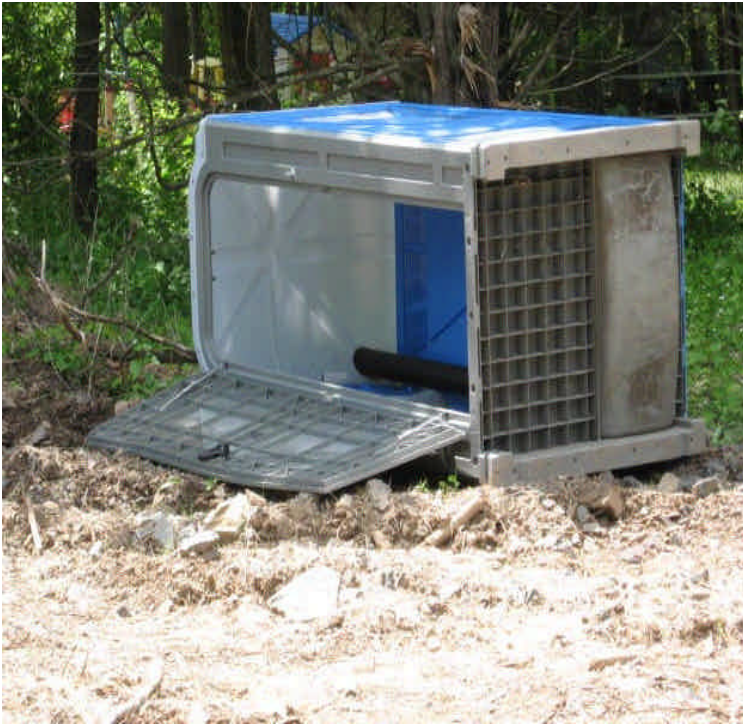
**A portable sanitary facility west of Powder Hill Rd. has tipped over. This should be righted and secured.**

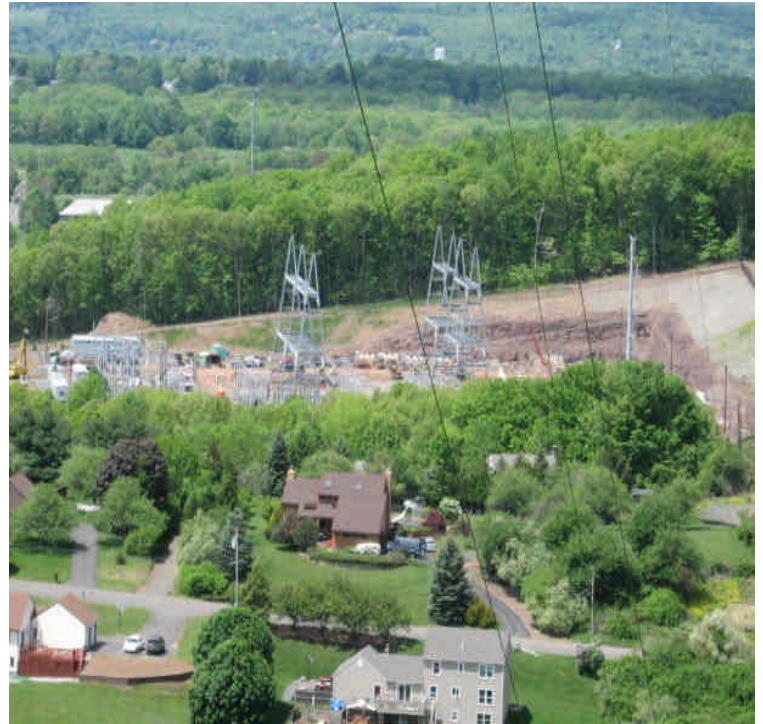
**Looking west from Beseck Mountain towards the construction at Beseck SS**

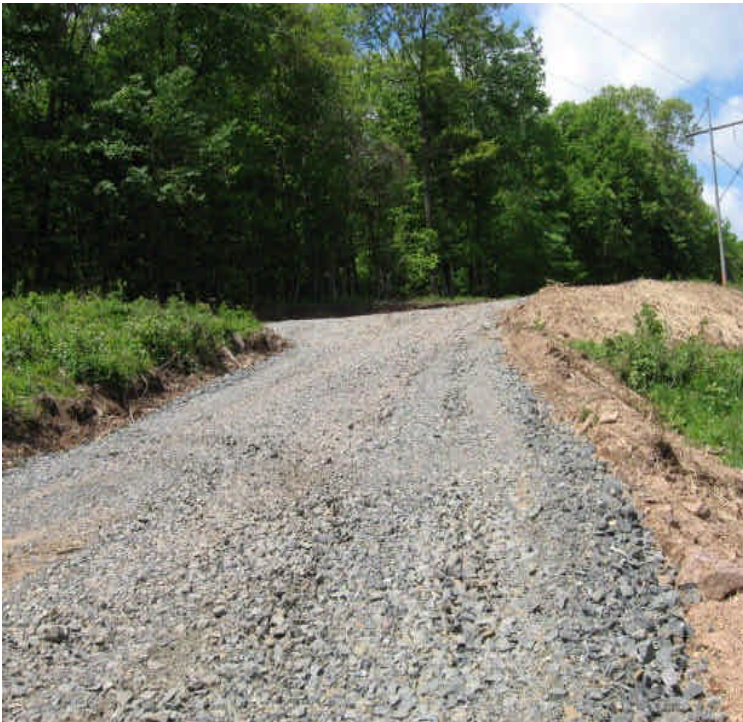
**New pad site and stone access area north of Beseck SS.**

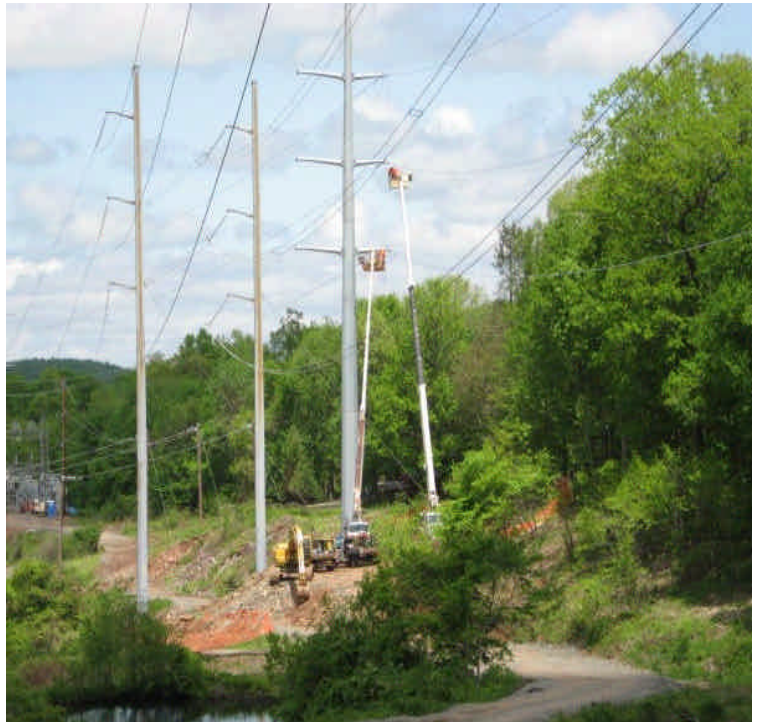
**Line installation continues near East Meriden SS.**

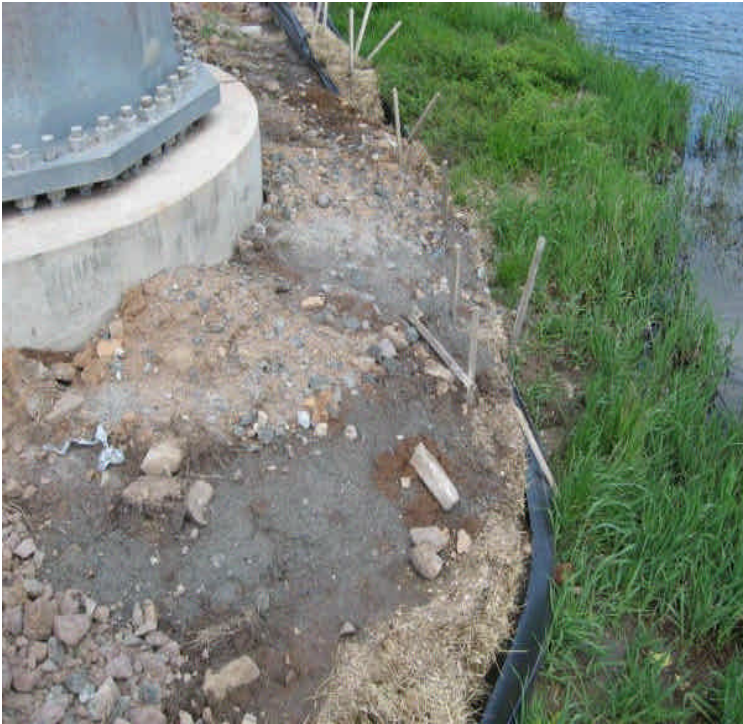
**Controls remain in place along the pond north of Beseck SS to E. Meriden SS off Fleming Rd where pole installation is complete. However, sediment has filled controls to capacity immediately adjacent to the pond and needs to be removed**

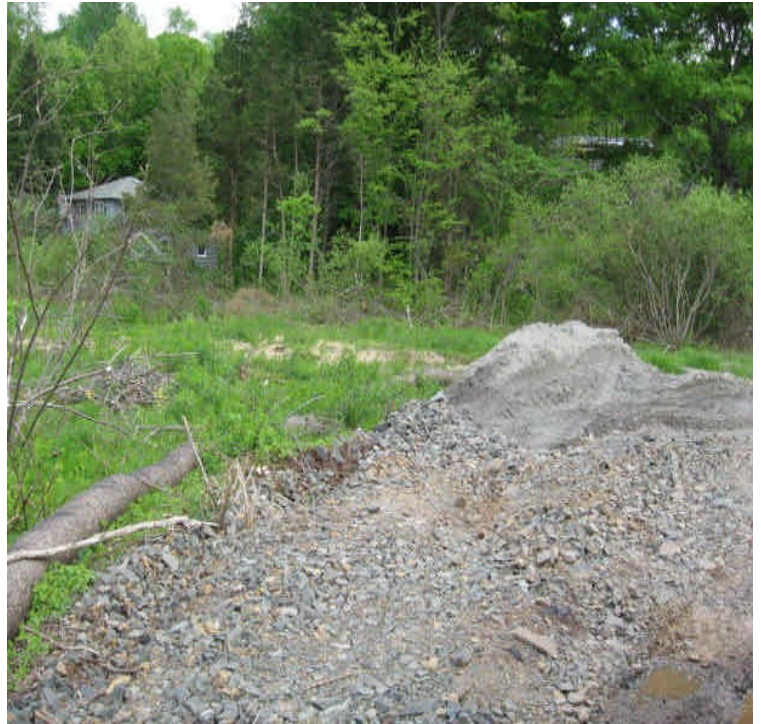
**Sediment pile located on access road in wetlands south of High Hill Rd. Remove pile and locate all stockpiles away from wetlands.**

Filter socks are in place along the edge of wetland areas. Stream banks remain mulched with hay and partial bales. 5/21/07	Ensure the controls are adequate for run-off in this area. 5/21/07	NA
	Area north of E. Meriden SS has reinforced controls to prevent turbid water from entering the nearby pond but filter socks are still not fully in place. 4/23-5/21/07	Ensure the controls are adequate for run-off in this area. Toe-in fiber rolls to ensure water doesn't channel underneath. 4/23-5/21/07	Controls were reinforced but needs some attention.
High Hill Rd. (north to Black Pond)	A soil stockpile was noted on the access road within controls but immediately adjacent to undisturbed wetlands. 5/21/07	Remove/relocate the stockpile and avoid placing materials near wetlands. 5/21/07	Needs attention

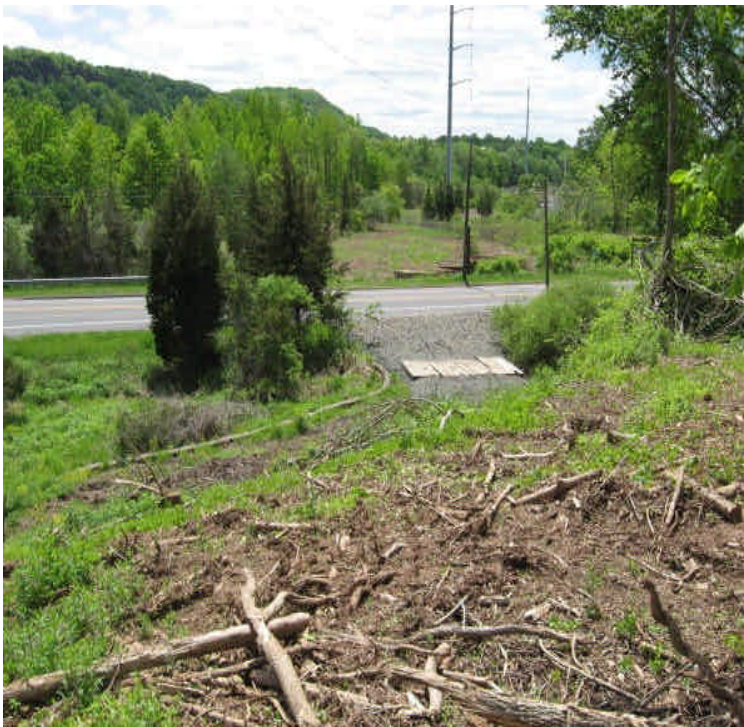
**Site access north of East Main Street. Controls/filter socks were installed.**

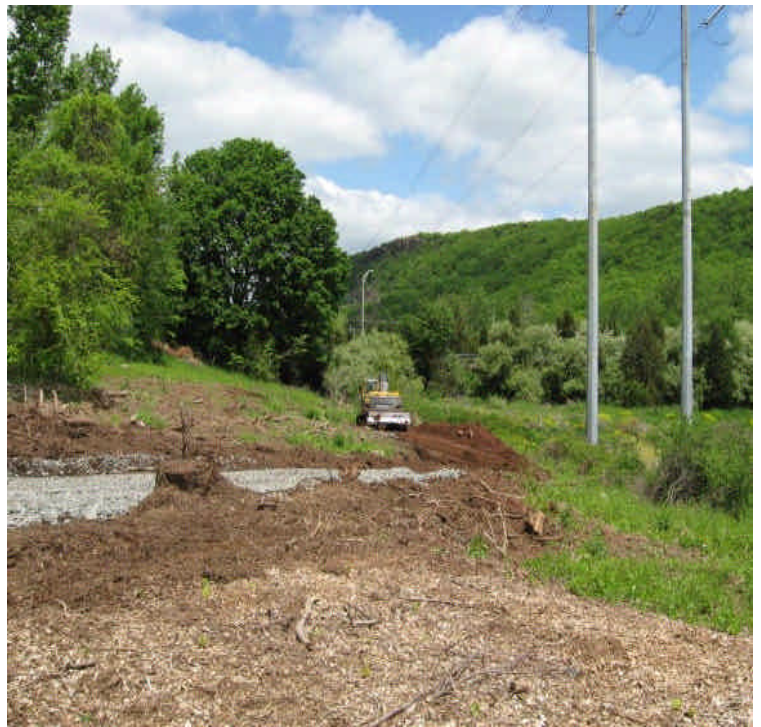
**Site work north of East Main Street. Controls need to be extended as work continues.**
