Docket No. 272 – Development and Management Plan Inspection

Segment 1b (Royal Oaks Bypass) Inspection

Date: May 7, 2007

Location: Segment 1b (Royal Oaks Bypass)

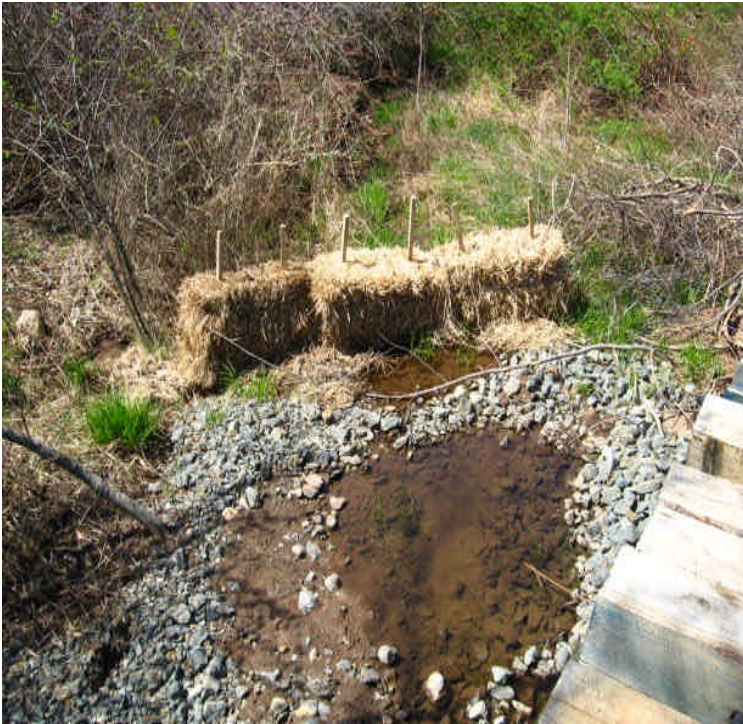
Stormwater controls remain adjacent to the timber mat crossing off Rte 17. Clear water was flowing off site.

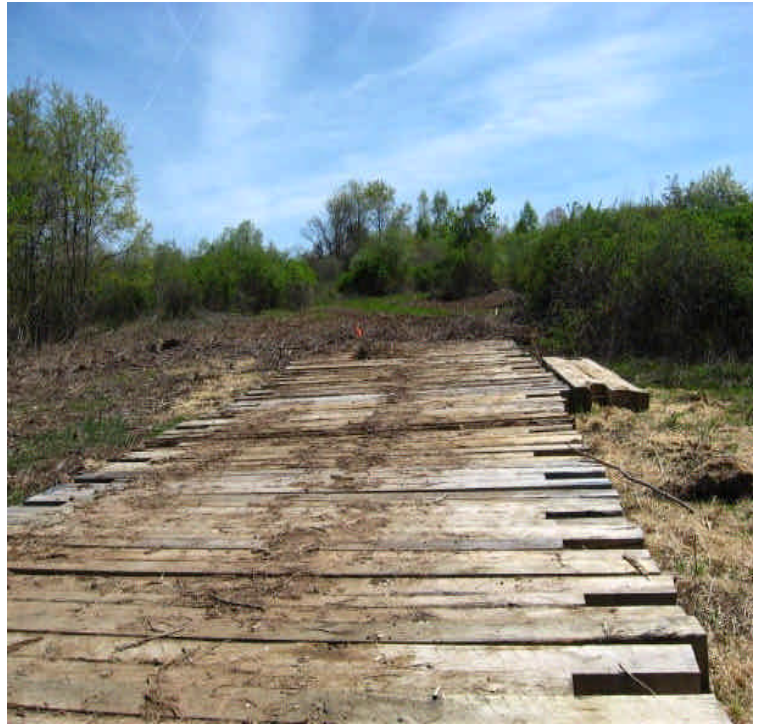
Hay mulch was spread at exposed soil along wetlands near Rte 17 to increase stability.

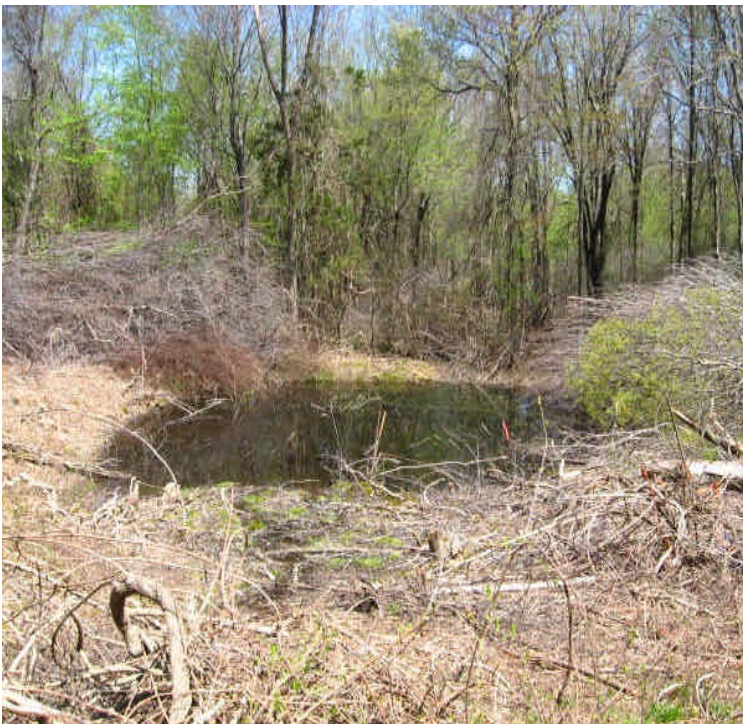
View of ponded area within the ROW and shrubs/roots retained.

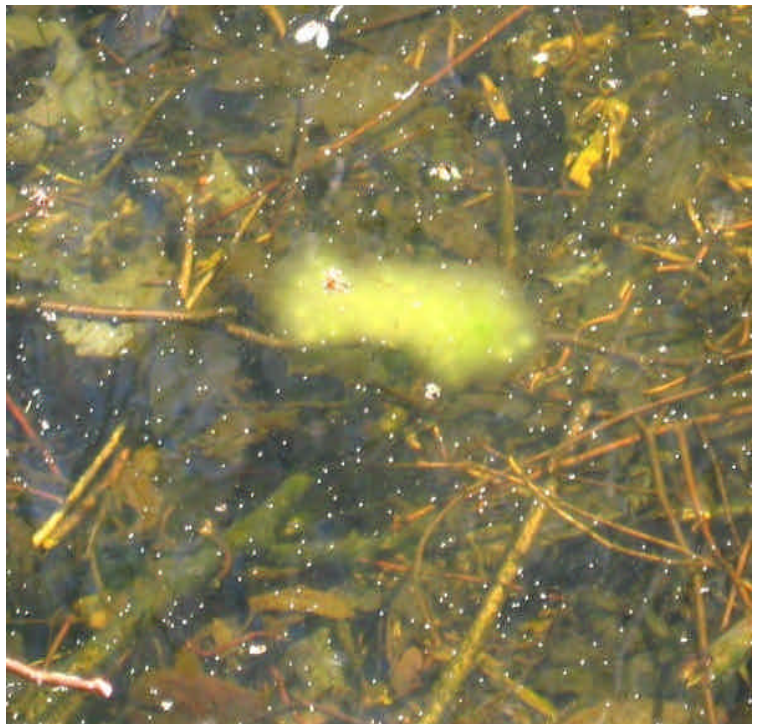
View of egg mass in the ponded area within the ROW. This pond was protected from direct impacts by using multiple access points into the ROW.
