**Docket No. 272 – Development and Management Plan Inspection**

**Segment 1b (Royal Oaks Bypass) Inspection**

**Date:** May 14, 2007

**Location:** Segment 1b (Royal Oaks Bypass)

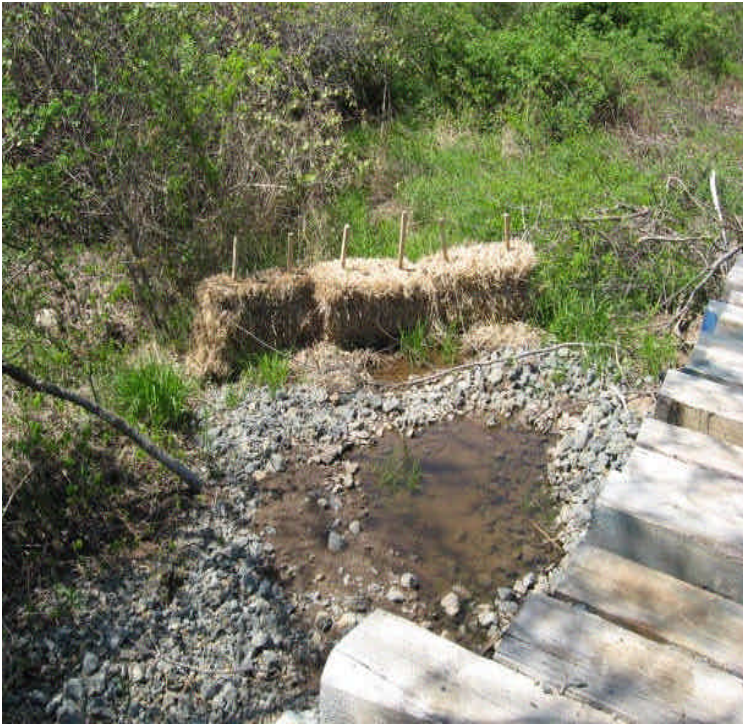
Stormwater controls remain adjacent to the timber mat crossing off Rte 17. Clear water was flowing off site.

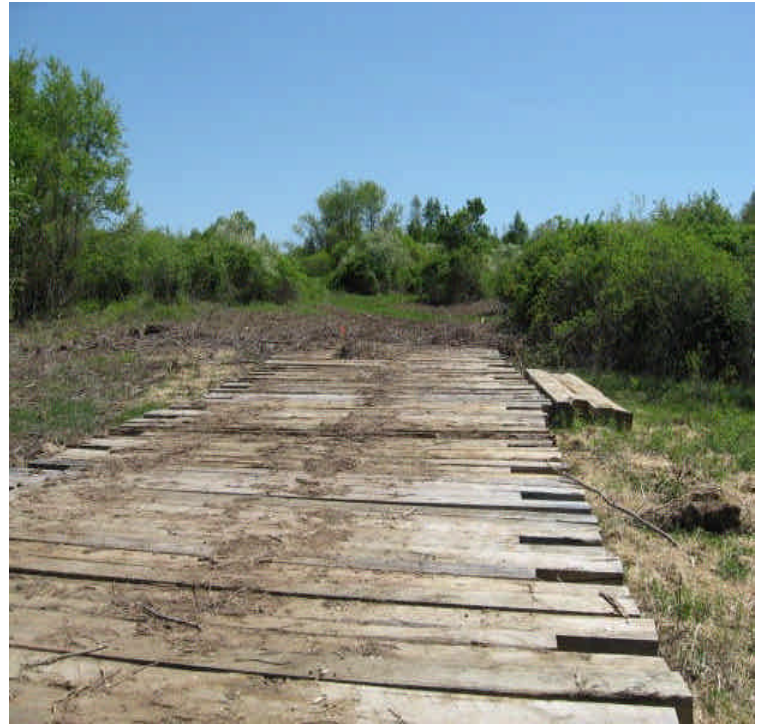
Hay mulch remains at exposed soil along wetlands near Rte 17 to increase stability.

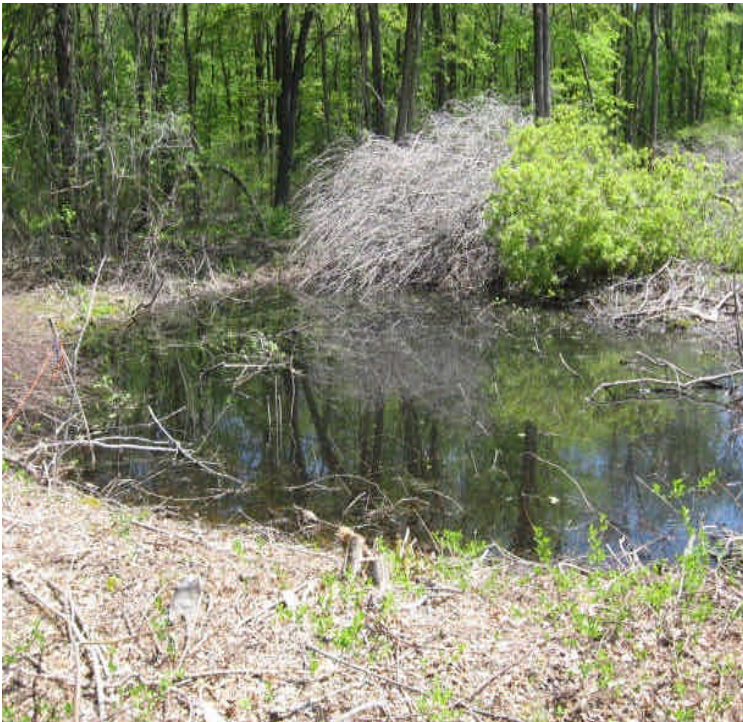
View of ponded area within the ROW with shrubs/roots retained.

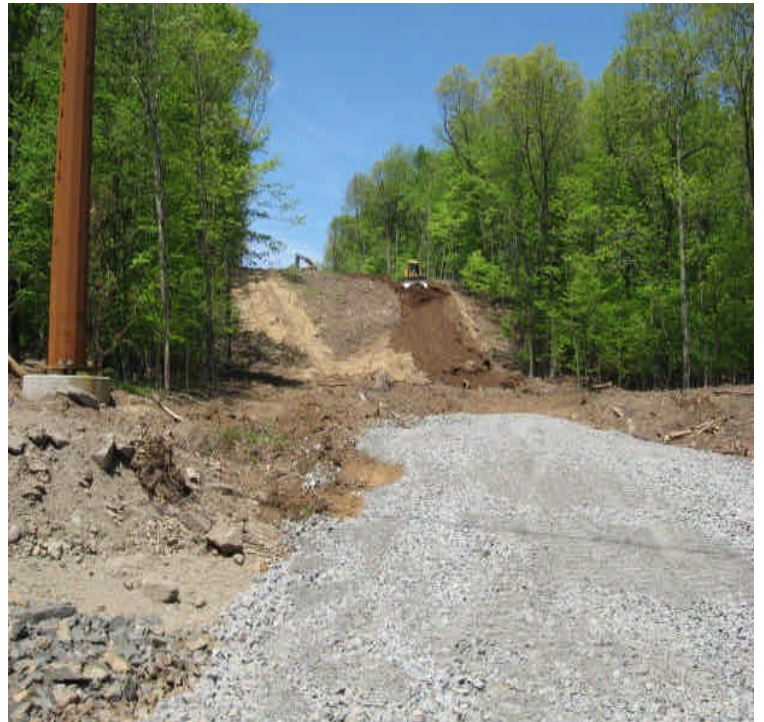
View of access road grading along a steep slope and installation of stone base. Controls such as erosion control blankets may be needed for stability/restoration here.
