Docket No. 272 – Development and Management Plan Inspection

Segment 2a Inspection

Date: May 8, 2007

Location: Segment 2a – Beseck Switching Station to Cheshire/Hamden Town Line

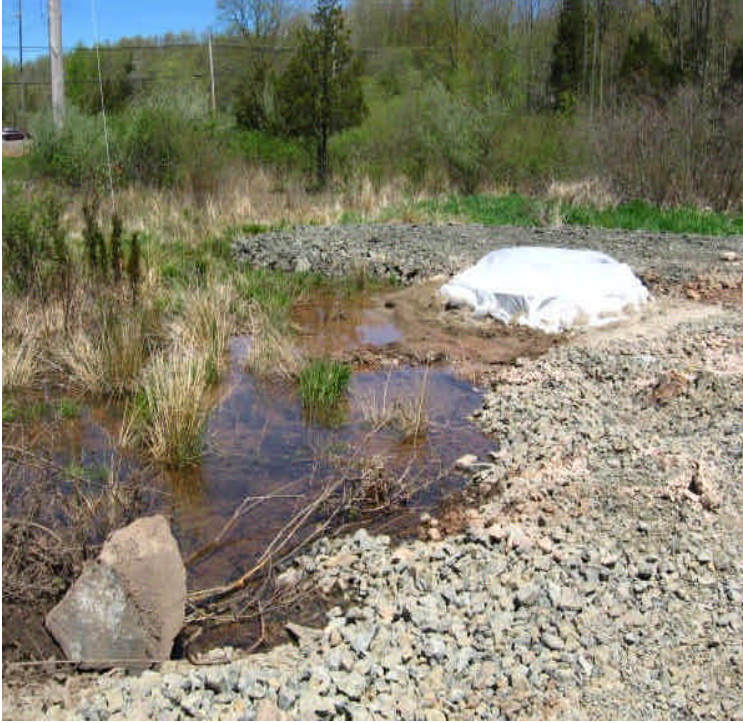
New foundation was installed within the wetland edge off Carpenter Lane. Place a filter sock between the exposed soil and the undisturbed portion of the wetland.

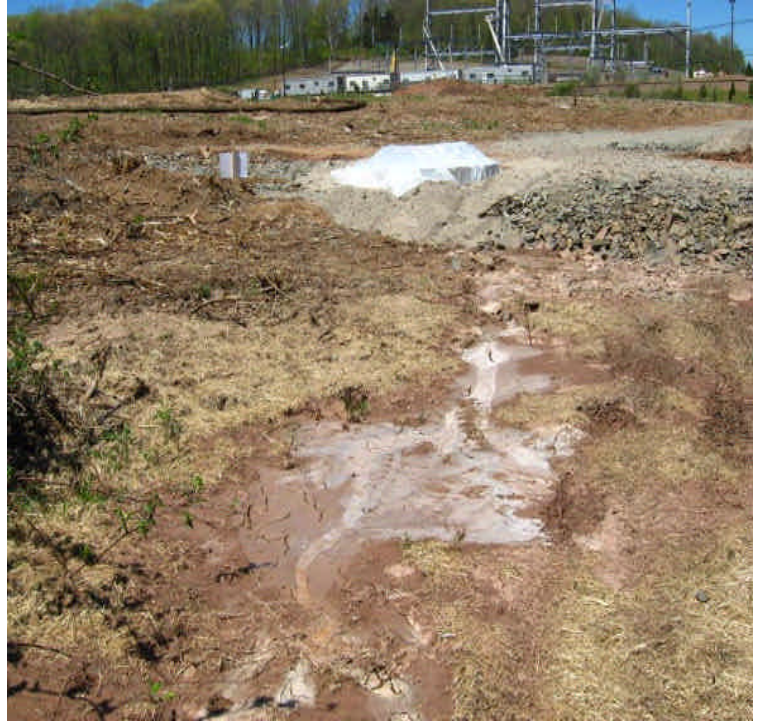
Slurry and sediment from a foundation had reached the edge of the and accumulated here against the haybales. Sediment over 2" deep should be carefully removed from the wetland by hand.

Dewatering	Dewatering was required at the foundations installed south of Carpenter Ln. and will be required when pouring the final foundation.	Monitor dewatering closely and remove slurry accumulation from wetlands. Maintain adequate controls when dewatering. See erosion	Needs evaluation

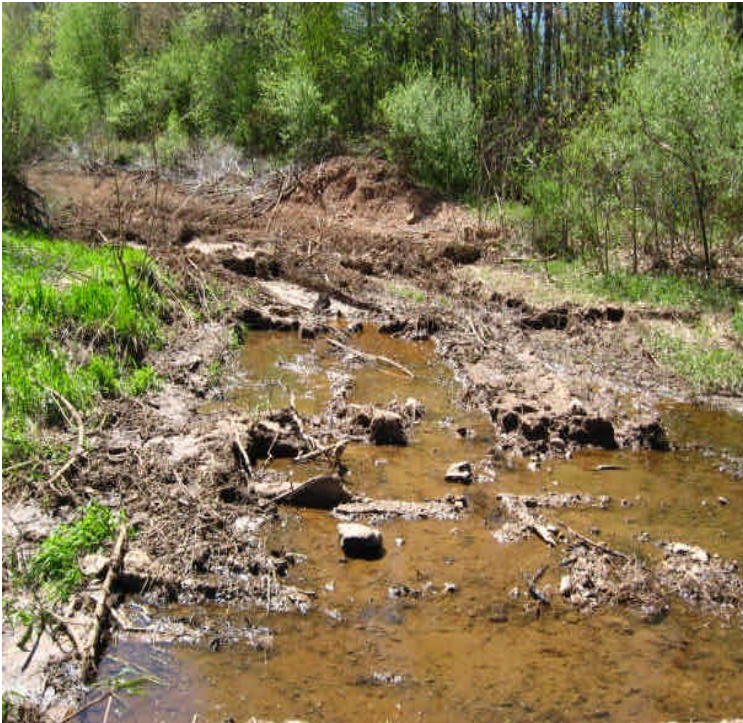
Wetland crossing off Williams Rd. Controls are needed to contain the disturbed soil and prevent run-off to the wetland.

Areas of Inspection	Observation	Recommended Action	Corrected Action
	<p>where timber mats had been at the stream crossing and wetlands off Williams Rd. Clear water run-off was noted but controls are needed to protect the undisturbed portion of the wetlands. 5/2-5/8/07</p>	<p>between the exposed soil and the undisturbed portion of wetlands. 5/8/06</p>	
	<p>According to the D&M plans, a potential vernal pool is located in this area. 5/8/07</p>	<p>See state listed species section for more details. 5/8/07</p>	<p>Needs evaluation and attention.</p>
<p>Powers Rd. & Woodhouse Ave.</p>	<p>Erosion controls remain along the stone pad at the wetland edge off Woodhouse Ave. The stone is stressing the silt fence and a section of it was crushed, however, run-off was not observed in the wetland 4/3-5/8/07</p>	<p>Monitor and maintain controls. Add controls as needed. 4/3-5/8/07</p>	<p>Needs some proactive attention</p>

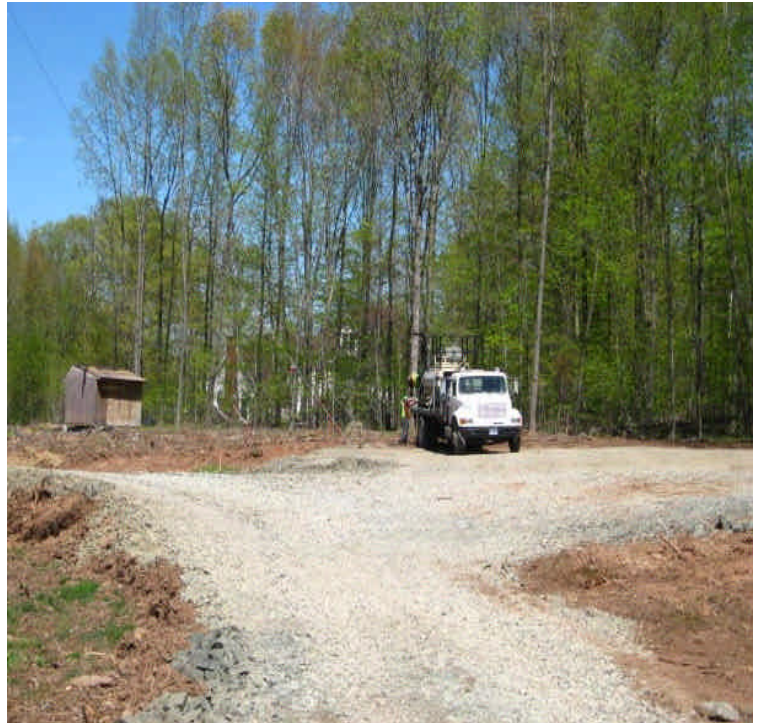
Crews were preparing to hydroseed exposed soil north of Stony Brook Road.

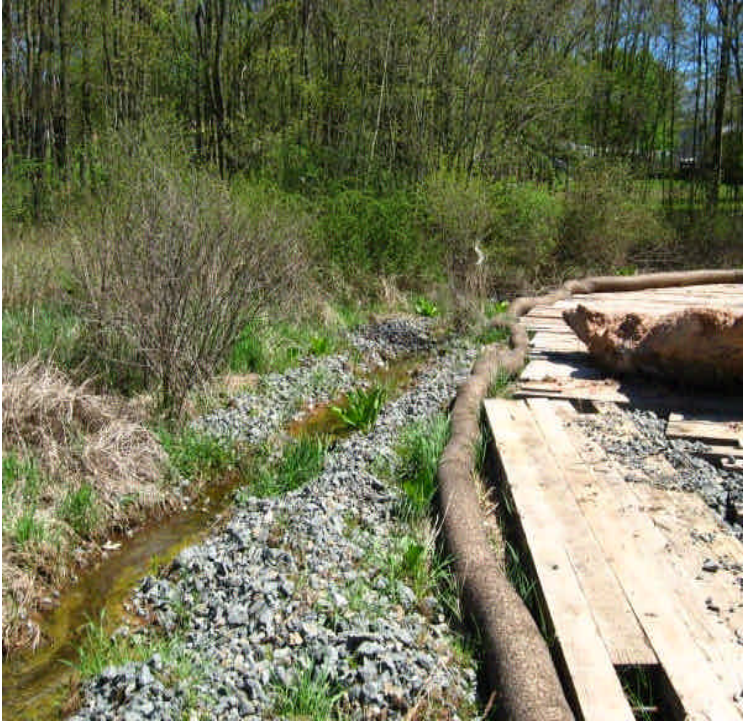
Controls and timber mats off Powers Road.

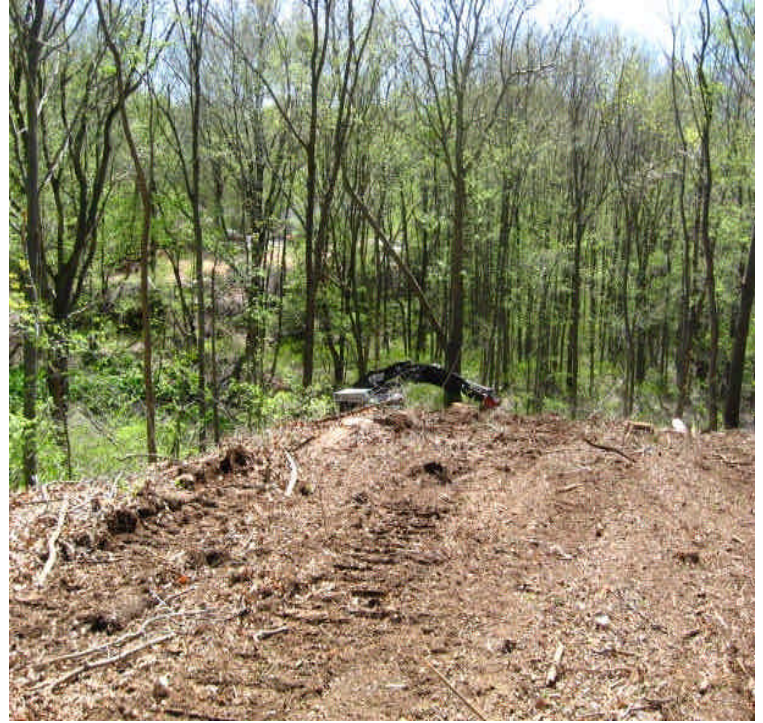
<p>State species of concern, threatened and endangered species.</p> <p>Woodhouse Ave.</p> <p>Liney Hall Rd.</p>	<p>According to the D&M plan, state-listed species are not located in the current work areas. However, an Eastern box turtle was accidentally crushed by equipment in the new ROW clearing off Woodhouse Ave. This area was not marked as a potential area for Eastern box turtles according to the D&M plan, DEP response letter and NDDDB website. 5/8/07</p> <p>Several frog and salamander egg masses were noted within a pool located off Liney Hall Ln. 5/9/07</p>	<p>Now that the Eastern box turtle has been discovered in this area, it should receive the same attention as known protected habitat area along the ROW. Sweeps for turtles should be performed regularly in this area before equipment progresses. 5/8/07</p> <p>Prevent turbidity and direct impacts to this area to the extent feasible. 5/9/07</p>	<p>The turtle observation was reported appropriately and sweeps should now be performed.</p> <p>NA</p>

Clearing new ROW off Woodhouse Avenue on a steep slope adjacent to wetlands and previously unidentified Eastern box turtle habitat. Crews should now treat the area as habitat and perform turtle sweeps prior to equipment movement.

<p>Clearing was occurring adjacent to wetlands along a steep slope off Woodhouse Ave. 5/8/07</p>	<p>As soil is exposed, add controls to protect wetland and carefully monitor the area. 5/8/07</p>	<p>NA at this time.</p>
	<p>A small riprap diversion moves run-off around the timber mats, through a riprap channel flowing off-site and into silt fence barriers. 5/8/07</p>	<p>Monitor controls for effectiveness. Clean sediment from riprap as needed. 5/8/07</p>	<p>NA</p>
<p>S. Turnpike + Merritt Parkway Area</p>	<p>The slope did not have any new erosion issues. The silt fence along the base of slope remains intact. 5/8/07</p>	<p>Monitor access road slope for future washout or erosion issues, add controls/diversions if needed 5/8/07</p>	<p>NA</p>
<p>Mansion Rd.</p>	<p>An existing riprap slope and culvert are present near the entrance from the road. Controls remain intact. 5/8/07</p>	<p>Continue to monitor and adjust controls in this area. Remove sediment as needed. Evaluate whether a run-off diversion is needed. 5/8/07</p>	<p>Continue to evaluate.</p>

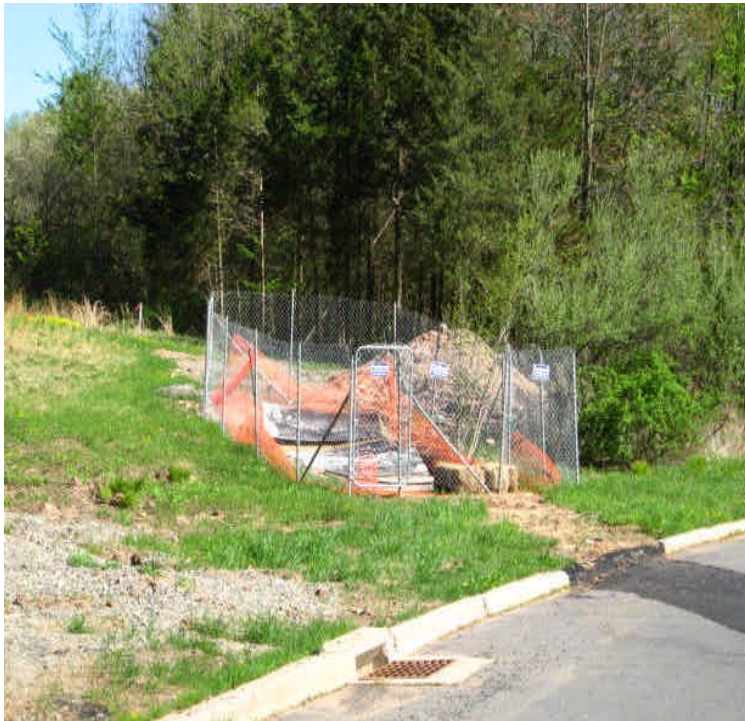
An area of adjacent exposed soil and leftover fill is located in the overhead ROW off Old Farms Rd. Extra material should be removed or controlled and the disturbed area should be stabilized.

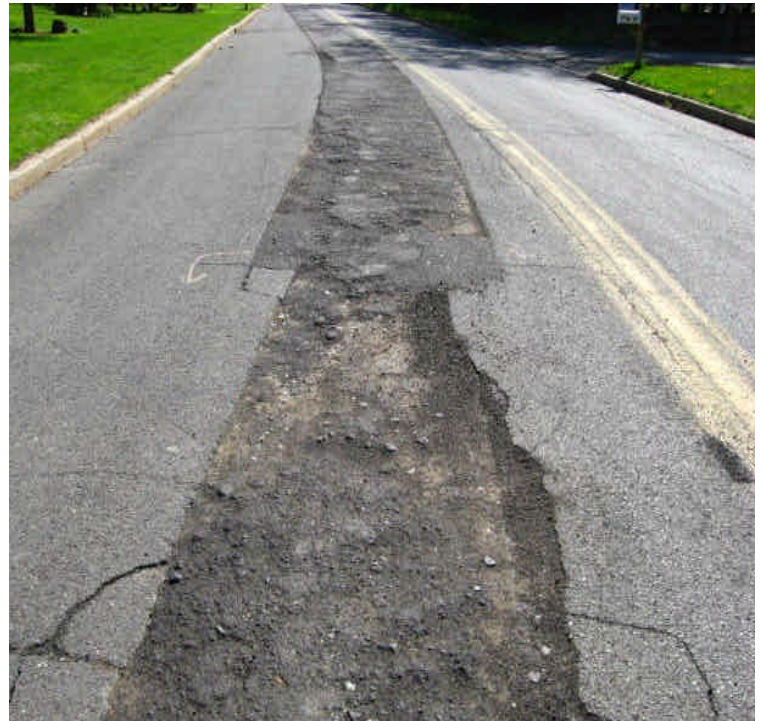
<p>Old Farms Rd. (115kV Underground trench-work)</p>	<p>Some loose asphalt “crumbling” is still noted at the trench patch but looks better. Small potholes have developed with the recent rains. (Noted since 4/24) The patch continues to deteriorate. 5/8/07</p>	<p>Arrangements to re-pave and finish the road surface should be made as soon as feasible. Continue to clean loose asphalt until area can be properly repaved. 4/24-5/8/07</p>	<p>Needs regular attention and evaluation.</p>

The asphalt patch along the trench along Old Farms Road is deteriorating and asphalt continues to crumble and accumulate along the roadway. Crews should finalize this surface as soon as feasible.
