**Docket No. 272 – Development and Management Plan Inspection**

**Segment 2a Inspection**

**Date:** May 22, 2007

**Location:** Segment 2a – Beseck Switching Station to Cheshire/Hamden Town Line

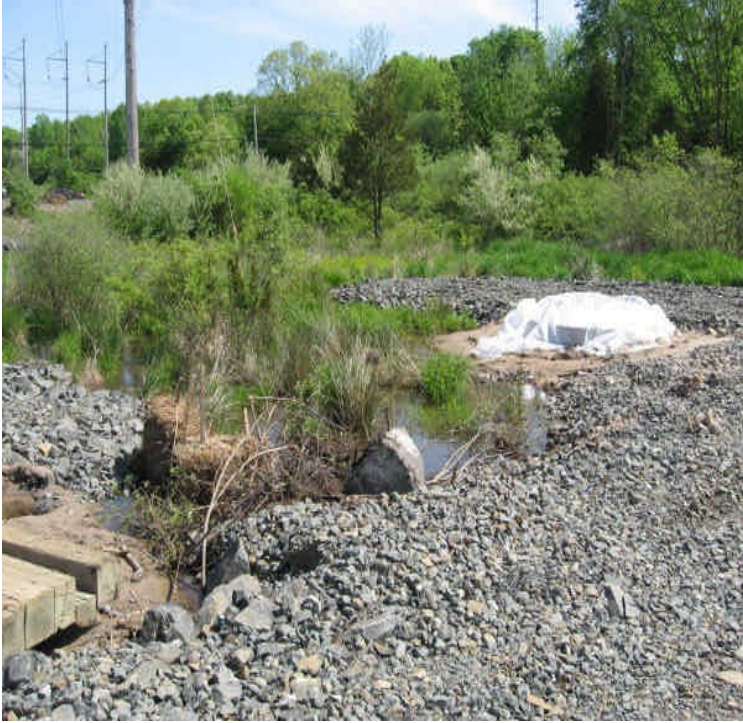
**The foundation is in place within the wetland edge off Carpenter Lane. Place a filter sock between the exposed soil and the undisturbed portion of the wetland.**

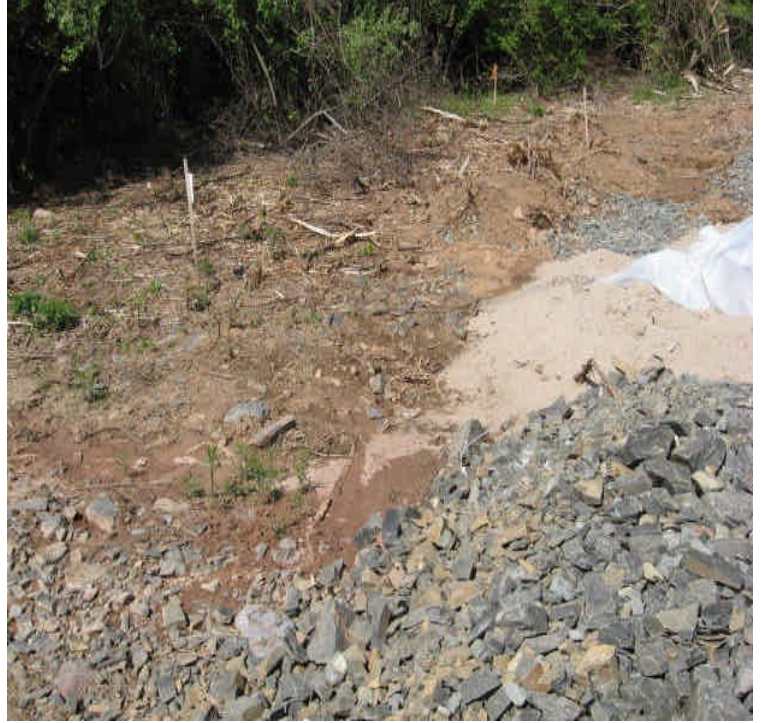
**Slurry and sediment from a foundation had reached the edge of the and accumulated here against the haybales. Sediment over 2" deep should be carefully removed from the wetland by hand.**

<p><b>Dewatering</b></p>	<p><b>Dewatering was required at the foundations installed south of Carpenter Ln. and will be required when pouring the final foundation. Some slurry did migrate to the line of controls at the wetland. 5/8-5/22/07</b></p>	<p><b>Monitor dewatering closely and remove slurry accumulation from wetlands. Maintain adequate controls when dewatering. See erosion control section. 5/8-5/22/07</b></p>	<p><b>Needs evaluation and attention.</b></p>

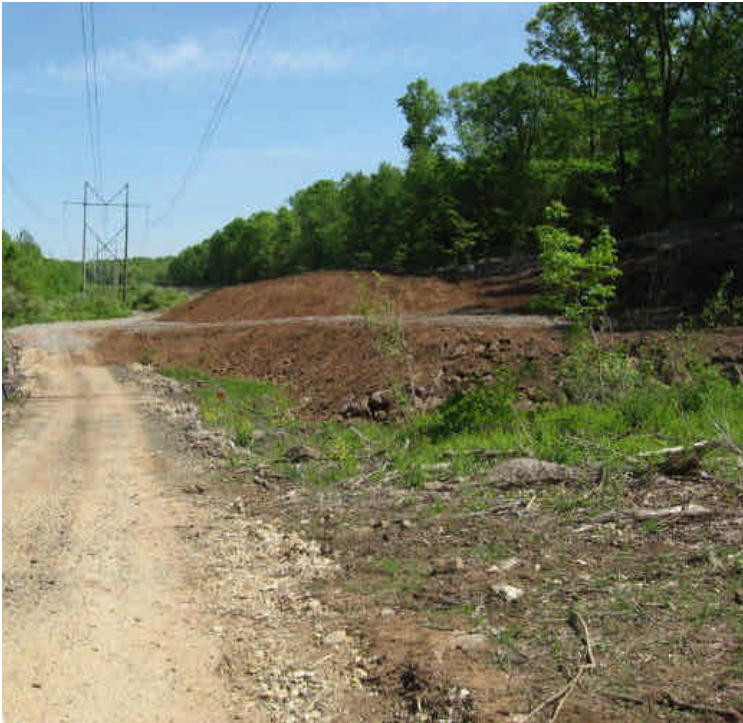
**New pad site installed upgradient from a wetland crossing off High Hill Rd. Controls should be installed to contain exposed soil where needed.**

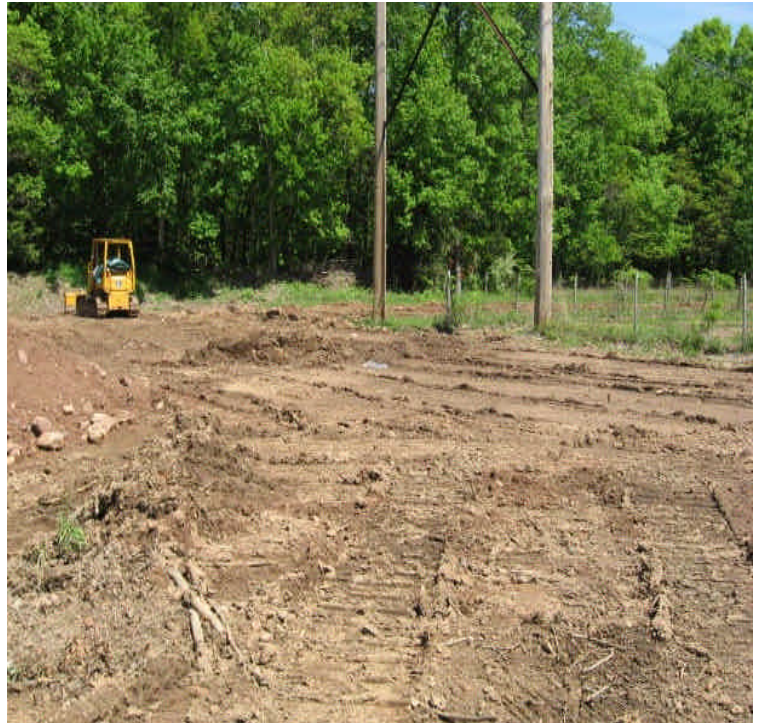
**Williams Rd. ROW. The grading work noted here was performed by the landowner.**

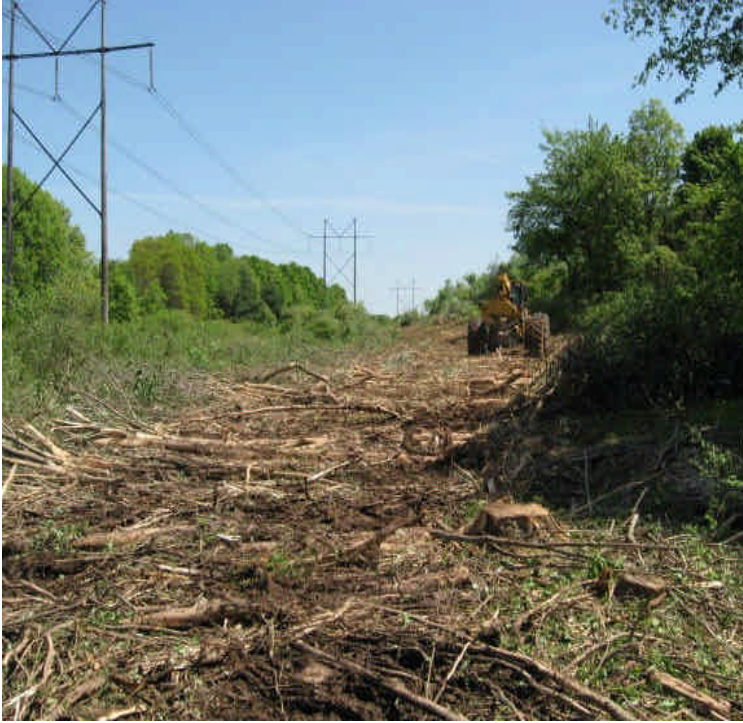
**Wetland crossing using timber/corduroy off Powers Road.**

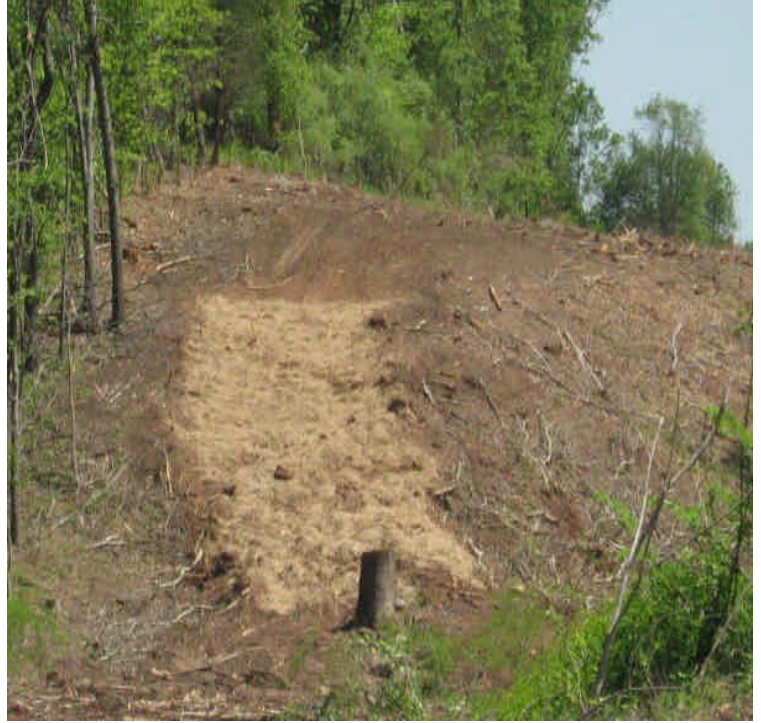
**Looking toward Woodhouse Ave., new mulch placed on a steep slope upgradient from wetlands and Eastern box turtle habitat.**

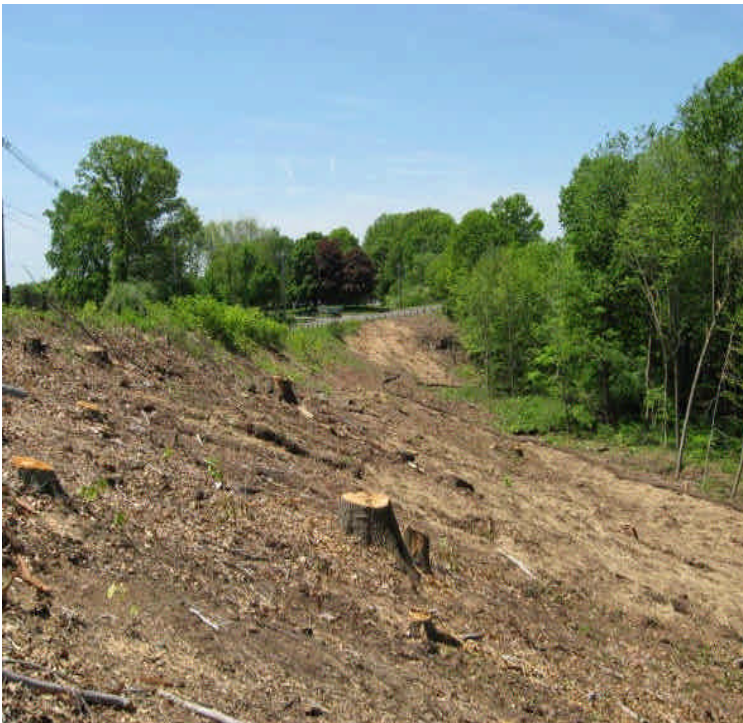
**View of clearing off Harrison Rd. along a steep slope upgradient from a wetland. Hay and seed were placed along the slope**

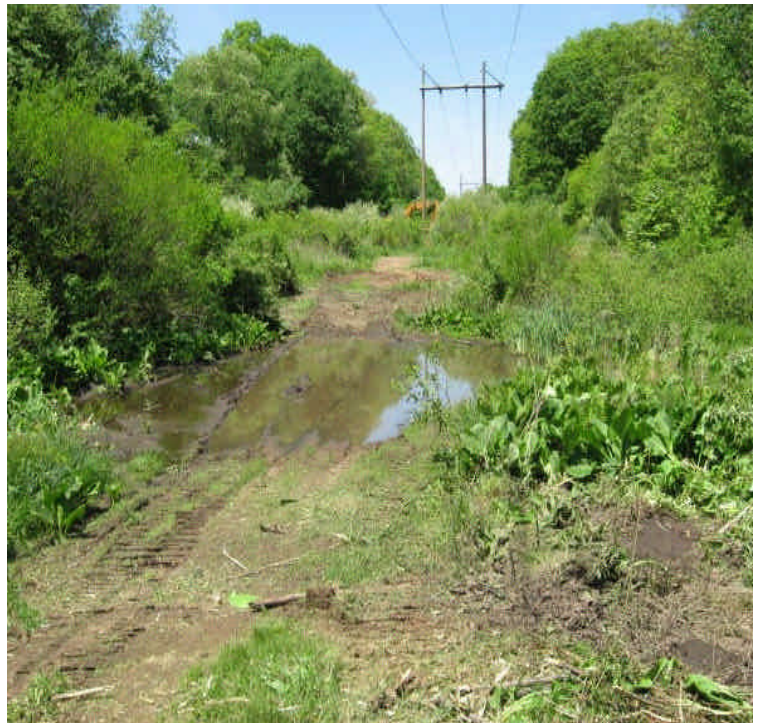
<p>Pond Hill Rd.</p>	<p>Clearing crews accessing northwest and southeast of Pond Hill Rd. Several wetland crossings were noted, including a small pond with tadpoles and egg masses. Water in pond was turbid from equipment and appropriate crossing techniques were not observed. 5/22/07</p>	<p>Limit pond crossing and impacts to the extent feasible. Add controls and appropriate crossing measures. 5/22/07</p>	<p>Needs attention/evaluation.</p>
<p>Old Farms Road</p>	<p>Plywood is being used to reduce impact to the driveways crossing the ROW from equipment crossing. Two driveways have some minor marks from equipment. 12/27/06-5/22/07</p> <p>No run-off from the low, saturated spot (filled during access road construction) noted during this inspection. In the past, turbid run-off has been observed reaching Old Farms Rd and entering a CB, flowing directly to receiving wetlands off-site at one driveway. 5/22/07</p>	<p>Continue to monitor for sediment on roadway and driveways; continue to use rubber mats or plywood to protect driveways. 12/27/06-5/22/07</p> <p>Monitor run-off and hydrology in the area and add controls as needed. 12/18/06-5/22/07</p> <p>Evaluate whether pre-existing drainage patterns were altered during construction. It appears run-off diversion is necessary. 2/21-5/22/07</p>	<p>Plywood is used to protect driveways from equipment damage (proactively).</p> <p>No immediate issues; needs future evaluation and attention.</p>

**New clearing and small pool crossing off Pond Hill Rd. Controls and approved crossing method are needed.**
