**Docket No. 272 – Development and Management Plan Inspection**

**Segment 2b Inspection**

**Date:** June 22, 2007

**Location:** Segment 2b – Cheshire/Hamden Town Line to East Devon Substation

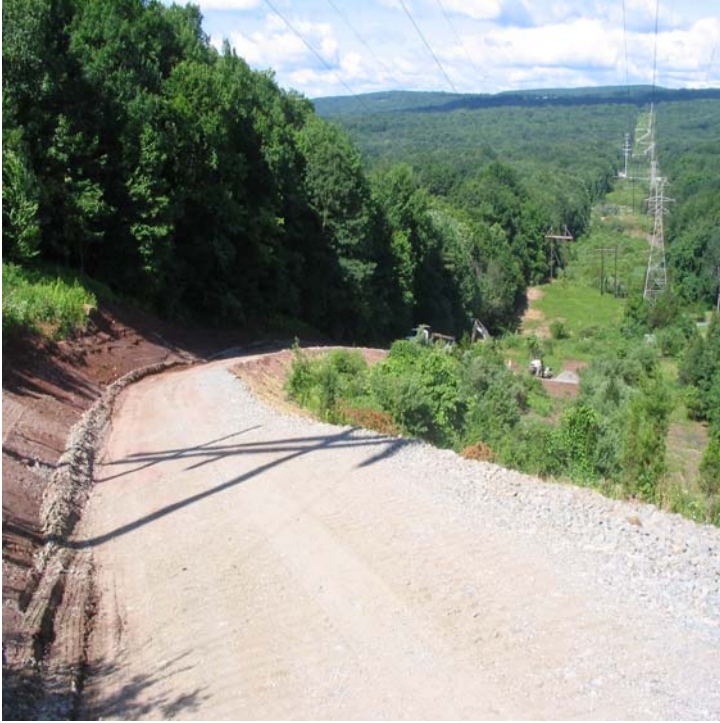
Old Lane Rd (Hamden): Access road construction continues.

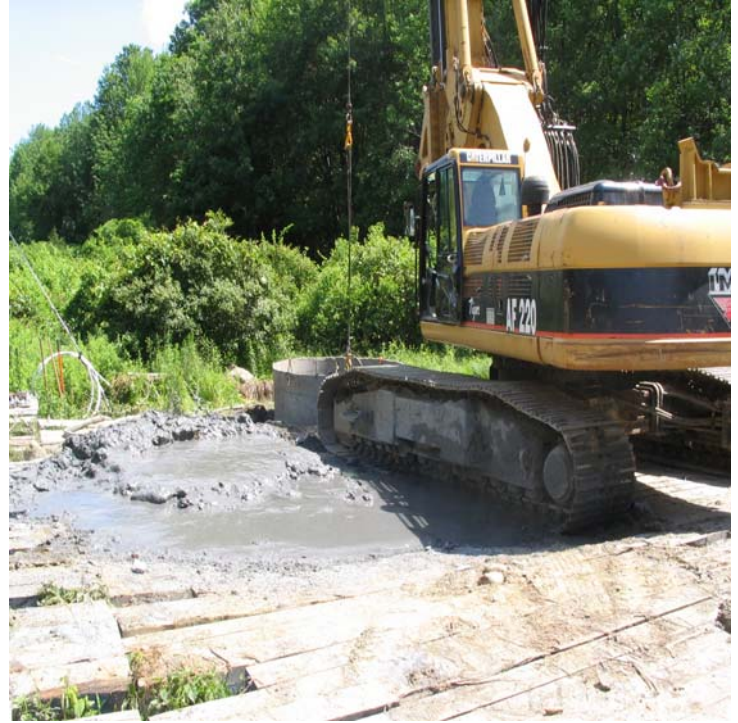
Manville Rd North (Woodbridge): Slurry was pumped directly to the timber mat crane pad here. Dewatering controls should be used at all times.

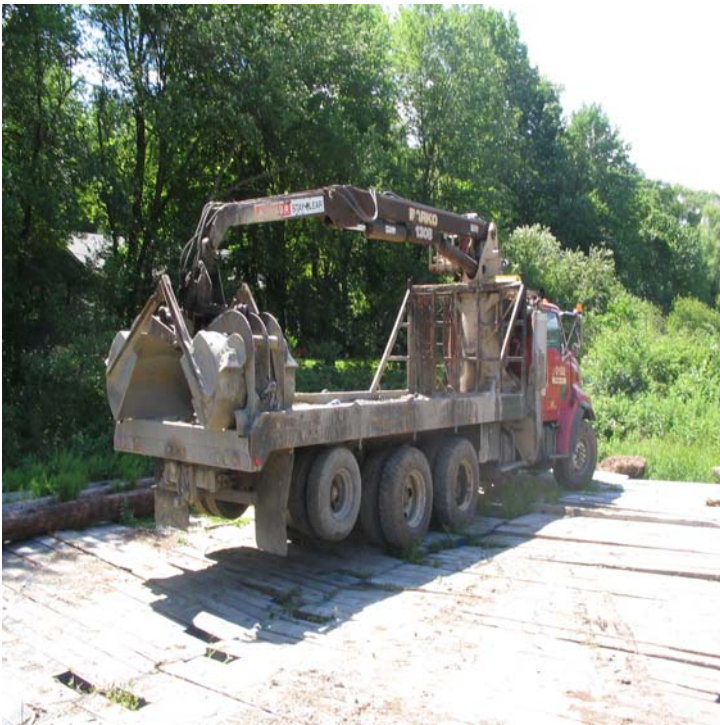
Manville Rd (Woodbridge): Equipment should be parked 100 feet from wetland areas when feasible.

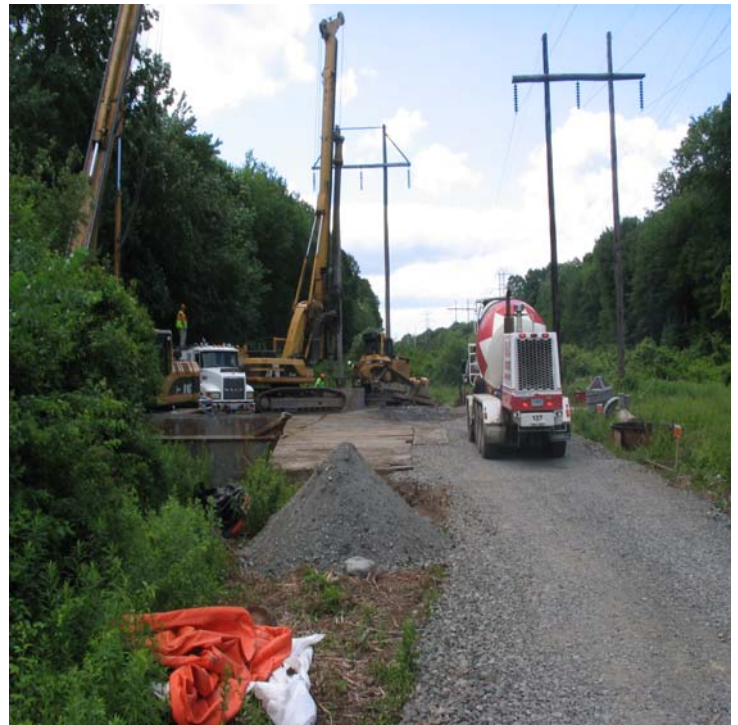
Ansonia Rd South (Woodbridge): Foundation drilling continues in this section. Water trucks were used for dewatering.

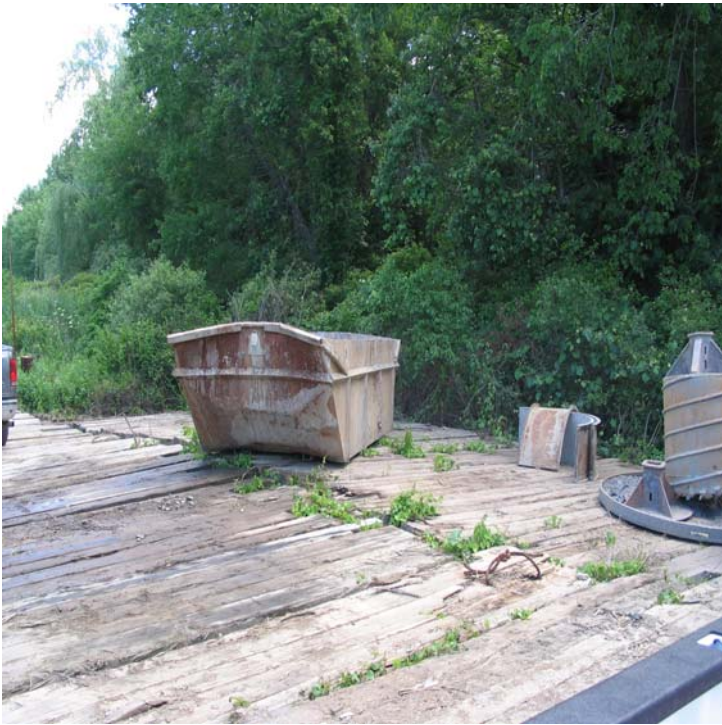
Ansonia Rd North (Woodbridge): Concrete is being washed to containment bins in this section.

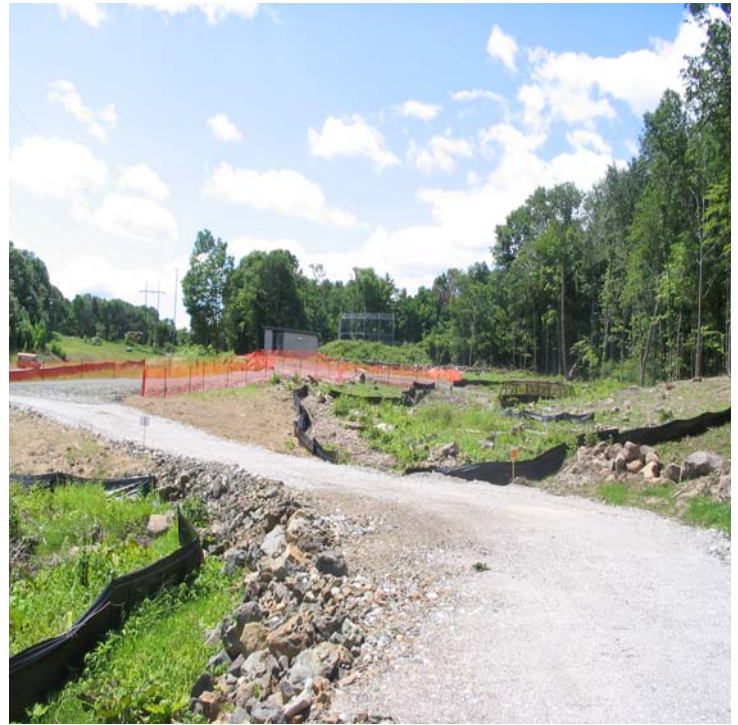
JCC (Woodbridge): Significant grass growth was noted in previously disturbed areas here. Erosion controls remain intact.

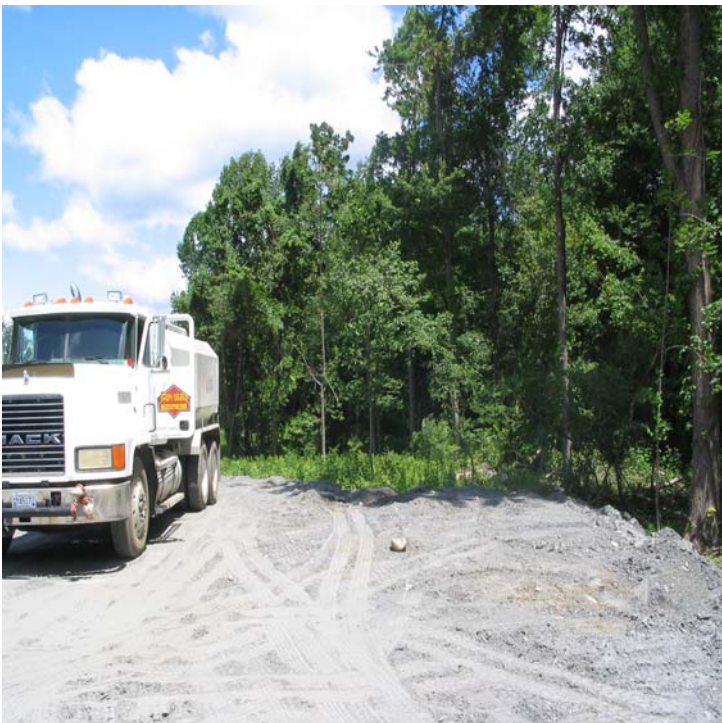
Pease Rd (Woodbridge): A view of the upland dewatering area here. Water is pumped from the truck to a filter bag at this location.

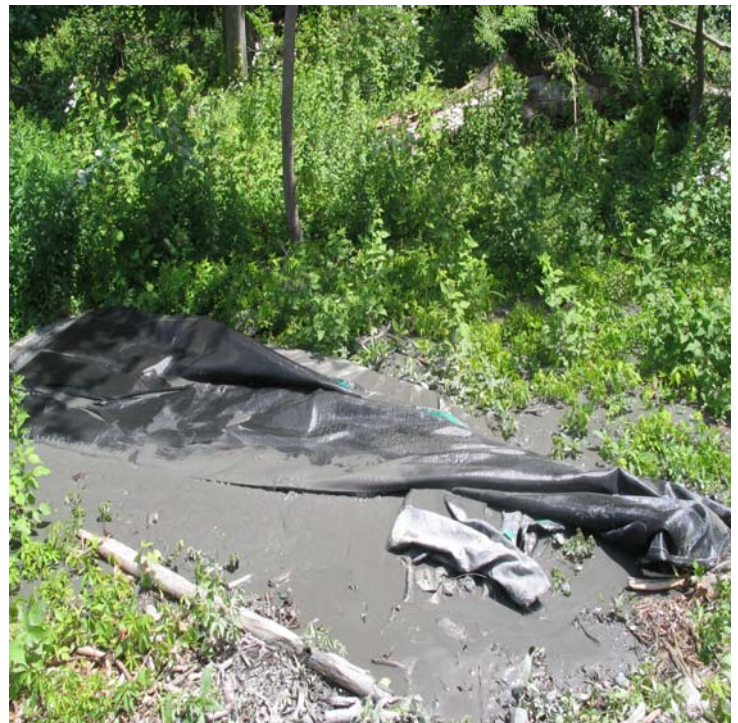
Pease Rd: Close up view of the filter bag at the dewatering area shown in the photo on the left. Sediment has escaped the controls here. The filter bag should be placed in a basin or surrounded by haybales to slow flow and increase filtration.
