Docket No. 272 – Development and Management Plan Inspection

Segment 3 Underground Line

Date: May 10, 2007

Location: East Devon Substation to the Housatonic River Crossing

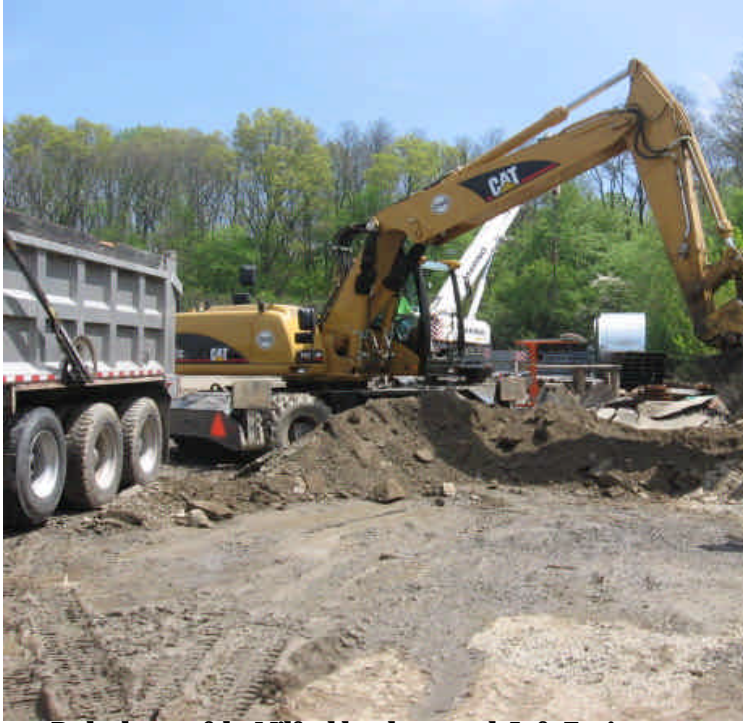
Both photos of the Milford lay-down yard. Left: Equipment removing disposal soil, including the concrete washout material observed here during last week's inspection. Right: Efforts were made to remove sediment that had accumulated adjacent to the erosion controls at the entrance. Seed and mulch may be necessary to stabilize the exposed soil and reduce future run-off to the catch basin.

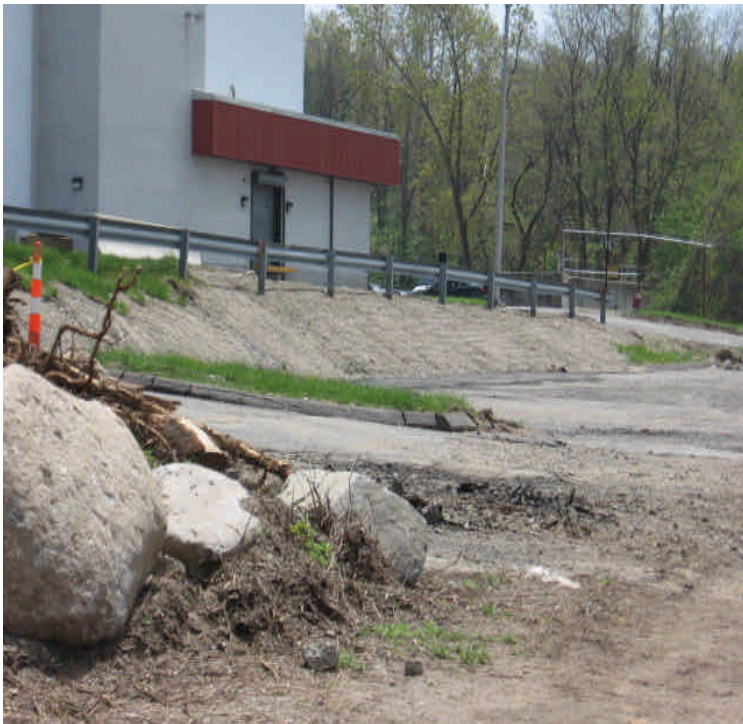
Photo of the exposed slope covered with hard-pack located near sta. #1076. Determine if the slope should be loamed and seeded to restore original conditions.

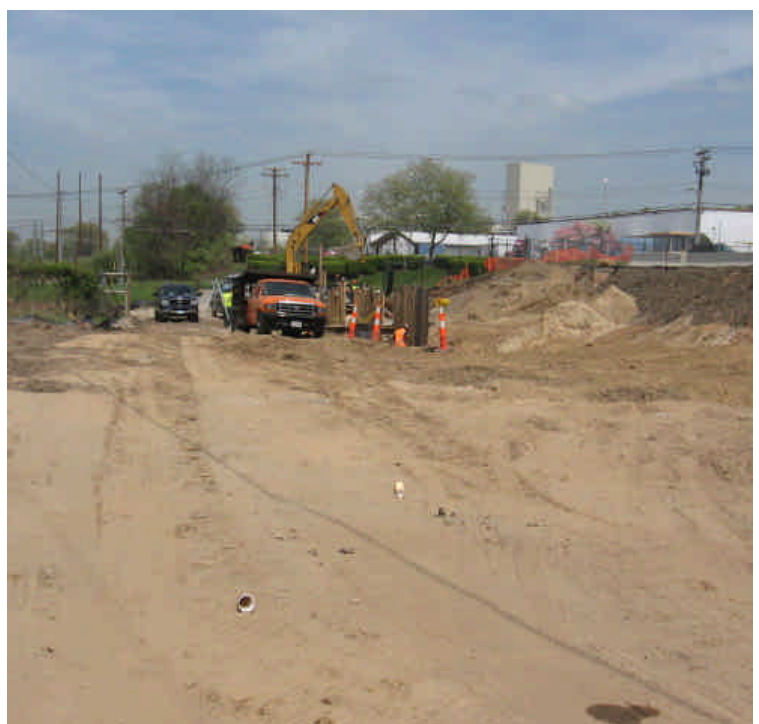
Trenching activities at sta. #1081. Exposed soil and disturbed areas should be stabilized as soon as feasible.
