**Docket No. 272 – Development and Management Plan Inspection**

**Segment 3 Underground Line**

**Date:** May 22, 2007

**Location:** East Devon Substation to the Housatonic River Crossing

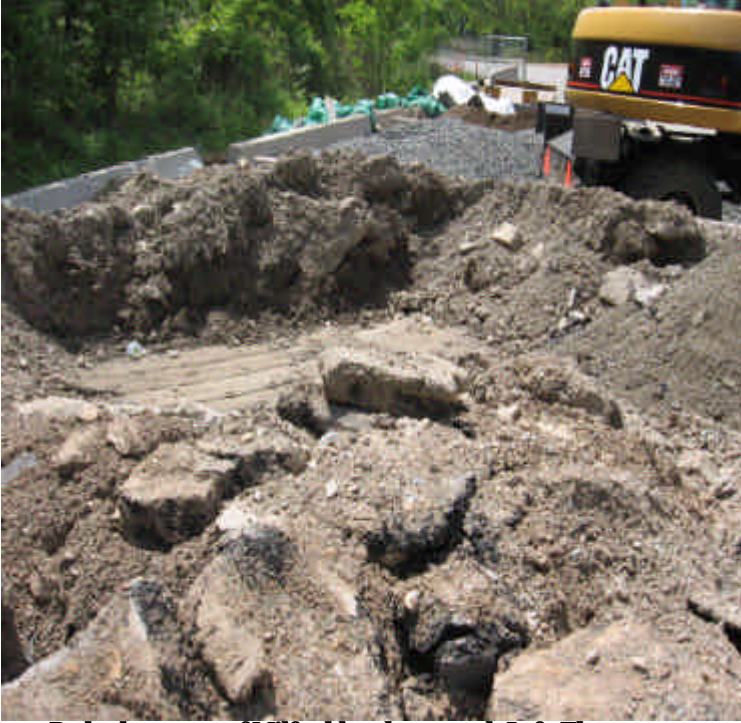
**Both photos are of Milford lay-down yard. Left: The concrete washout material appears to have been removed from the soil disposal pile. Right: Some airborne dust migration resulting from vehicle traffic was noted at the time of inspection. Dust control measures should be implemented.**

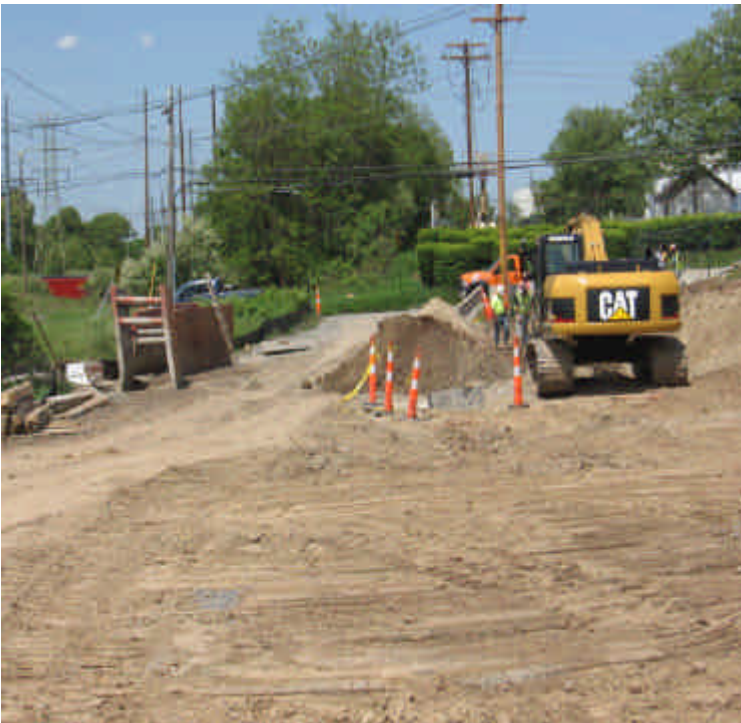
**Construction/trenching activities continue at station #1080.**

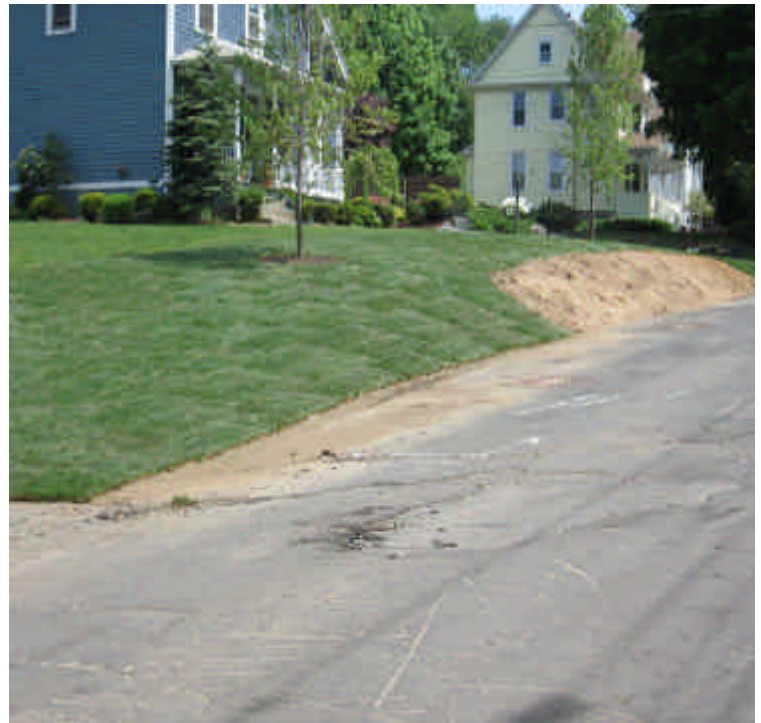
**Turf has been applied to the majority of exposed soil and a tree was planted at the vault #3 location, in a good effort to restore the pre-construction conditions. Hay mulch remains on the remaining portion.**

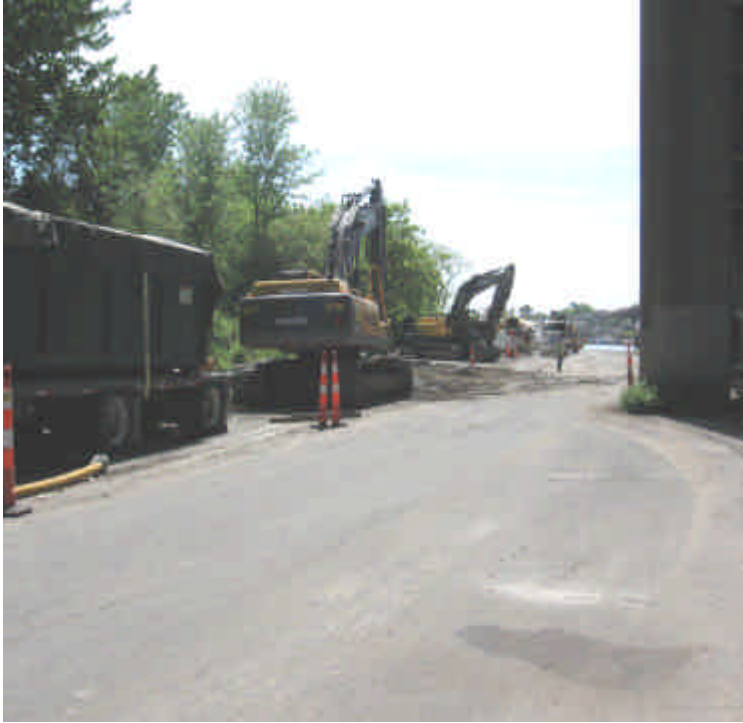
**Vault #1 Construction Activities**

**Photo shows an overview of the construction area.**

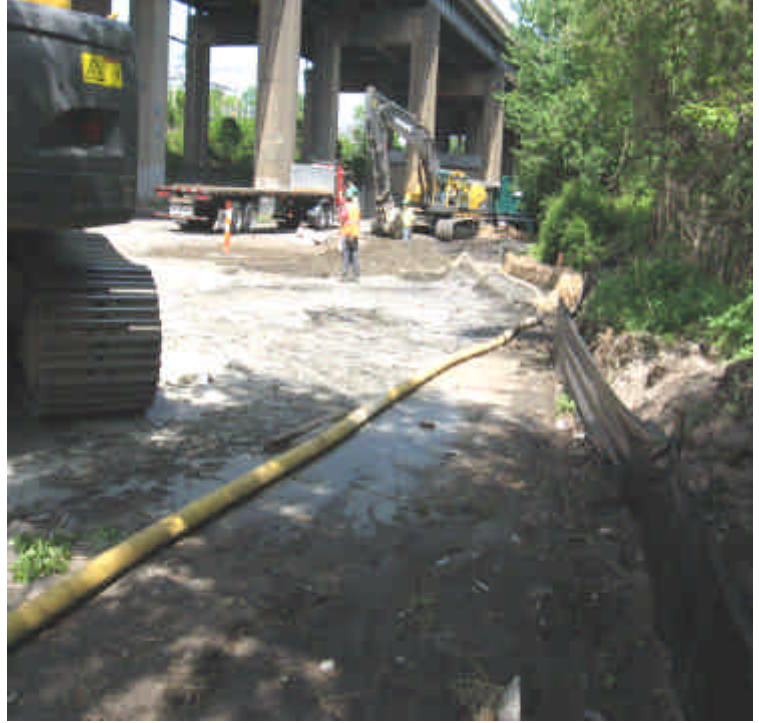
<p><b>Erosion controls are in place adjacent to the vault #1 activities. A film/slurry resulting from the groundwater and flow fill was accumulating along the adjacent pavement within the EC barrier. Most was contained but a portion of the slurry breached the controls and followed an adjacent drainage channel for approximately 5 feet. 5/17/07</b></p>	<p><b>Reinforce controls in this section and remove accumulated sediment to the extent feasible. The material had not yet reached a brook located downgradient from the drainage channel. 5/22/07</b></p>	<p><b>Needs immediate attention to prevent potential impacts to nearby resource area. Contractors were aware of the clean-up requirements.</b></p>
<p><b>Airborne dust migration resulting from vehicle traffic was noted within the yard. 5/22/07</b></p>	<p><b>Attempt to prevent dust migration by implementing the dust control specifications within the 2002 CT Guidelines for Soil Erosion and Sediment</b></p>	<p><b>Needs regular attention.</b></p>

**A film of flowable fill was observed on the pavement down-gradient of the vault location. This appears to be a result of groundwater interception with the construction activities.**

A film/slurry resulting from flow fill and groundwater interactions at vault #1 was noted on the adjacent pavement. Most is contained with the erosion controls but some areas need improvements. 5/22/07	Sweep adjacent pavement if feasible to remove the accumulated film/slurry. See erosion control section for more details. 5/22/07	Needs attention

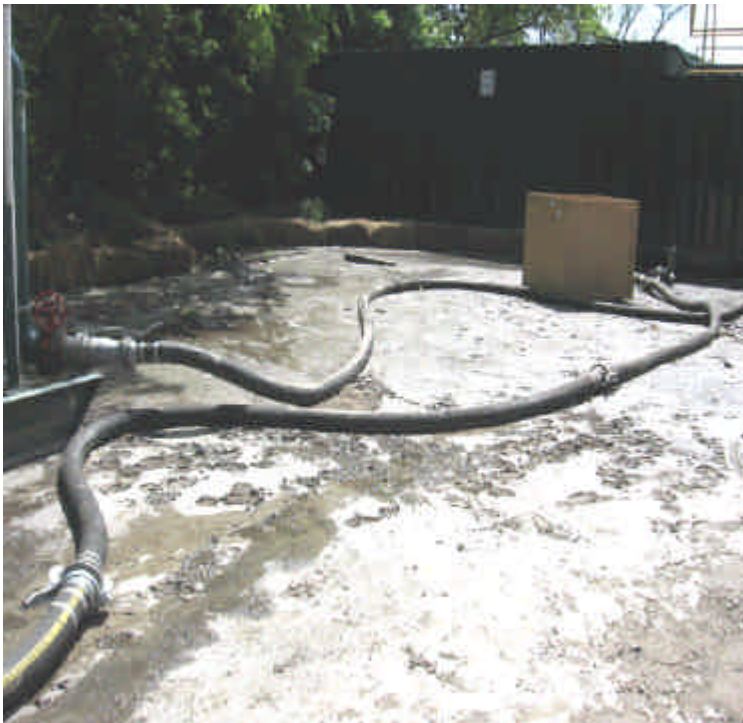
**Left: The flowable fill film or slurry has accumulated over a large surface area of the adjacent pavement, with the majority contained within the erosion control barriers. Right: A portion of the flowable fill has migrated just beyond the erosion control barrier in one location and was noted for approximately 5-feet along a drainage channel leading to an adjacent brook. No fill has reached the brook at this time. Contractor was aware of the clean-up requirements at the time of the site visit.**
