Docket No. 272 – Development and Management Plan Inspection

Segment 3 Underground Line

Date: May 31, 2007

Location: East Devon Substation to the Housatonic River Crossing

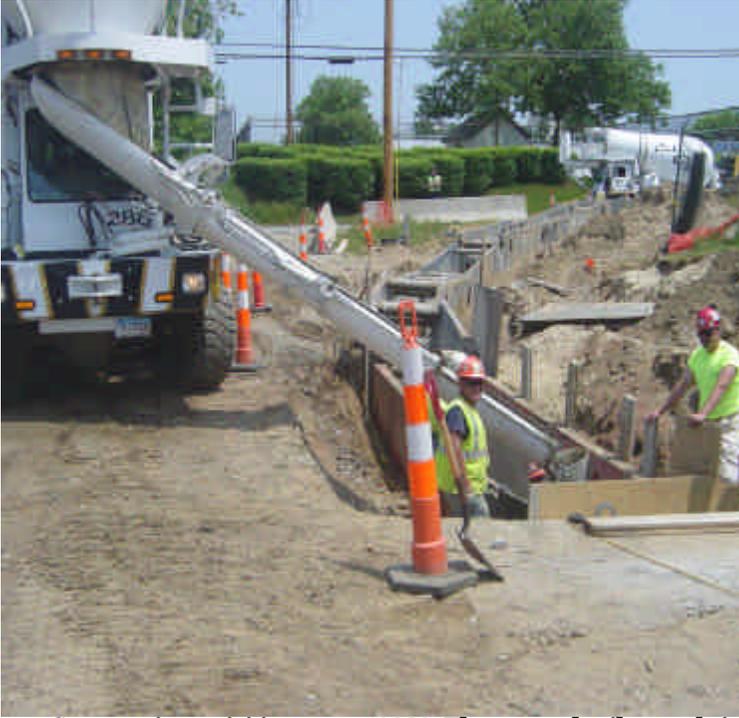
Construction activities at sta. #1080. The exposed soils were being watered down to prevent airborne dust.

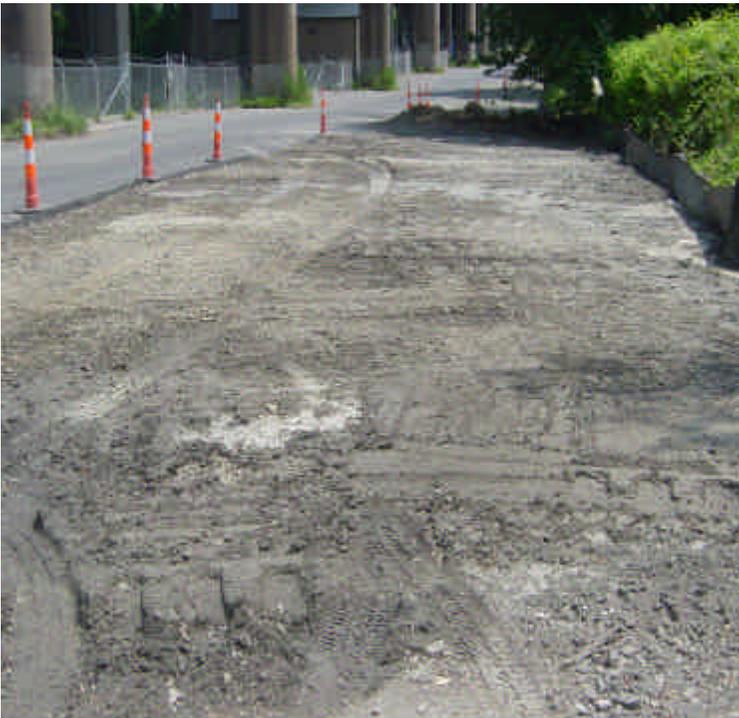
Both photos are of the vault #1 location. Left: The vault has been backfilled and top dressed with a hard pack material. Right: Unwashed stone has been placed in the drainage swale that received a film of flowable fill last week in an attempt to filter any migrating sediment. However, during rain events, soil within the unwashed stone has the potential to enter the stream. It is also unclear whether this is allowable through the D&M plan. Stone should be removed to the upgradient/work area side of the erosion control barrier or removed from the site.
