Docket No. 272 – Development and Management Plan Inspection

Segment 4a Underground Line

Date: May 10, 2007

Location: Singer Substation to Fairfield/Westport Town Line

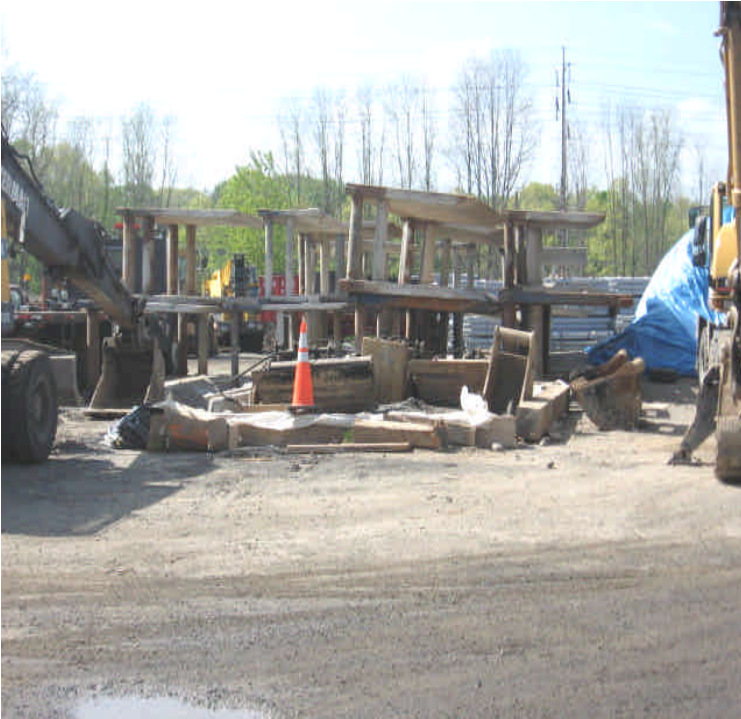
Fluid filled equipment is being adequately and proactively stored in a lined containment area.

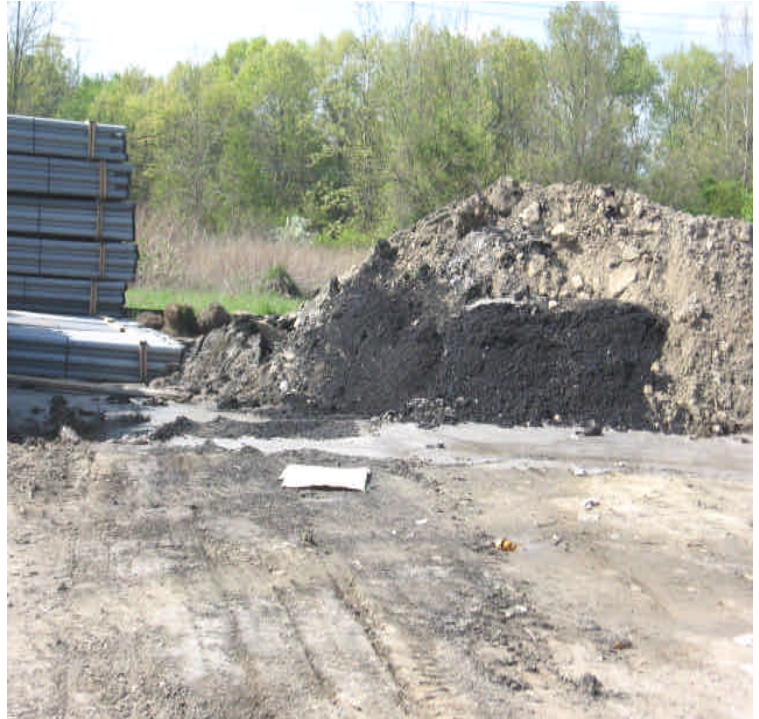
Slurry or concrete washout was deposited in an uncontained location within the yard. Concrete washout should occur in a proper containment area.

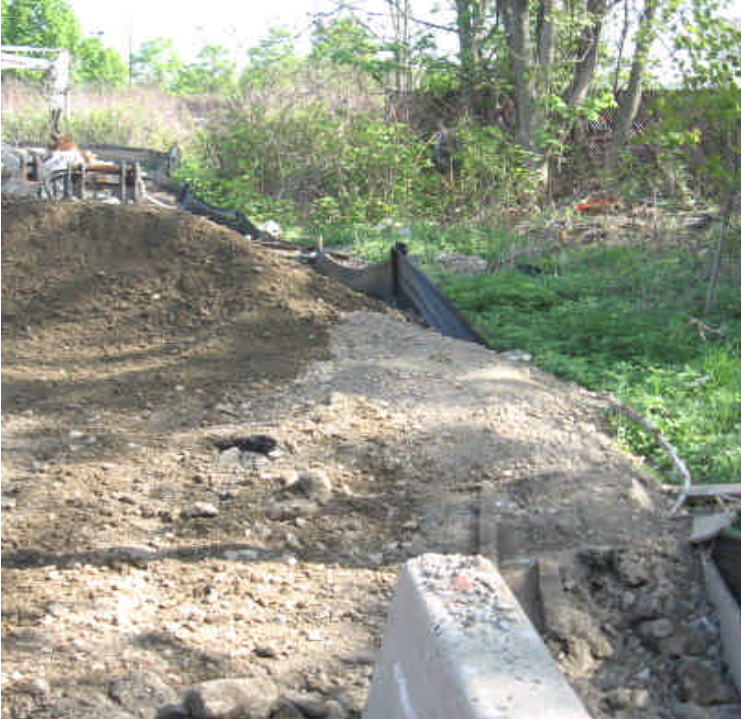
Material is overwhelming the perimeter controls in one location. Pull the soil back and restore the controls.

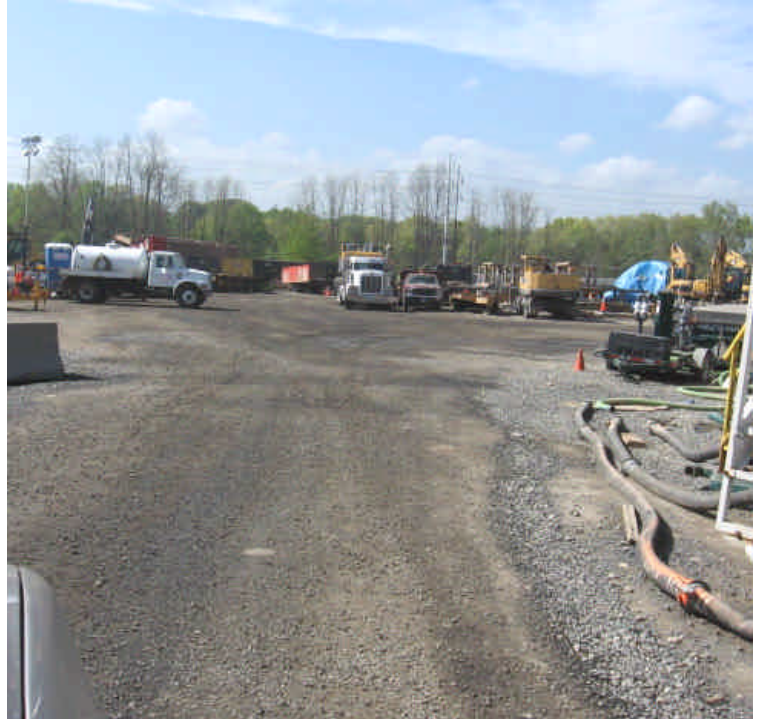
Calcium chloride has been applied to the yard in an effort to prevent dust migration proactively.

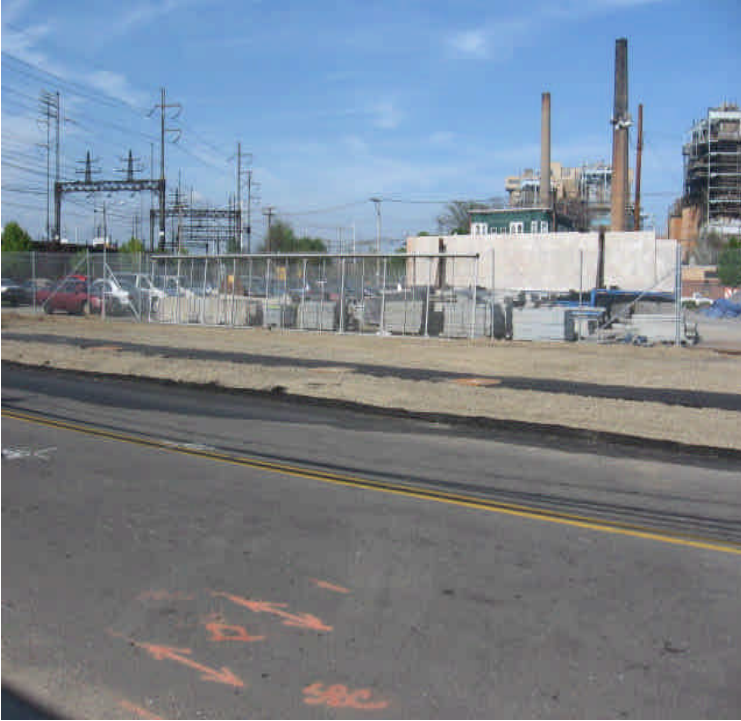
Photo of the vault #49 location. A hard pack material has been applied as a surface layer. Final stabilization/restoration measures should be implemented when feasible.

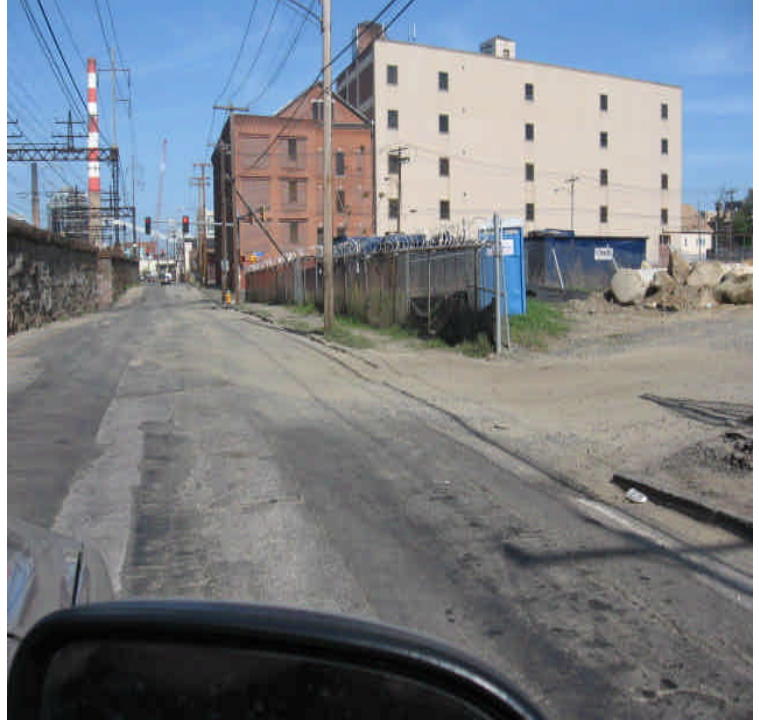
Photo of Railroad Ave. at its intersection with Myrtle Ave. Sediment tracking is regularly noted at this location but is due to a storage yard for a project not covered under this D&M plan.

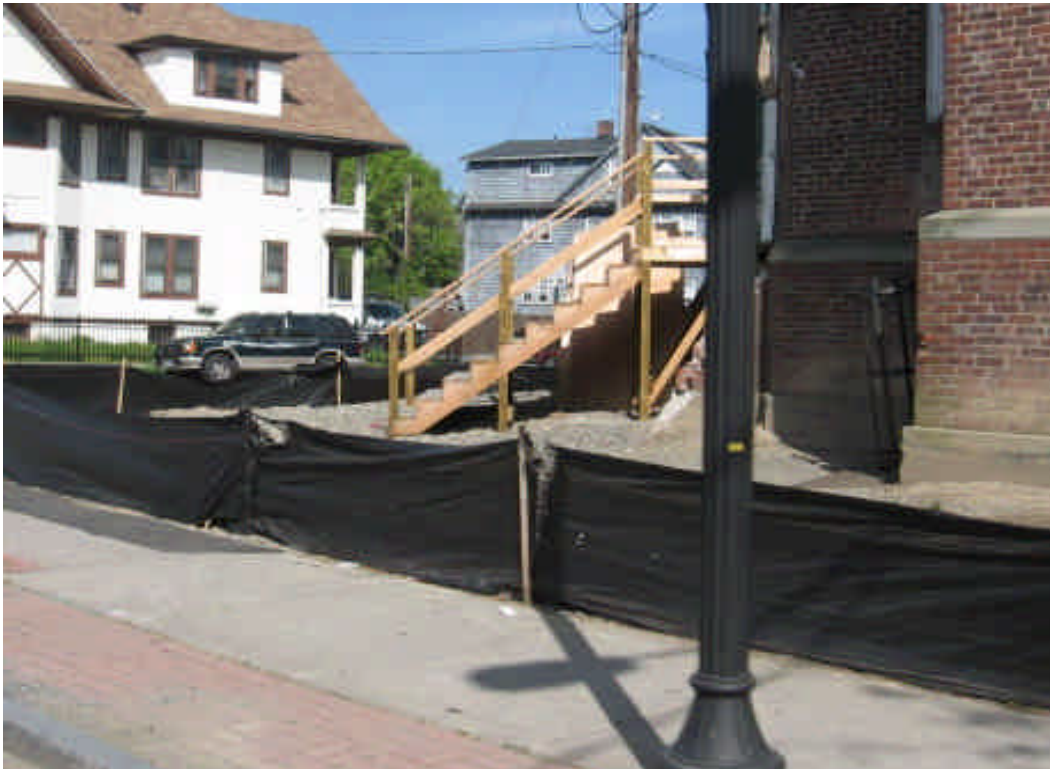
The perimeter erosion controls at vault #41 have been repaired.
