Docket No. 272 – Development and Management Plan Inspection

Segment 4a Underground Line

Date: May 22, 2007

Location: Singer Substation to Fairfield/Westport Town Line

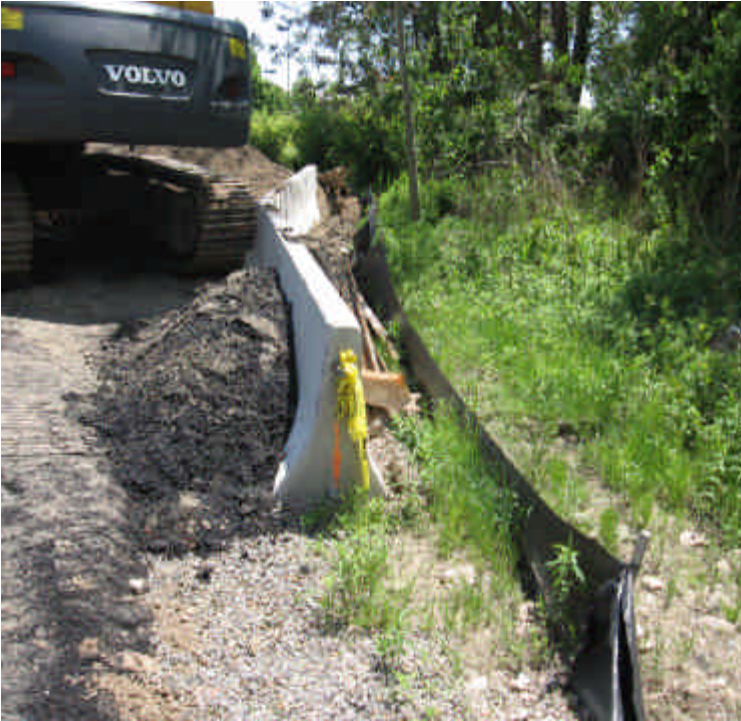
Areas of Inspection	Observation	Recommended Action	Corrected Action
Kings Highway Lay-down Yard (Off Kings Highway, near Rt. 1 rotary)	<p>This is not covered under this D&M plan. 5/22/07</p> <p>The portion of silt fence that was compromised/overwhelmed by materials has been re-established. One section may still need reinforcement. 5/22/07</p>	Continue to monitor and maintain the perimeter silt fence as necessary. 5/22/07	The majority of the silt fence was re-established.
Inland Wetland and Watercourse encroachment and mitigation	The Kings Highway lay-down yard is located adjacent to potential resource areas and a concrete lined waterway. 5/22/07	See erosion control section. 5/22/07	NA
Staging, Storage, and Parking Areas	<p>A contractor storage yard on Bostwick Ave. contains frac tanks, trailers, and available parking. Reserve spill kits are located in the equipment trailers. 5/22/07</p> <p>A contractor lay-down yard is located off of Kings Highway near the Rt. 1 rotary. Reserve spill kits are located in the equipment trailers. 5/22/07</p>	<p>Ensure that spill kits are also present with each vehicle during active construction, see Spills and Material Storage section for more detail. 5/22/07</p> <p>See erosion control section. 5/22/07</p>	<p>NA</p> <p>NA</p>

The majority of the compromised silt fence within the King's Highway lay-down yard has been re-established. The portion of the fence in the foreground of the photo required additional reinforcement when feasible.

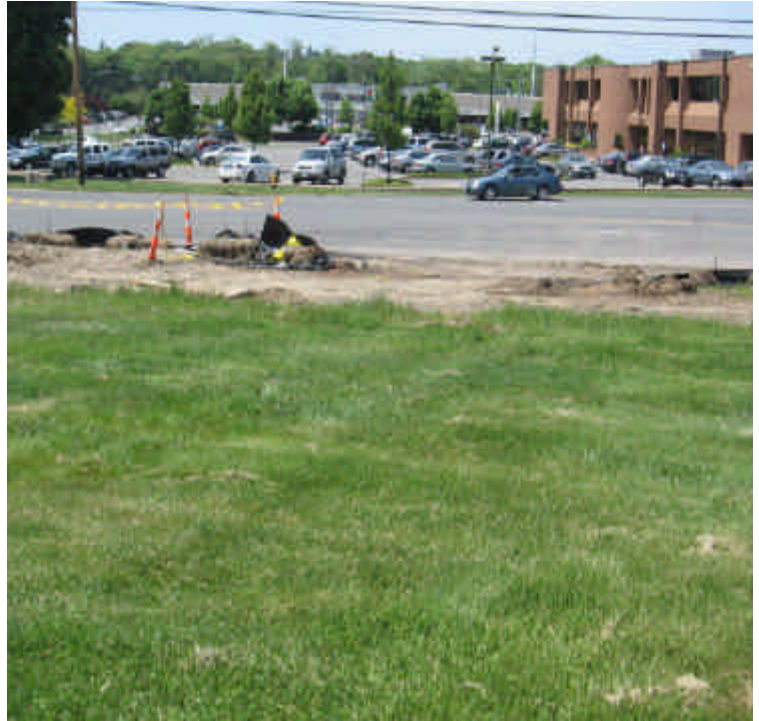
Fairfield	Access to construction activities near vault #37 has been gained via an opening in the erosion controls at station #612, leaving exposed soil uncontained at the close of each work period. 5/17-5/22/07	Erosion controls should be re-established in this location at the close of each work period to prevent potential sediment migration during heavy rain events. (Haybales could also be placed across the access.) 5/17-5/22/07	Needs attention.
	A private yard next to vault #28 remains stabilized with seed and hay mulch. 5/22/07	Continue to monitor to ensure adequate establishment of vegetation and lawn cover. 5/22/07	NA
Bridgeport	Sediment tracking is regularly observed at the Railroad and Myrtle Ave. intersection and catch basins in the area are overwhelmed by continued accumulation. Sediment was originating from a stockpile yard identified as being associated with the Glenbrook Cable project.	Noted for the record since contractors stated the sediment is not related to this project. 5/22/07	NA

Activities continue at the vault #37 location. Access to the construction area has been obtained through an entrance in the erosion controls. Recommend re-establishing controls or placing haybales at the close of each day to prevent sediment migration during heavy rain events.

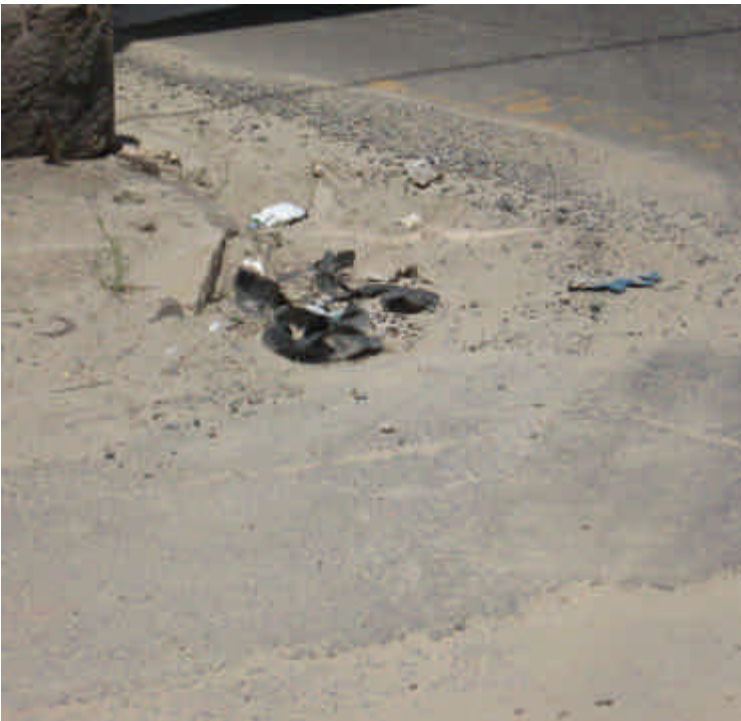
Catch basin location on the corner of Railroad and Myrtle Ave. Accumulated sediment is not project related, but a result of regular tracking attributed to a storage yard for a project not covered under this D&M plan.

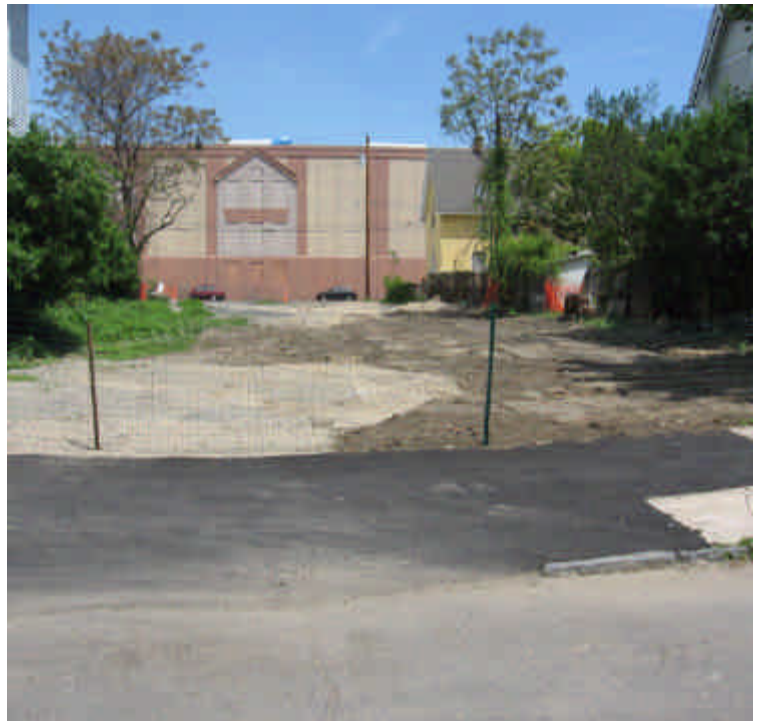
Topsoil is being added to the former trenching location between Broad and Main St. in an effort to restore the area.
