Docket No. 272 – Development and Management Plan Inspection

Segment 4a Underground Line

Date: June 29, 2007

Location: Singer Substation to Fairfield/Westport Town Line

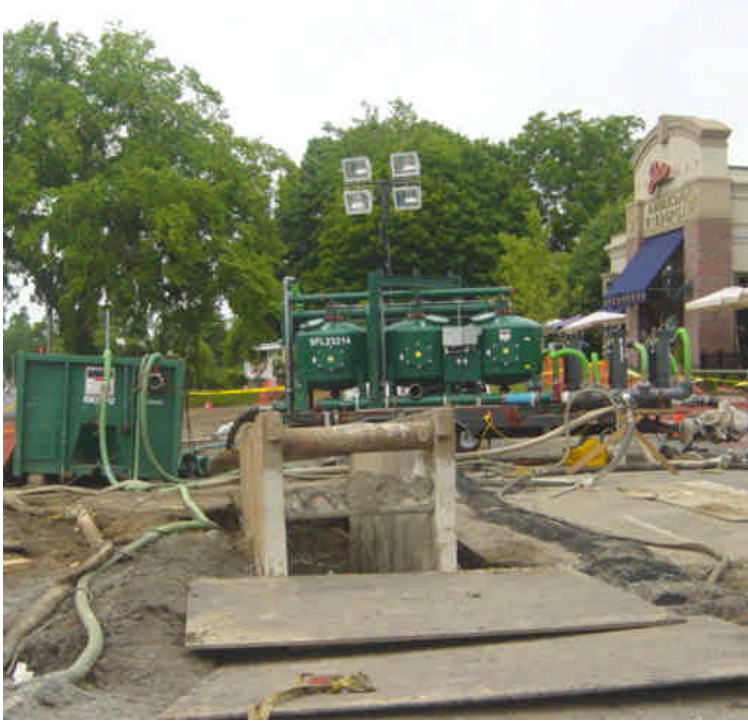
Dewatering	Dewatering activities were observed at near sta. #596 (near Vault #36), during this week's inspection. A frac tank was in place. 6/29/07	When dewatering is necessary, continue to appropriately contain and/or filter discharge water. 6/29/07	A frac tank was in place.
Blasting	No blasting has been proposed. 6/29/07	None 6/29/07	NA
Spills and Material Storage	<p>Spill cleanup materials/kits were observed in the storage yards. 6/29/07</p> <p>Fluid filled equipment in the King's Highway yard continue to be proactively stored on liners or similar containment. 6/29/07</p>	<p>Ensure that spill kits are also present with each vehicle during active construction 6/29/07</p> <p>Continue to monitor. Good proactive controls are being used even though leaks were not observed. 6/29/07</p>	<p>NA</p> <p>NA</p>

Open trench and ongoing dewatering activities near vault #36.

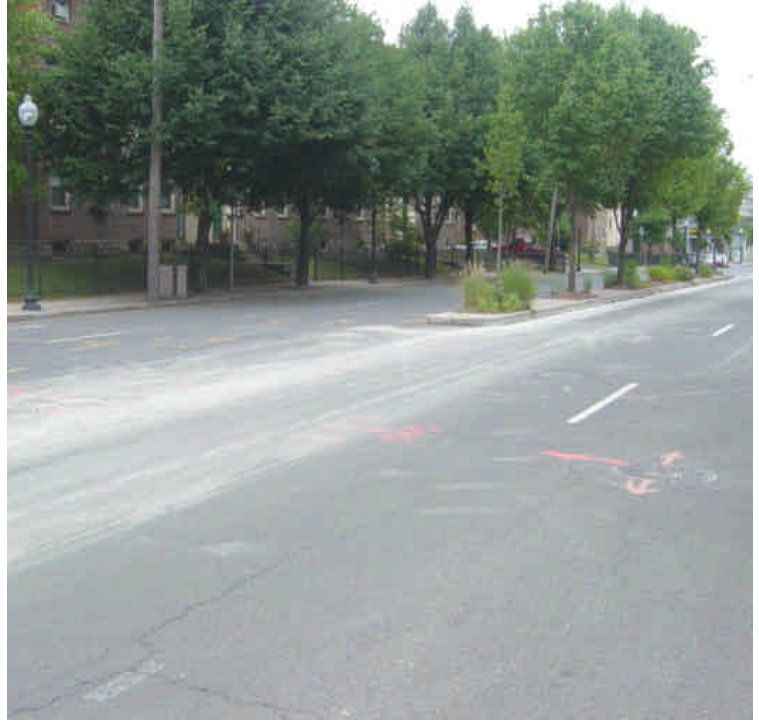
Saw cutting had recently occurred near sta. #675 to #680 and some of the dried slurry/dust remains along the roadway. Prevent slurry from entering catch basins and sensitive areas by quickly attending to it as it is generated. Sweep as needed.

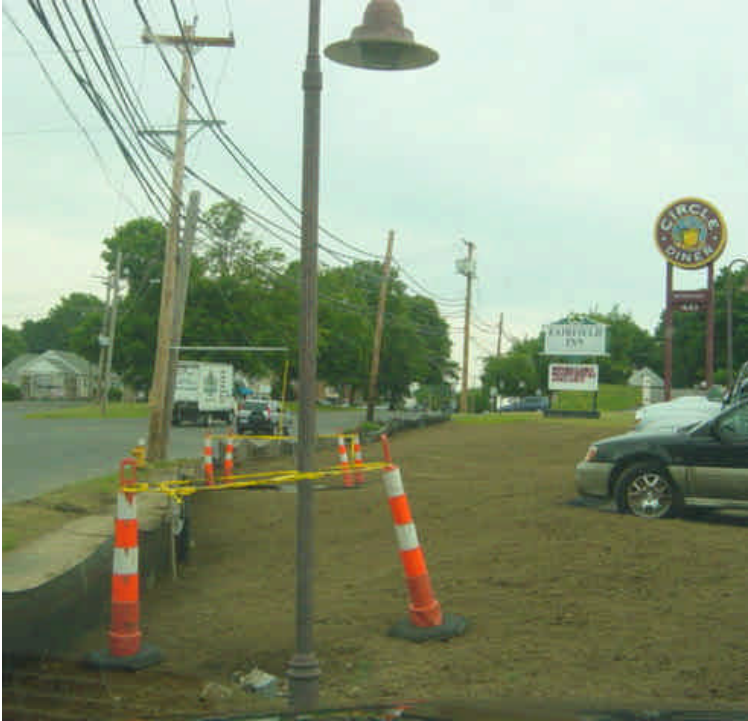
The area of exposed soil near vault #37 has been graded and topsoil was applied. The area needs to be seeded and mulched. Silt fence remains in place.

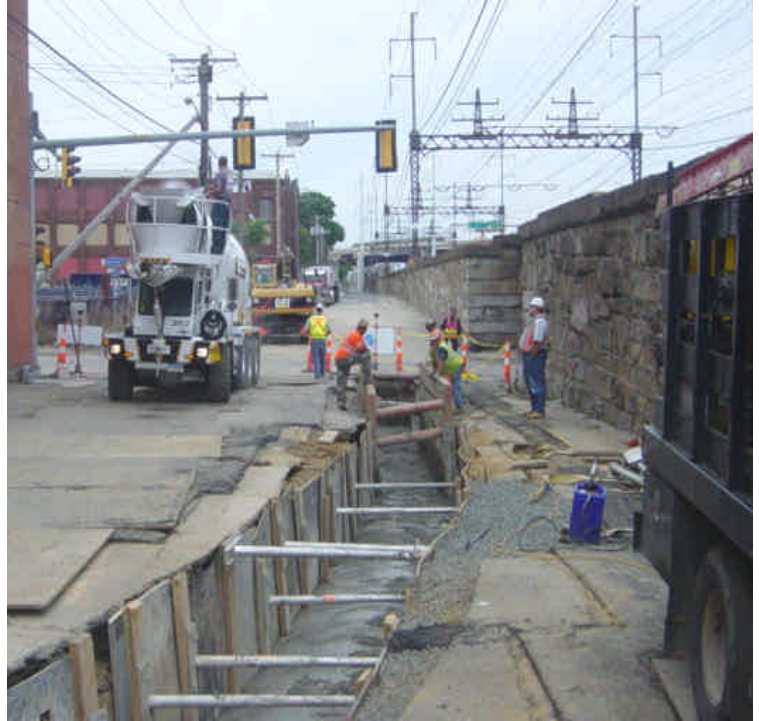
View of open trench and backfilling activities along Railroad Avenue near sta. #789.
