Docket No. 272 – Development and Management Plan Inspection

Segment 4a Underground Line

Date: July 5, 2007

Location: Singer Substation to Fairfield/Westport Town Line

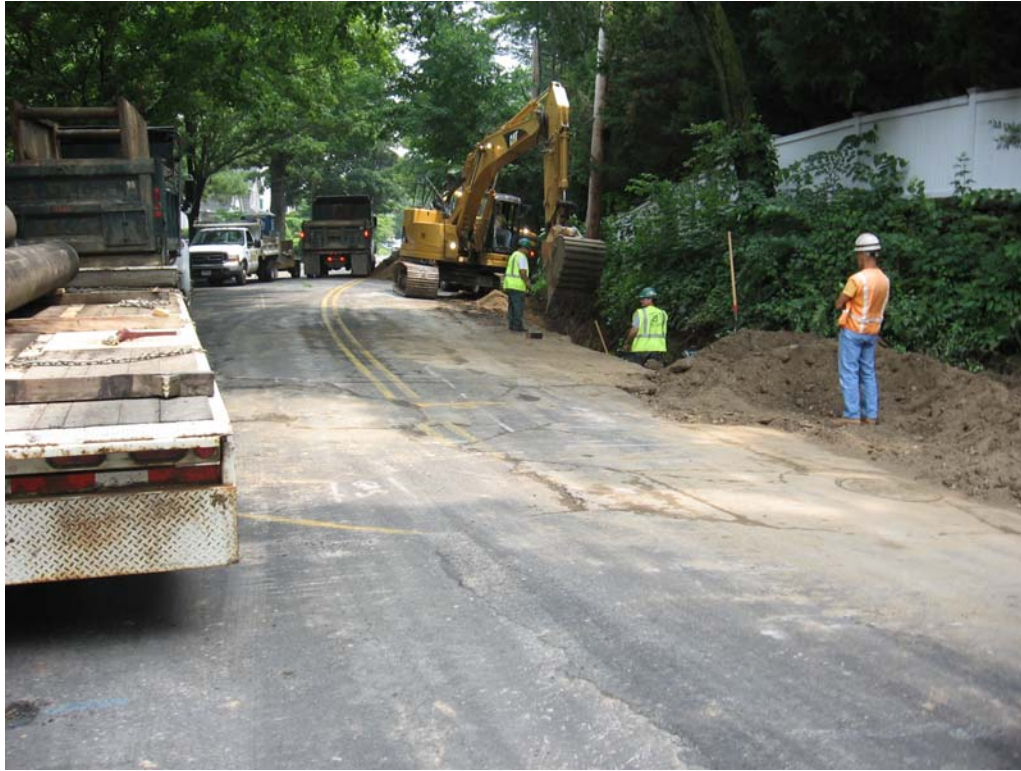
Photo of utility relocation activities along Pequot Ave. All catch basins were adequately protected. Sweep roadway as necessary.

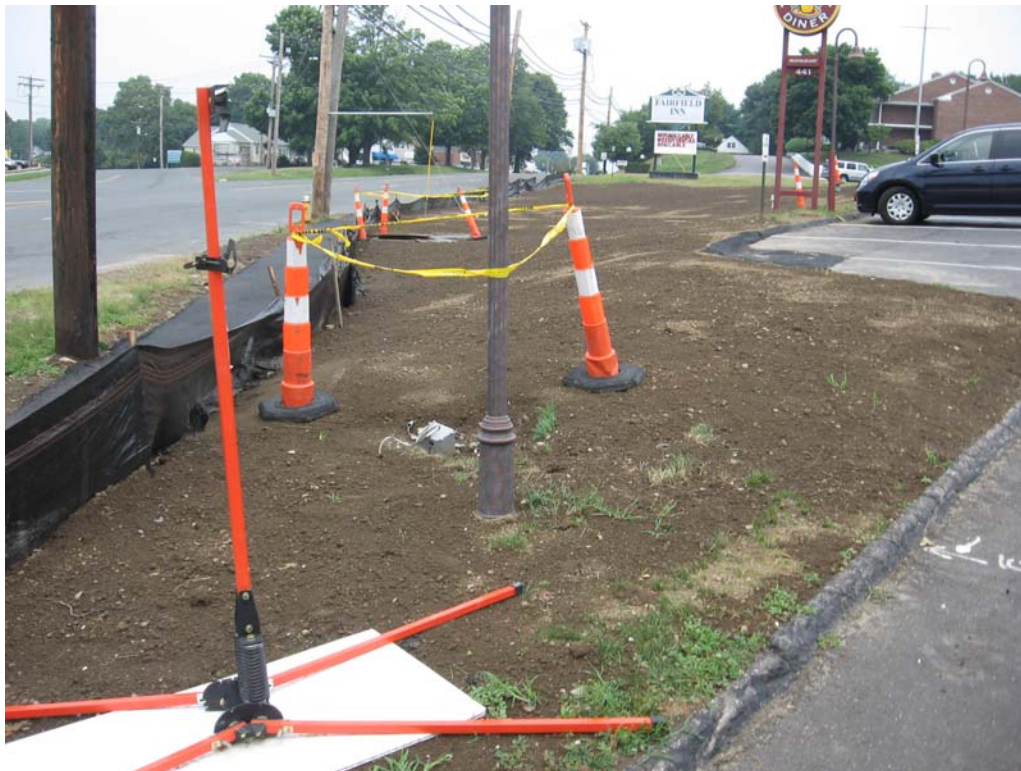
Soils remain exposed at vault # 37 location. Seed and mulch should be applied as soon as feasible to prevent erosion/gullyng and potential sediment migration during storm events. Erosion controls remain in place.
