Docket No. 272 – Development and Management Plan Inspection

Segment 4a Underground Line

Date: July 13, 2007

Location: Singer Substation to Fairfield/Westport Town Line

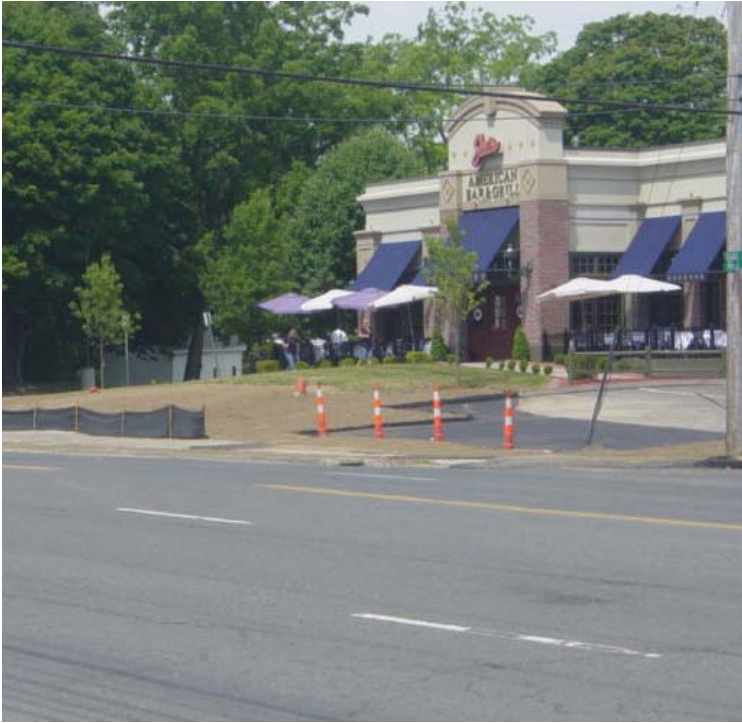
Vault #36 has been backfilled and requires seed and mulch for final restoration. Silt fence remains along the downgradient side of most of the work area.

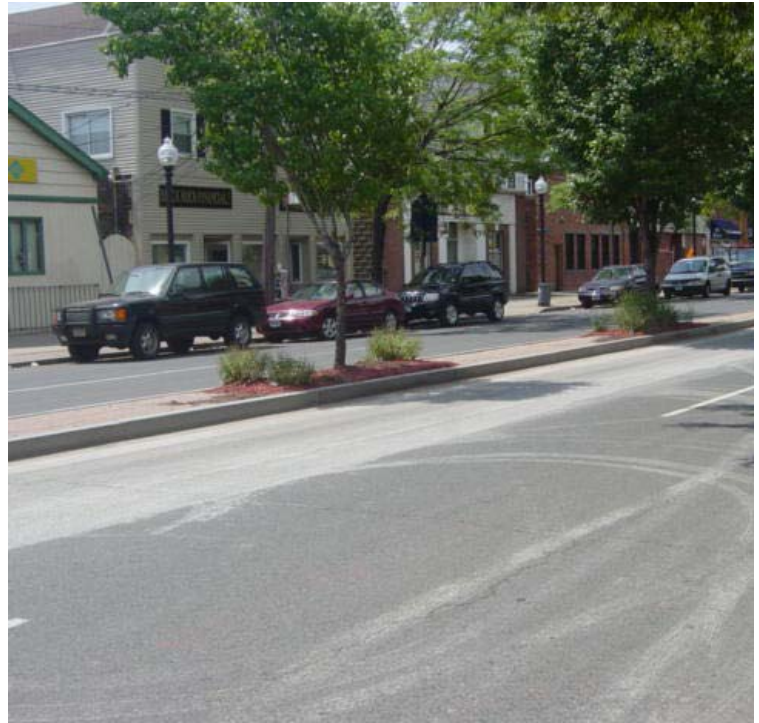
Saw cutting was recently performed near sta. #672 to #674 and some of the dried slurry/dust remains along the roadway. Prevent slurry from entering catch basins and sensitive areas by quickly attending to it as it is generated. Sweep as needed.

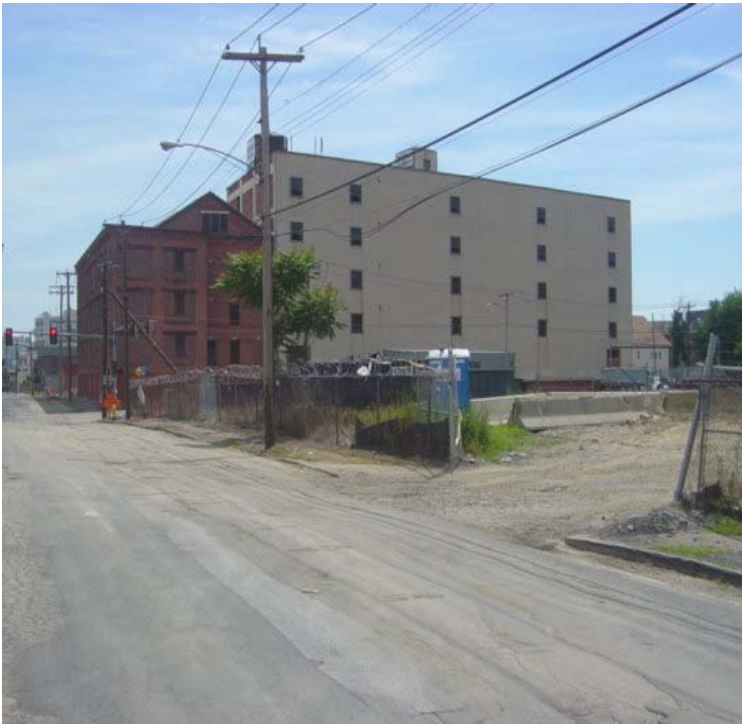
Sediment tracking continues from a storage yard not associated with this project near the intersection of Railroad Ave. and Myrtle Ave.

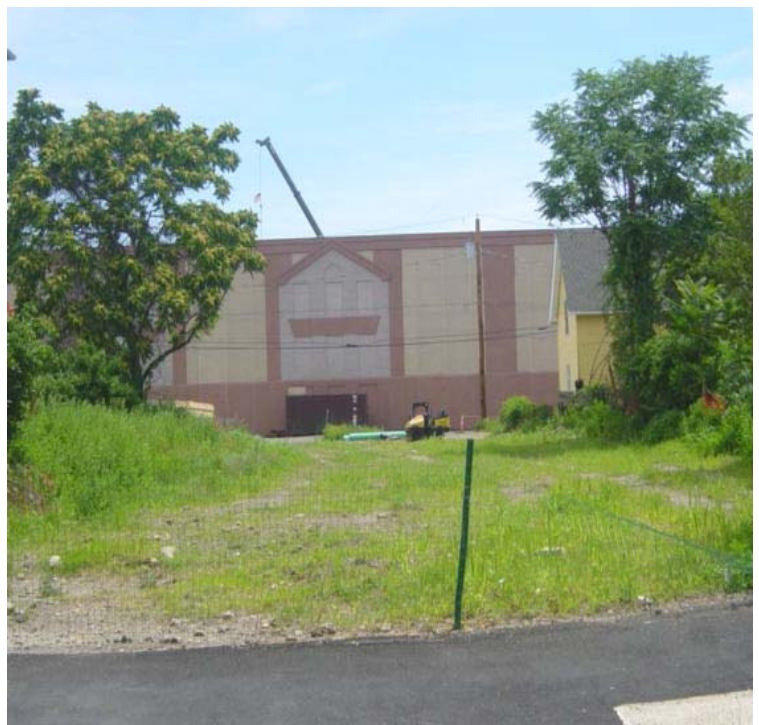
The area between Main Street and Broad Street is becoming increasingly stable. Vegetation is covering approximately 75% of the area.

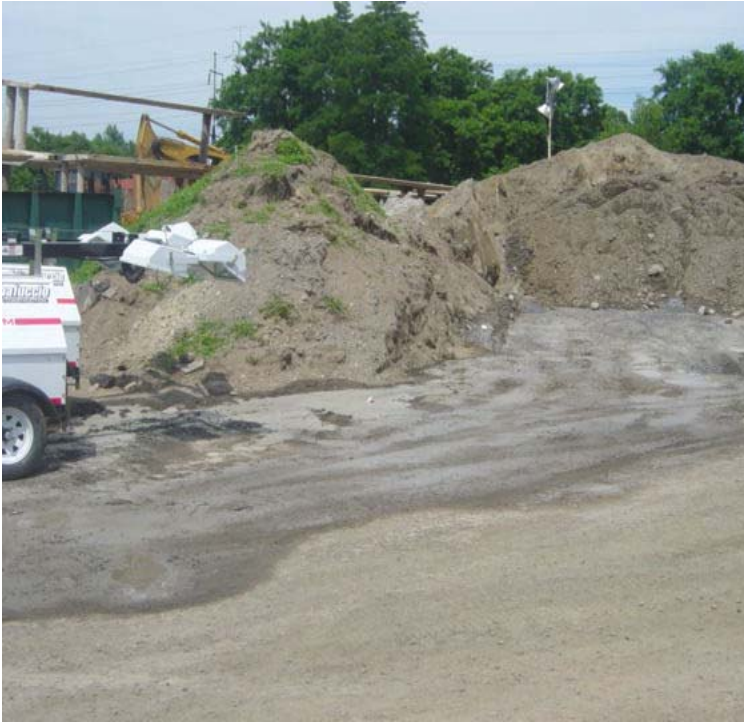
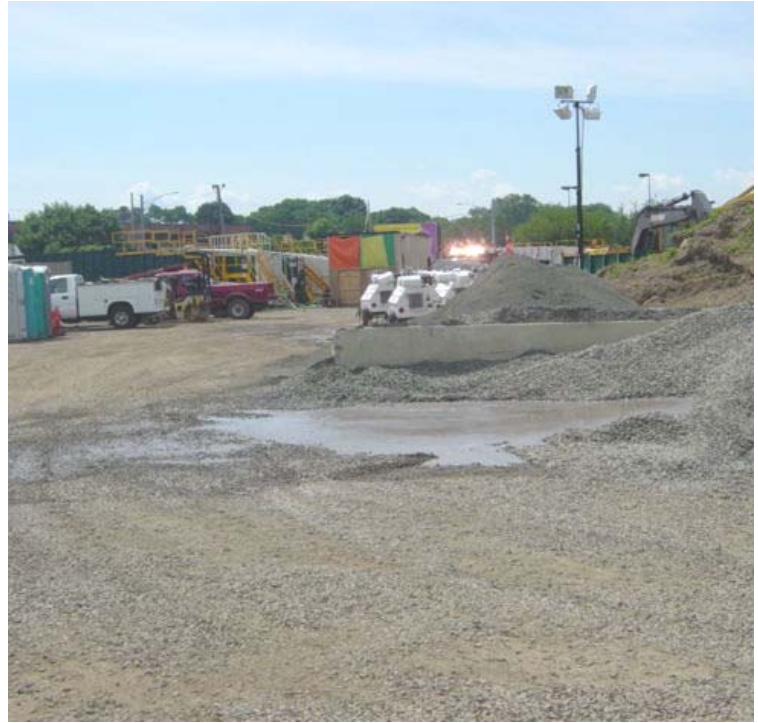
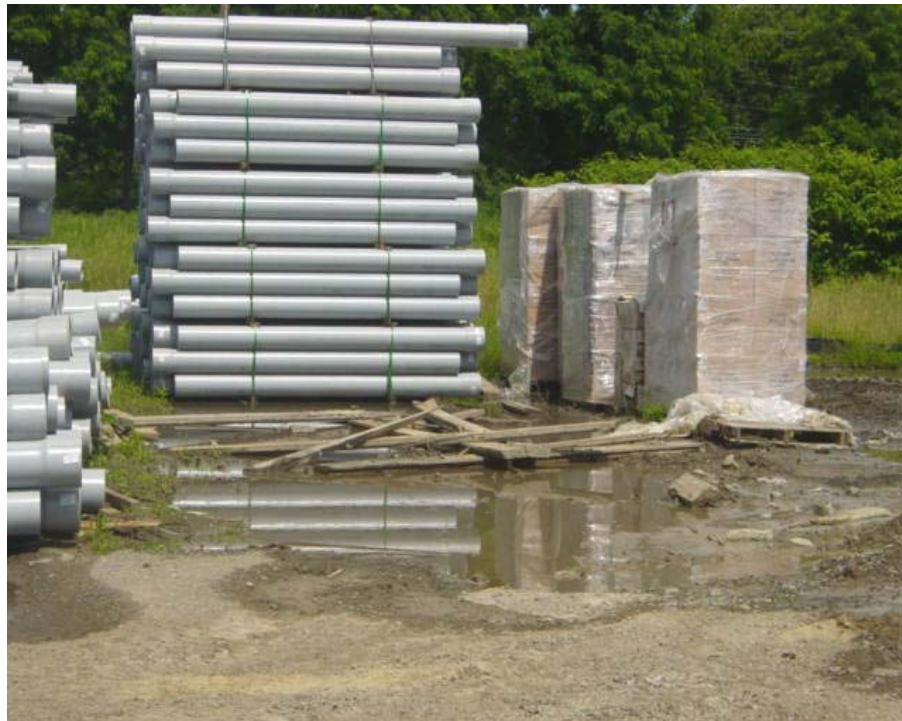
All three photos on this page show the King's Highway lay-down yard where concrete wash-out appears to have been deposited in several locations, near gravel and other material stockpiles. Concrete washouts remain within the yard but should be performed in a contained/designated area to minimize unnecessary impacts. Concrete slurry should be removed and properly disposed of.
