Docket No. 272 – Development and Management Plan Inspection

Segment 4b Underground Line

Date: May 2, 2007

Location: Fairfield/Westport Town Line to Westport Avenue in Norwalk

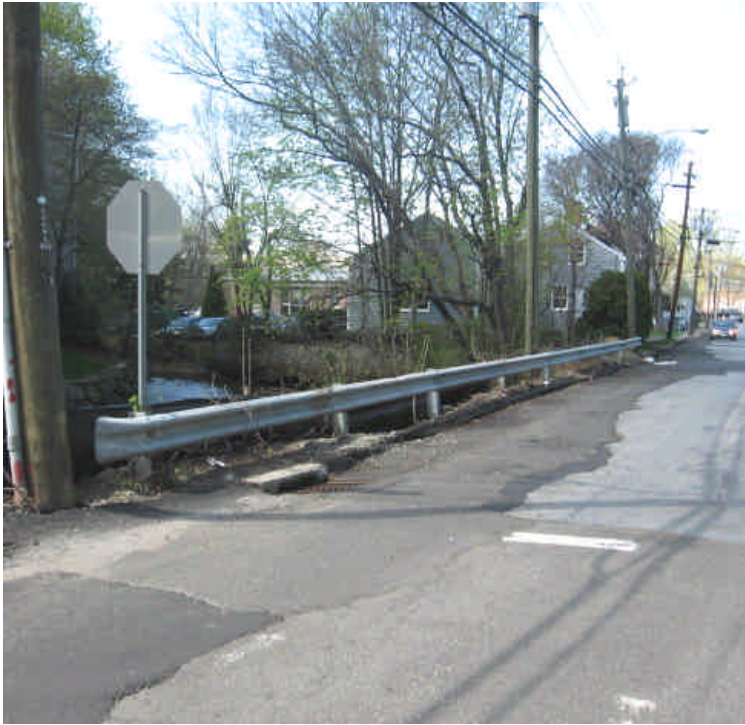
Although active work is not occurring here, silt fence remains between the road and the brook of	Ensure that silt fence is in good condition if work resumes here. 5/02/07	NA at this time

Photo of Imperial Ave. near sta. #260. The area is no longer active but erosion controls remain between the roadway and the creek for future work.

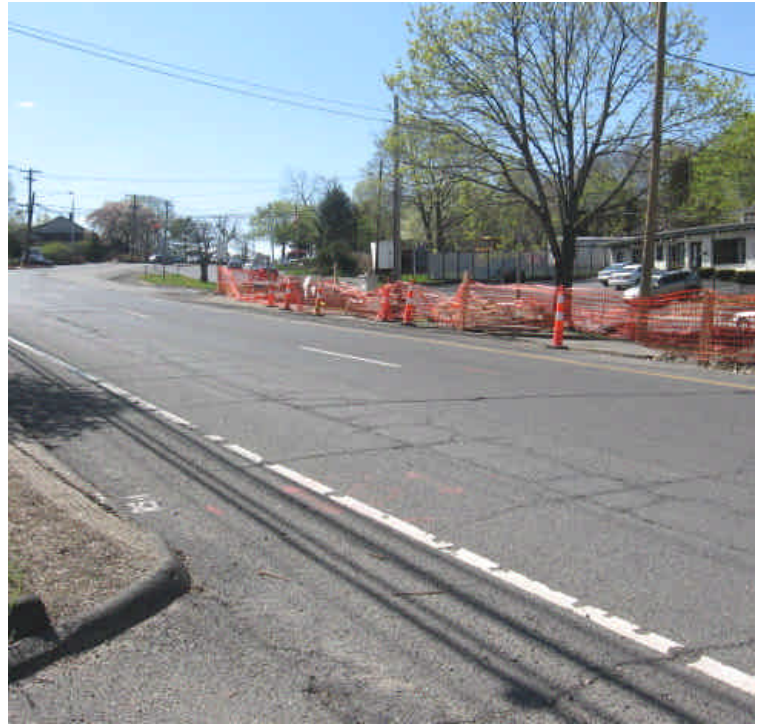
Trench from sta. #312 to #316 is covered with plates, connecting to vault #19.

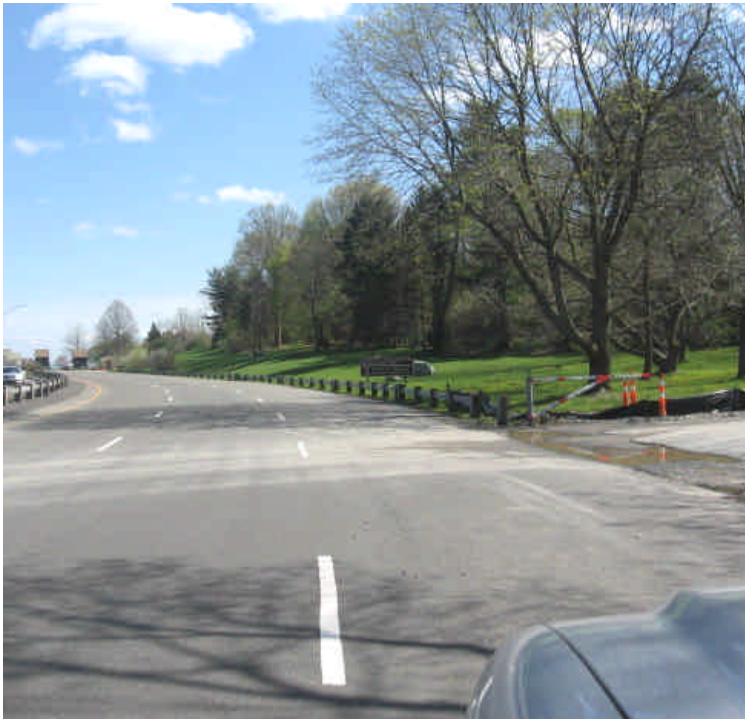
Photo of the entrance to the Sherwood Island lay-down yard. No obvious sediment tracking was noted.

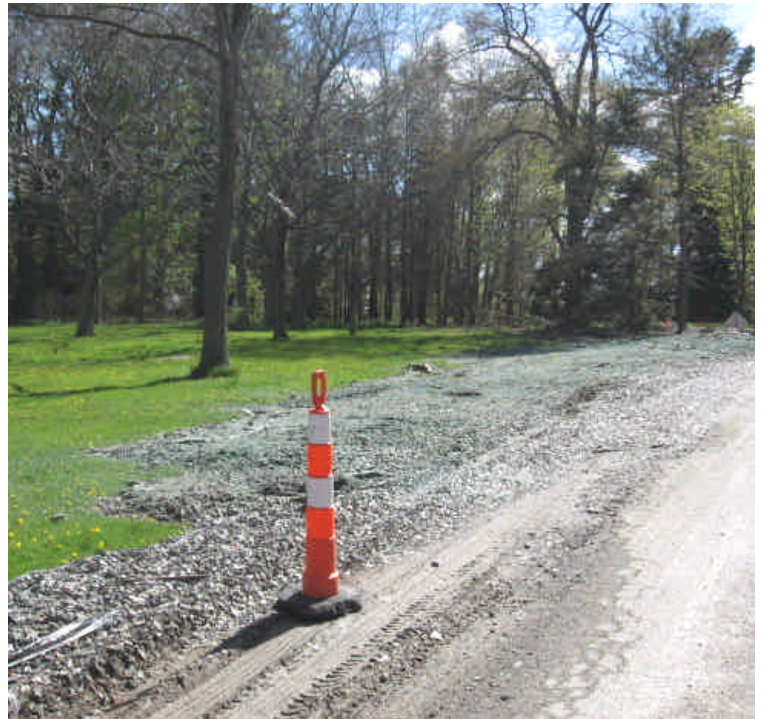
The majority of stone was removed, regraded, and hydroseeded (and mulched) along the edge of the access road to the Sherwood Island lay-down yard.
