Docket No. 272 – Development and Management Plan Inspection

Segment 4b Underground Line

Date: May 17, 2007

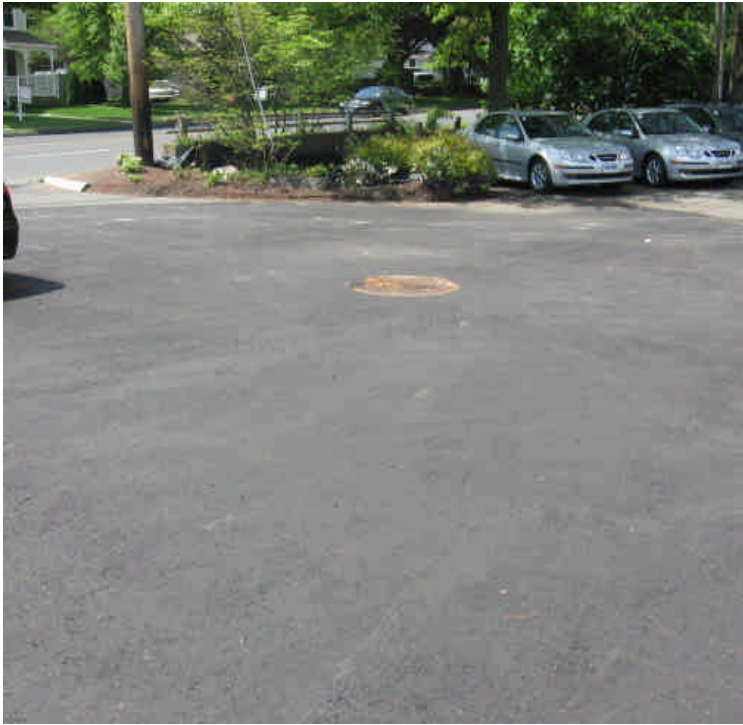
Photo of vault #13 where construction is complete and the area was repaved. Erosion controls remain in place for future trenching activities in the area.

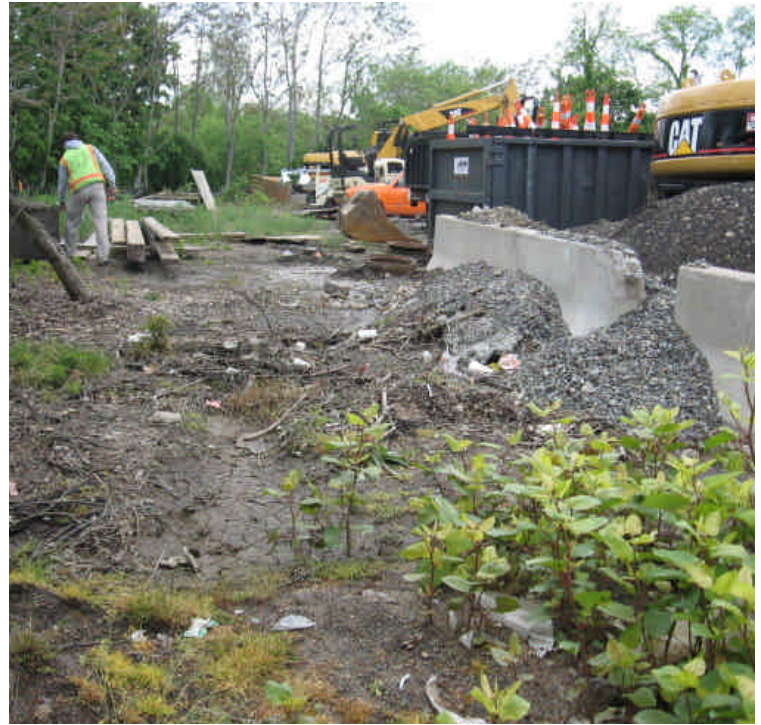
Stone being stored within jersey barriers has spilled beyond the containment bins but materials remain contained within the yard's boundary. 5/10-5/17/07	Attempt to contain all materials within their designated areas. 5/10-5/17/07	Needs proactive attention when feasible.
Additional Observations	None 5/17/07	None 5/17/07	NA

Photo of storage materials that have overflowed their containment bins, and of the drainage path of migrating sediment within the Imperial Ave. lay-down yard. Sediment and materials still remain within the perimeter of the yard.

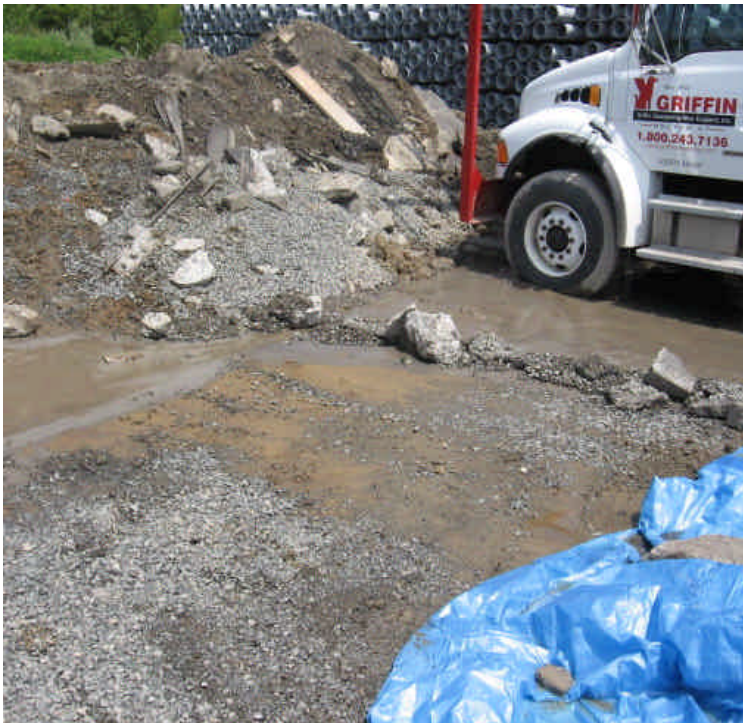
Both photos were taken within the King's Highway lay-down yard. Left: Accumulated slurry remains adjacent to the disposal soil pile. Right: Material is still overwhelming the silt fence perimeter control within the yard. Pull the soil back and restore the controls. However, resource areas are not located adjacent to this area.
