Docket No. 272 – Development and Management Plan Inspection

The Connecticut Light and Power Company Certificate of Environmental Compatibility and Public Need for the construction of a new 345-kV electric transmission line and associated facilities between Scovill Rock Switching Station in Middletown and Norwalk Substation in Norwalk, Connecticut, including reconstruction of portions of existing 115-kV and 345-kV electric transmission line, the construction of Beseck Switching Station in Wallingford, East Devon Substation in Milford, (and Singer Substation in Bridgeport), modifications at Scovill Rock Switching Station and Norwalk Substation, and the reconfiguration of certain interconnections.

Segment 4b Underground Line

Date: May 22, 2007

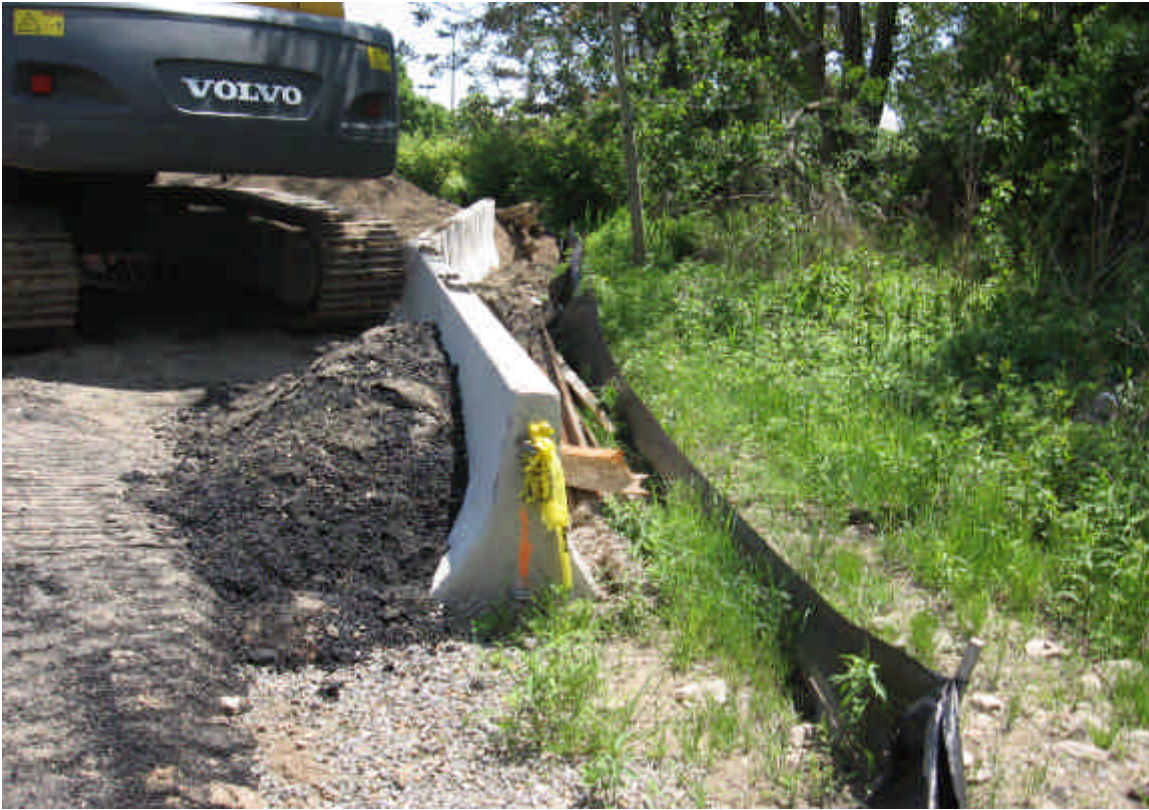
The majority of the compromised silt fence within the King's Highway lay-down yard has been re-established. The portion of the fence in the foreground of the photo required additional reinforcement when feasible.
