Docket No. 272 – Development and Management Plan Inspection

Segment 4b Underground Line

Date: May 31, 2007

Location: Fairfield/Westport Town Line to Westport Avenue in Norwalk

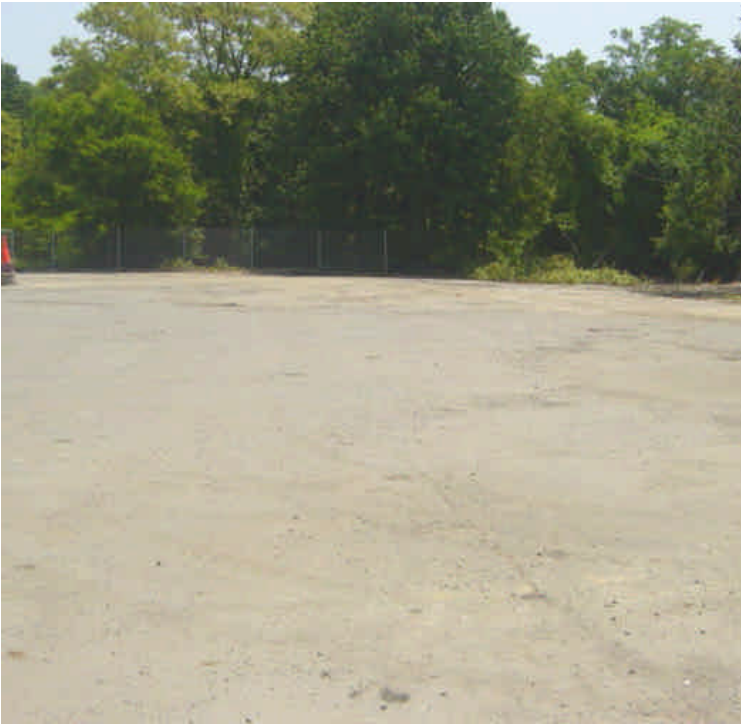
Most of the stored items within the Imperial Ave. lay-down yard have been removed as the yard is being demobilized.

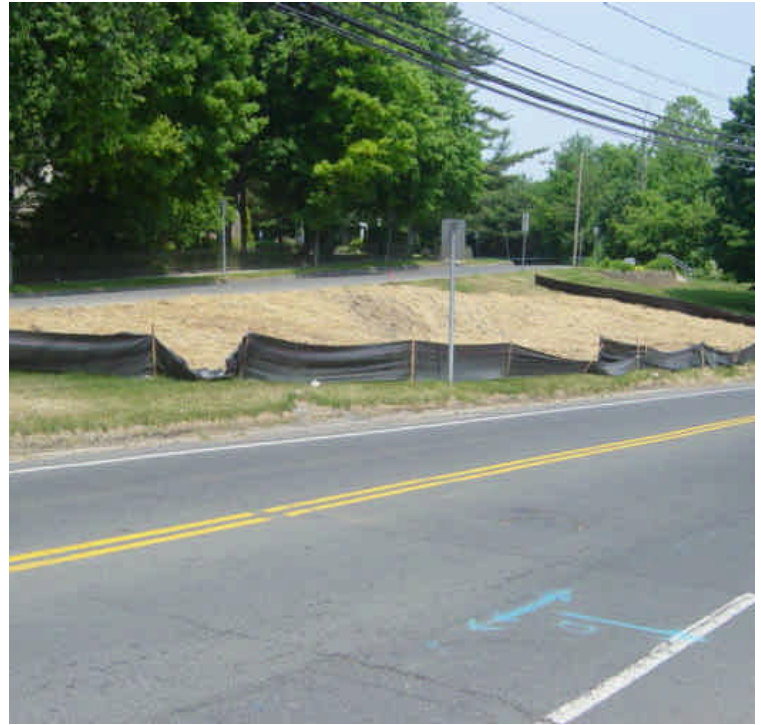
Photo of the vault #5 area. The surface has been top-dressed with a hard pack material and hay mulch. A small portion of the silt fence is slumping and should be re-established.

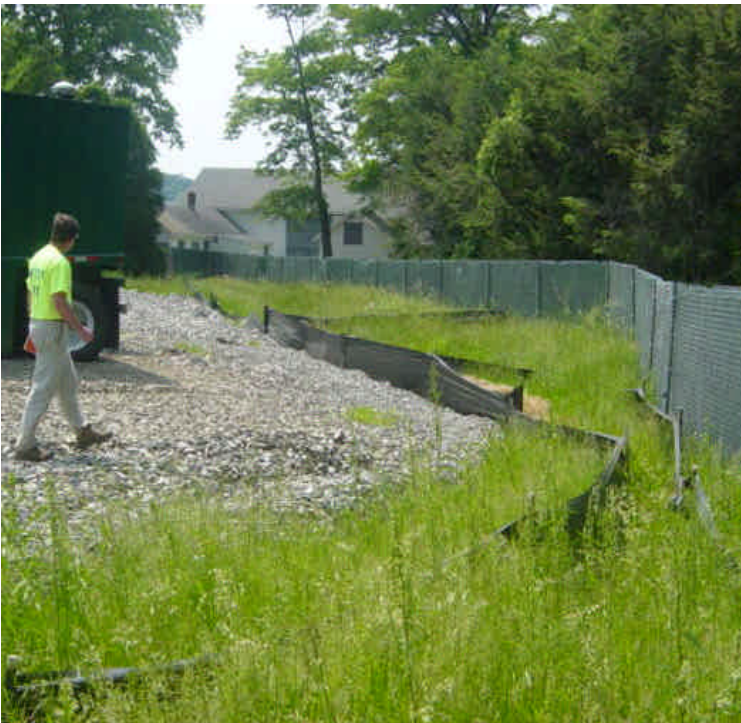
A portion of the controls within the Sherwood Ave. lay-down yard have been overwhelmed. The controls should be re-established

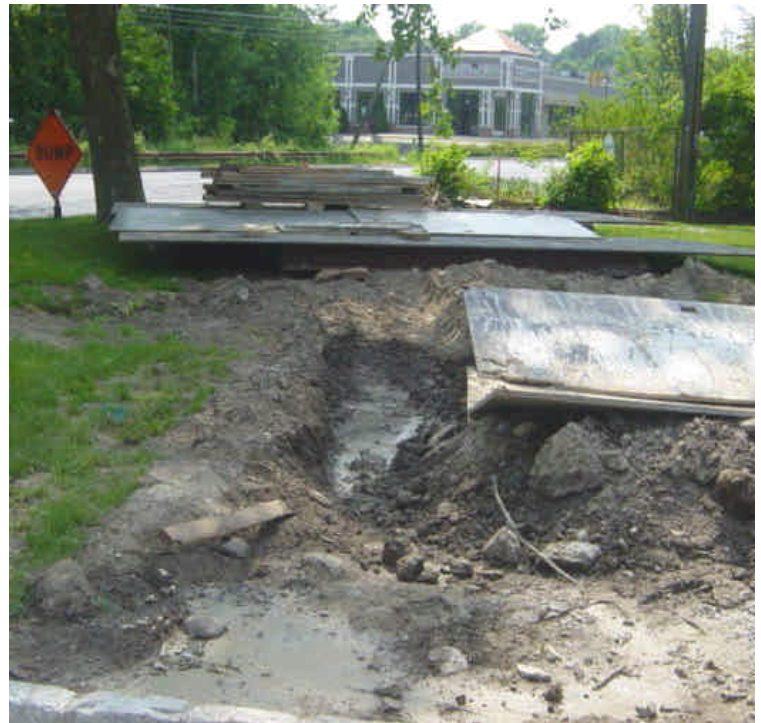
Photo of trenching activities at sta. #365.
