Docket No. 272 – Development and Management Plan Inspection

Beseck Switching Station Inspection

Date: November 7, 2006

Location: Beseck Switching Station

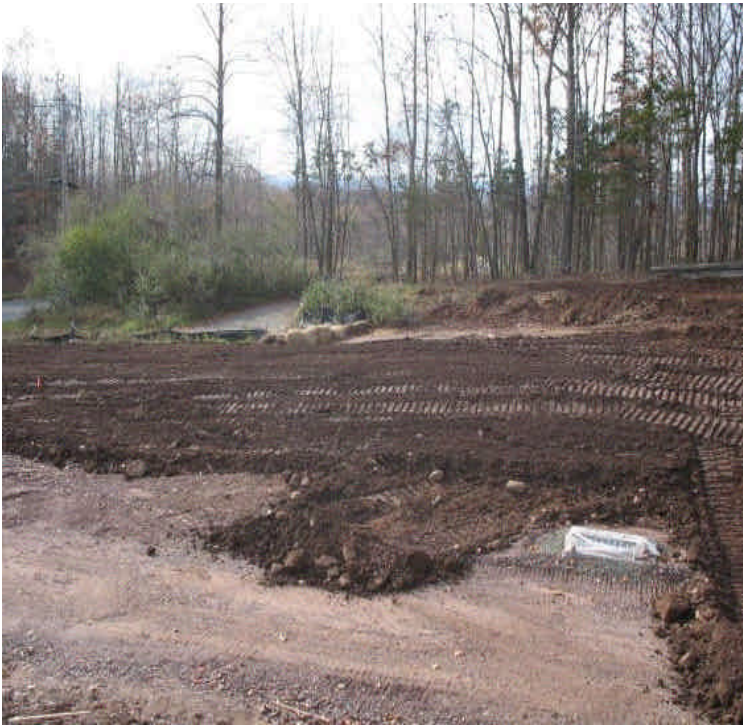
Old Zolnik entrance at Carpenter Lane. New haybales were added as the area is being graded.

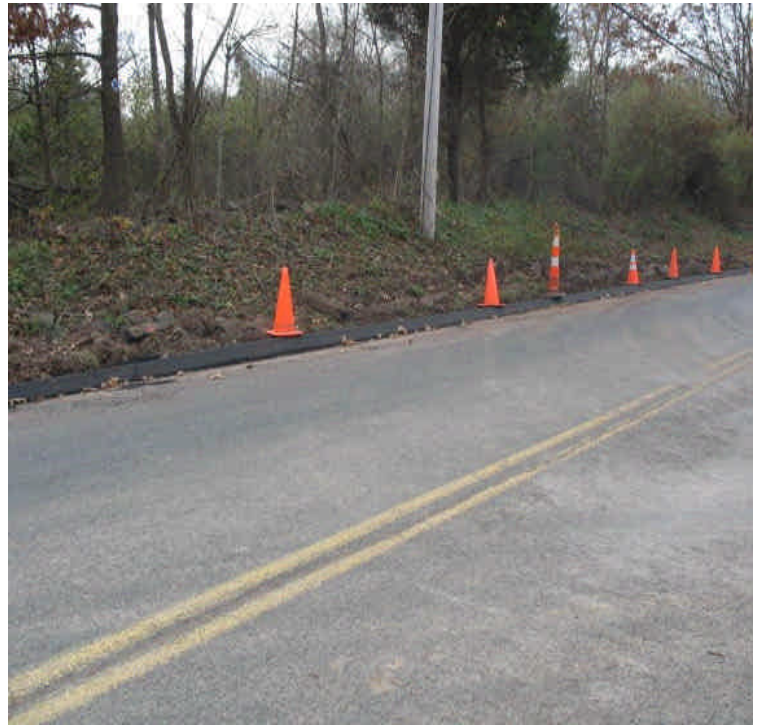
Asphalt curbing has been replaced across Carpenter Lane.

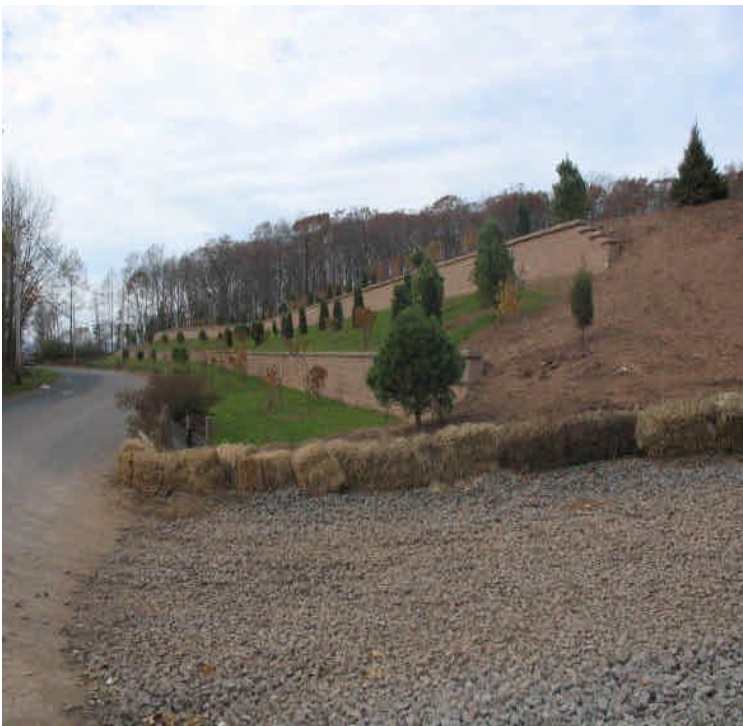
Stone site entrance at Carpenter Lane. Stone is fairly clean of sediment. Final landscaping was complete along the new retaining walls.

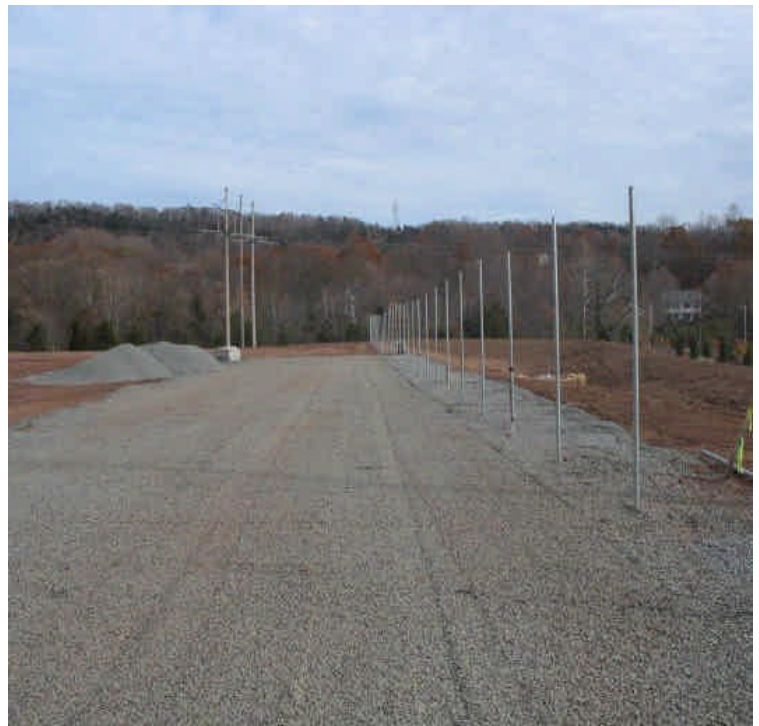
Crushed stone was added to finished areas above the new retention basins. This will also help to reduce exposed surfaces on site.

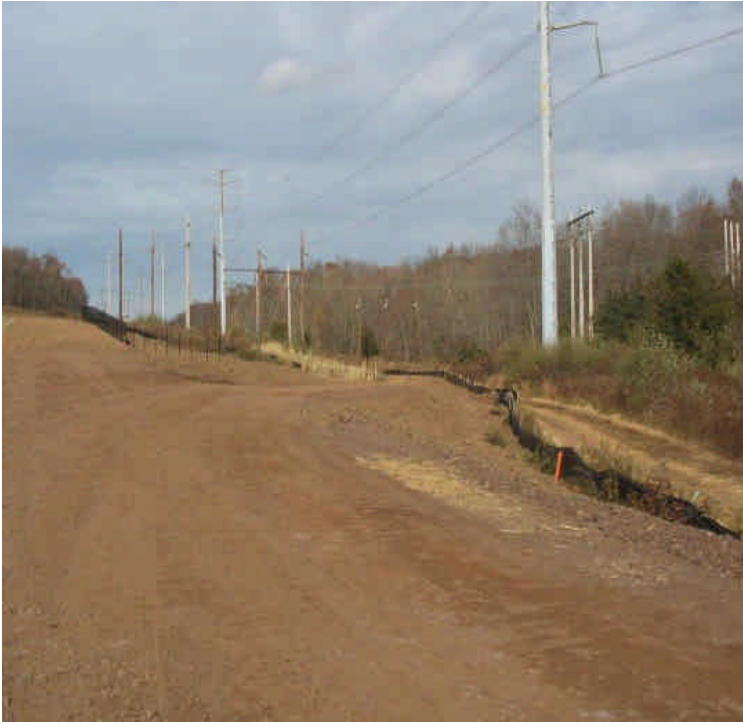
New ROW access from Beseck at finished grade; new silt fence installed.

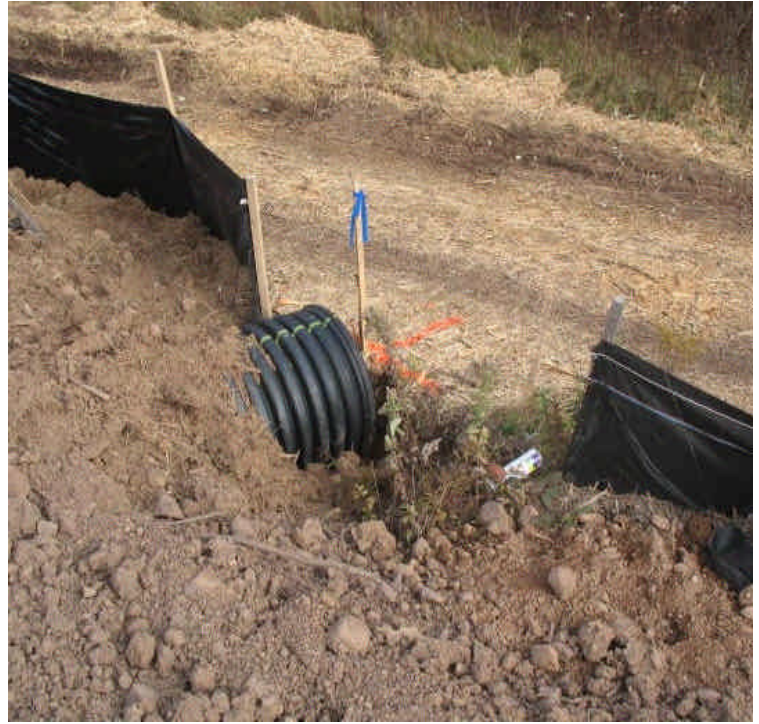
The culvert under the new access road is in place. A riprap sediment trap is still proposed for the outlet. 11/7/06	Install basin/trap at the outlet as soon as feasible to filter water before discharging it off site. 11/7/06	NA
	A new line of silt fence	Monitor road and erosion	Silt fence was installed

A culvert was installed under the new access road. The road connects the Beseck entrance to the ROW and will be used jointly. A sediment trap will still be needed at the outlet.

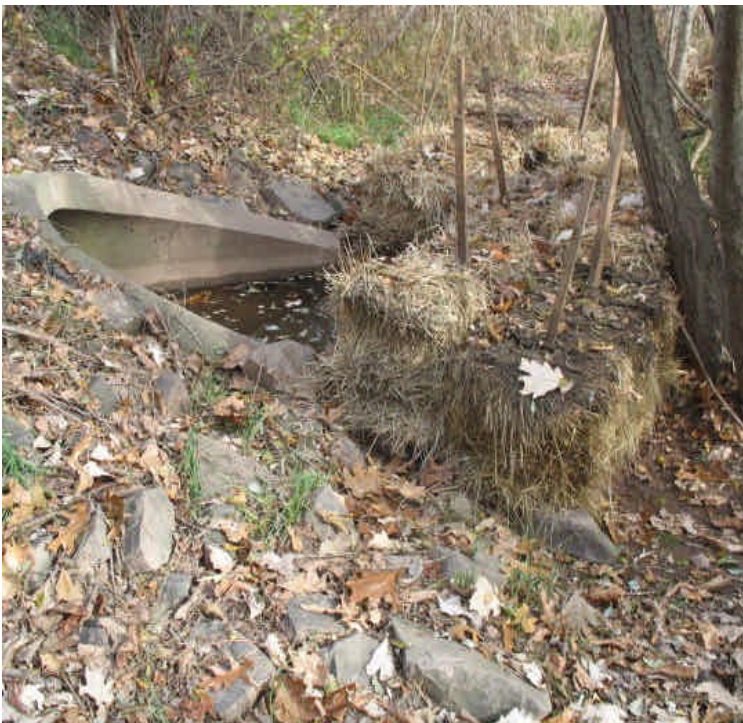
Sediment has settled out in the bottom of the storm drain outlet. A good haybale barrier is in place.

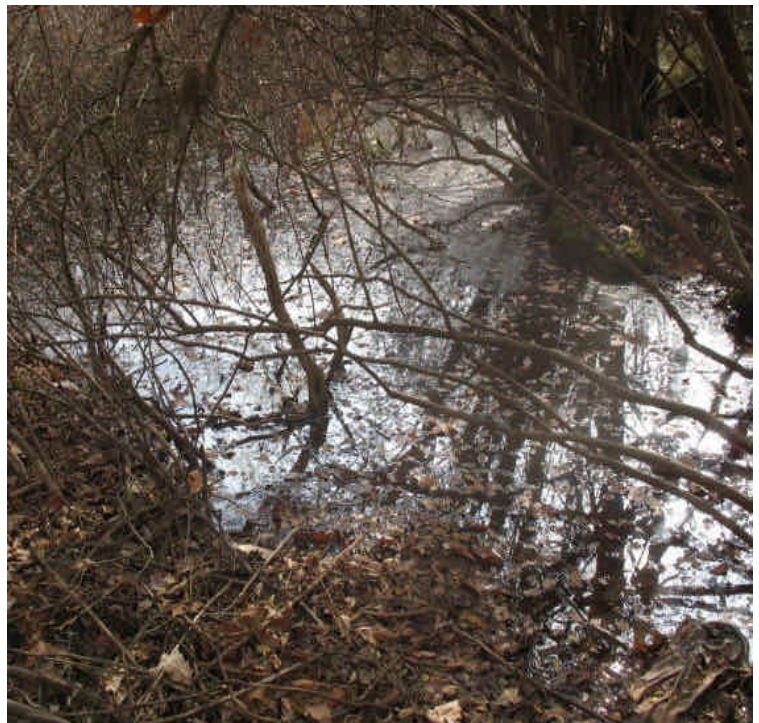
No new sediment or turbidity was observed in the wetlands following the small rain event.
