Docket No. 272 – Development and Management Plan Inspection

Beseck Switching Station Inspection

Date: November 14, 2006

Location: Beseck Switching Station

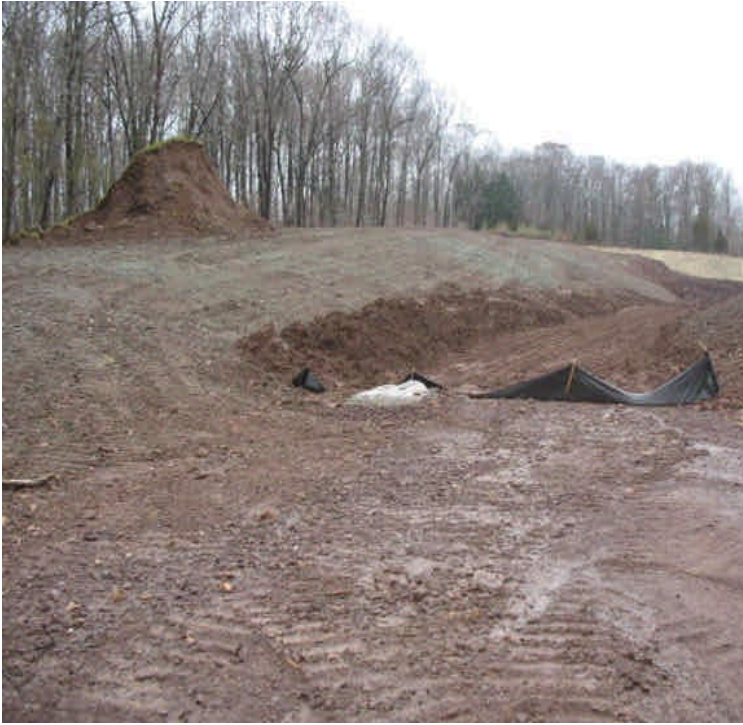
Old Zolnik entrance at Carpenter Lane. New haybales were added and the area was graded and hydroseeded.

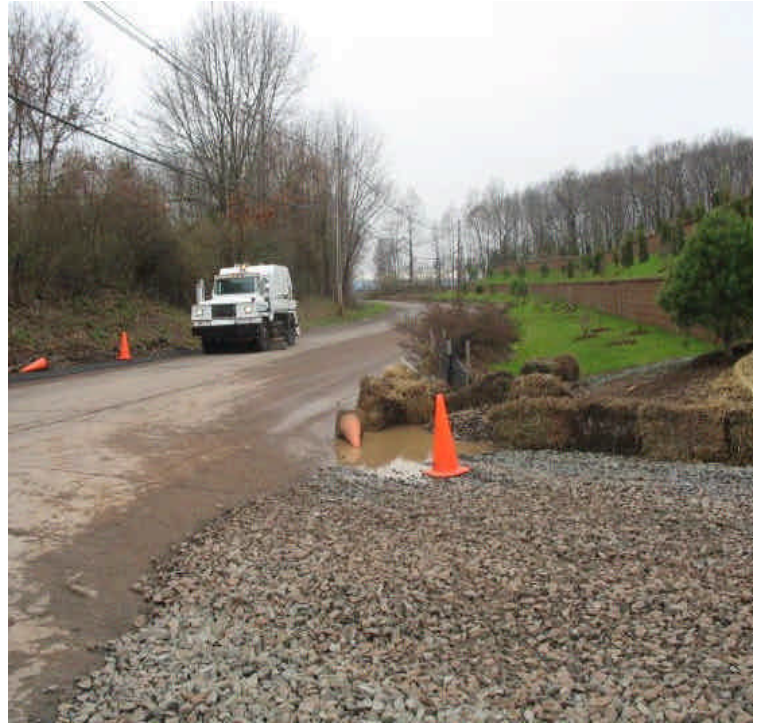
View of Carpenter Lane. Street sweeping was occurring and the stone entrance was reggraded but turbid run-off was still reaching the roadway.

Areas of Inspection	Observation	Recommended Action	Corrected Action
Access roads and adjacent roadways	All traffic leaving the site is using stone entrance on east side. Sediment was being swept from Carpenter Lane during the inspection. Some pooled turbid run-off had also reached the roadway. 11/14/06	Clean/sweep roadway regularly. Continue to monitor stormwater leaving the site; replace and add more controls as needed. Clean gutters by hand as needed. 11/14/06	Roadway being swept during the inspection.
	Stone access pad is mostly clean of sediment buildup. Trucking/ soil removal from site resumed this week to remove the final stockpile. Stone pad has been regraded. 11/14/06	Continue to clean/refresh stone construction entrance. Determine how to contain all run-off from reaching the road. 11/14/06	The stone was re-graded. Continue evaluation.
	Haybales remain at the edge of the entrance pad to filter storm water before leaving the site. However, turbid run-off was reaching the roadway and leaving the site. 11/14/06	Monitor haybales and replace or reposition as needed to filter run-off. Evaluate installing the berm that was discussed at the stone pad. 11/14/06	Needs attention.

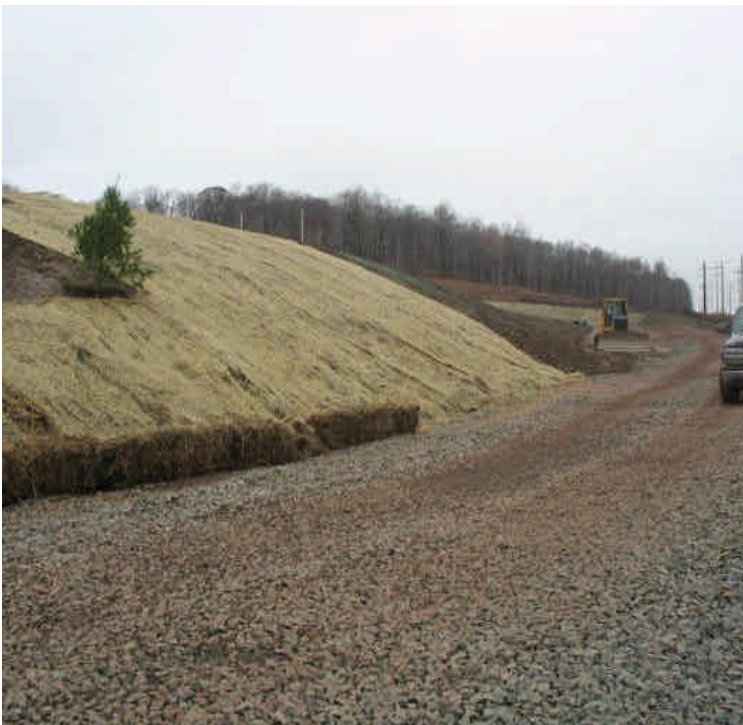
Erosion control mats were installed along steep slopes. Remaining exposed soil surfaces were hydroseeded.

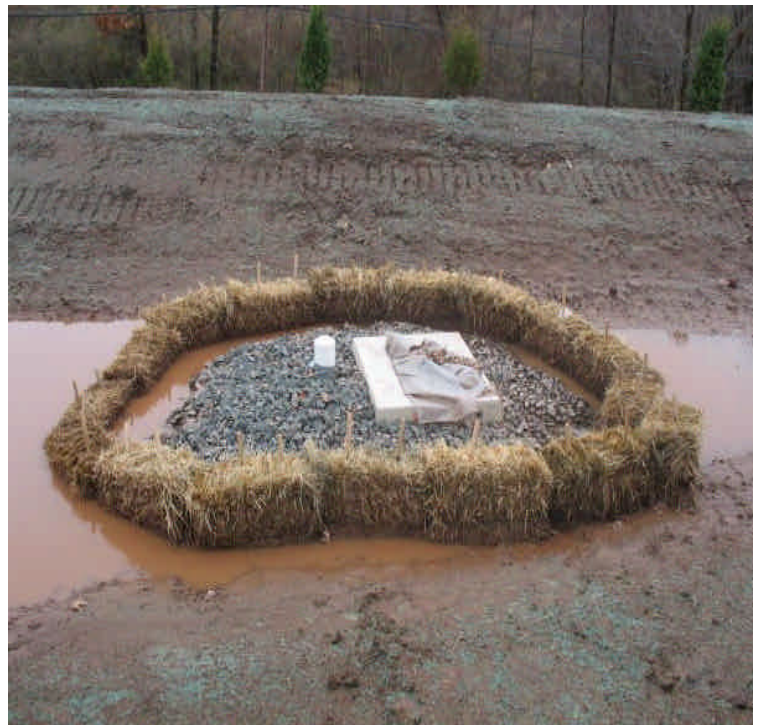
Efforts were made to control the new detention basin inlet until grass cover can establish. However, vegetative cover is not expected prior to the winter and additional controls are recommended to remove turbidity.

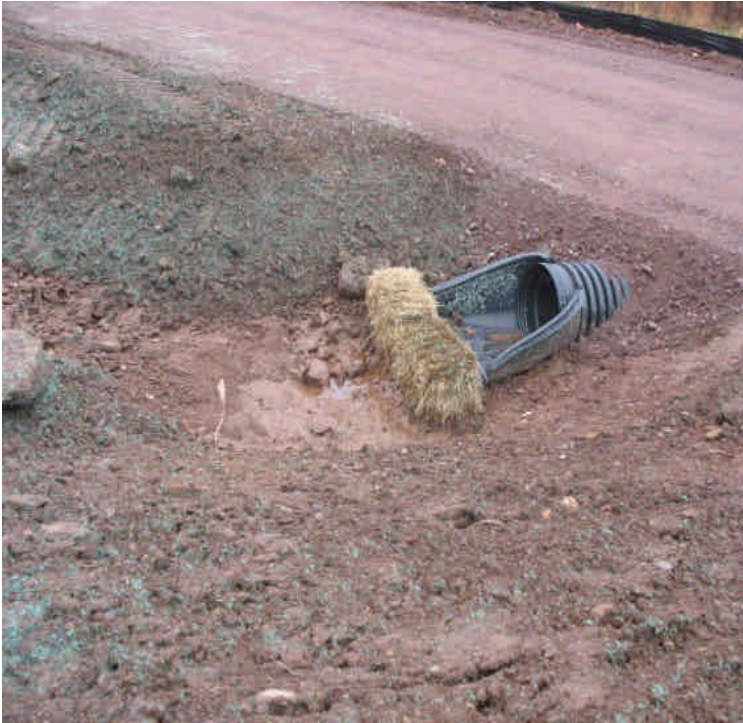
New culvert inlet at the ROW access road from Beseck. Haybales were in place to reduce sedimentation.

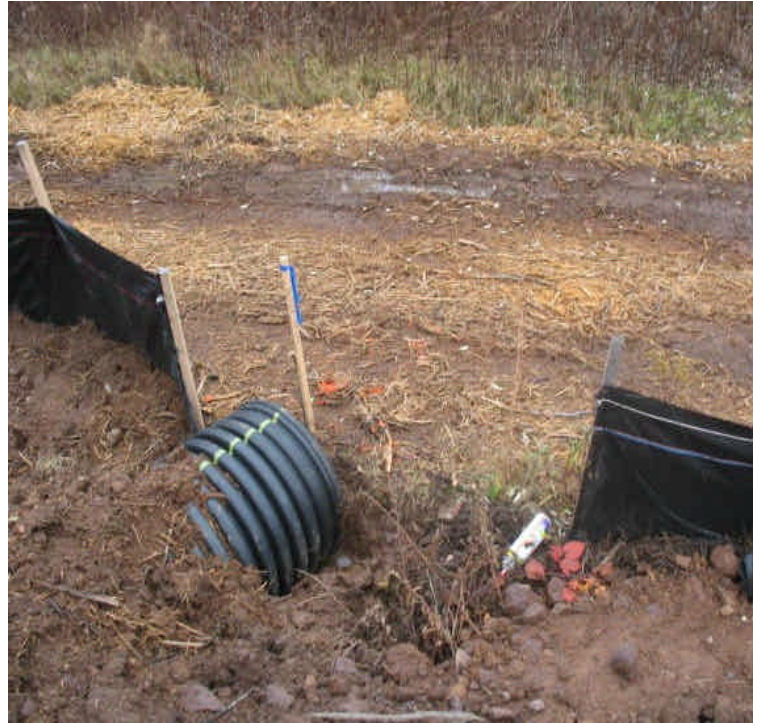
Culvert outlet installed under the new access road. The road connect the Beseck entrance to the ROW and will be used jointly. A sediment trap will still be needed at the outlet.

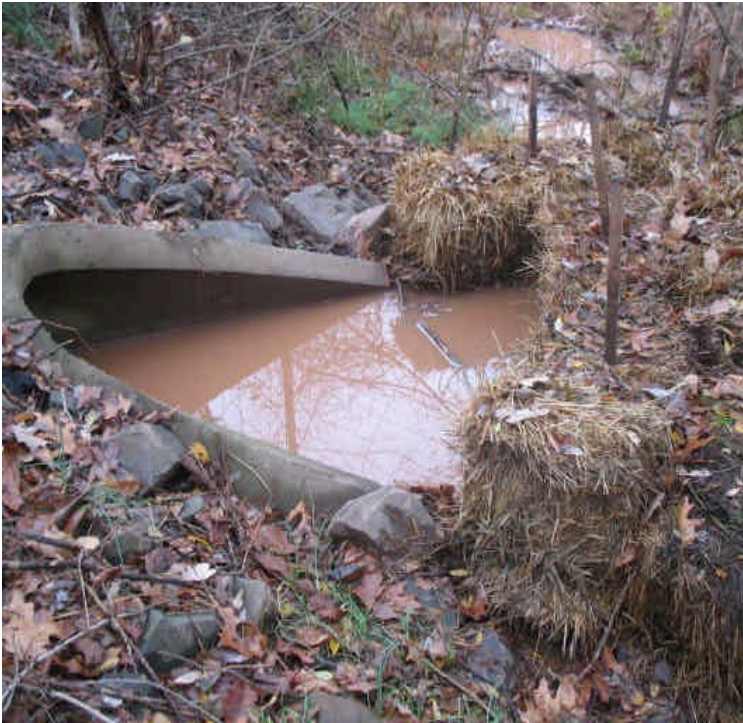
Following several large rain events, turbid run-off was again reaching the storm drain outlet across Carpenter Lane. This issue needs immediate attention again to determine the source and control it.

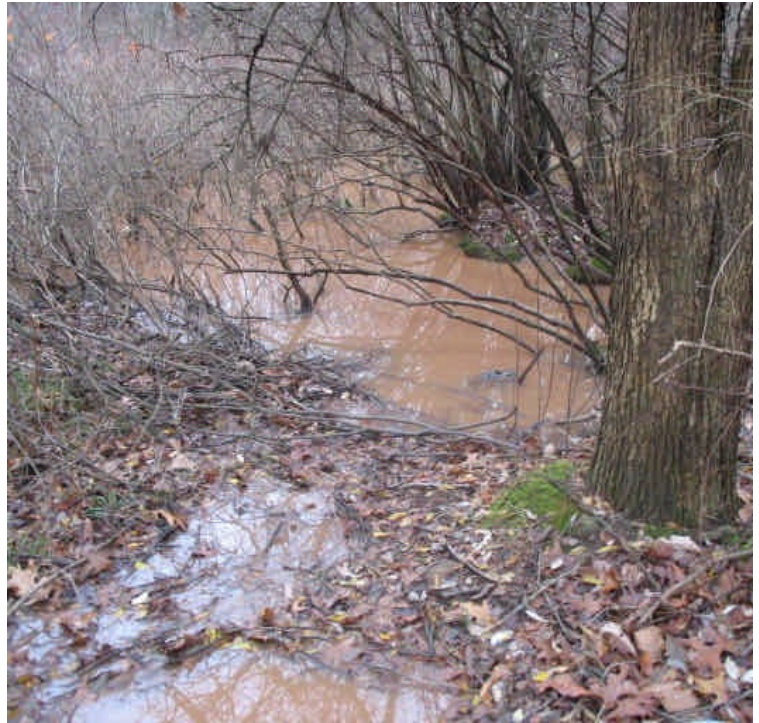
The turbid water had flowed through the haybale barrier and was observed in the wetlands. When this settles out, evaluate whether sediment removal is necessary.
