**Docket No. 272 – Development and Management Plan Inspection**

**Beseck Switching Station Inspection**

**Date:** November 20, 2006

**Location:** Beseck Switching Station

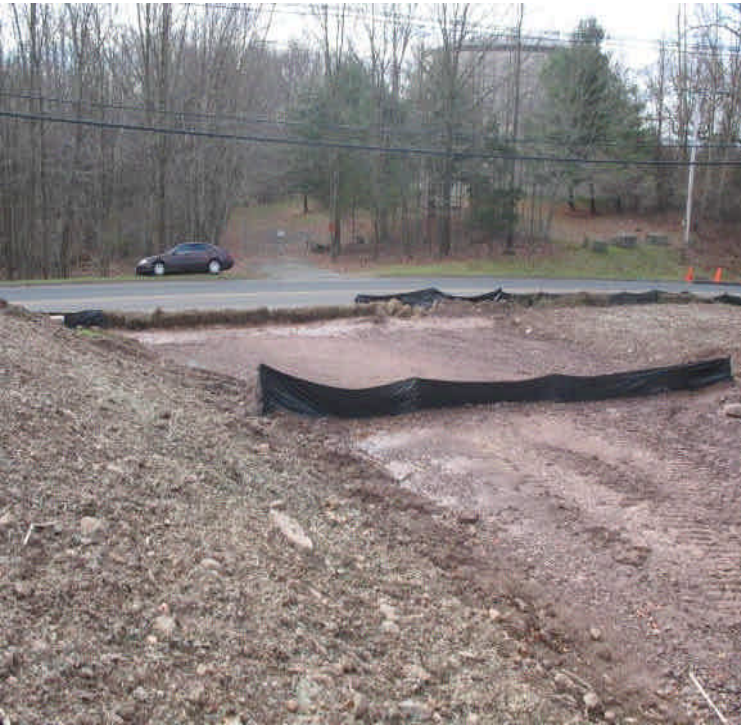
**New entrance off Carpenter Lane. Additional haybales and silt fence were installed.**

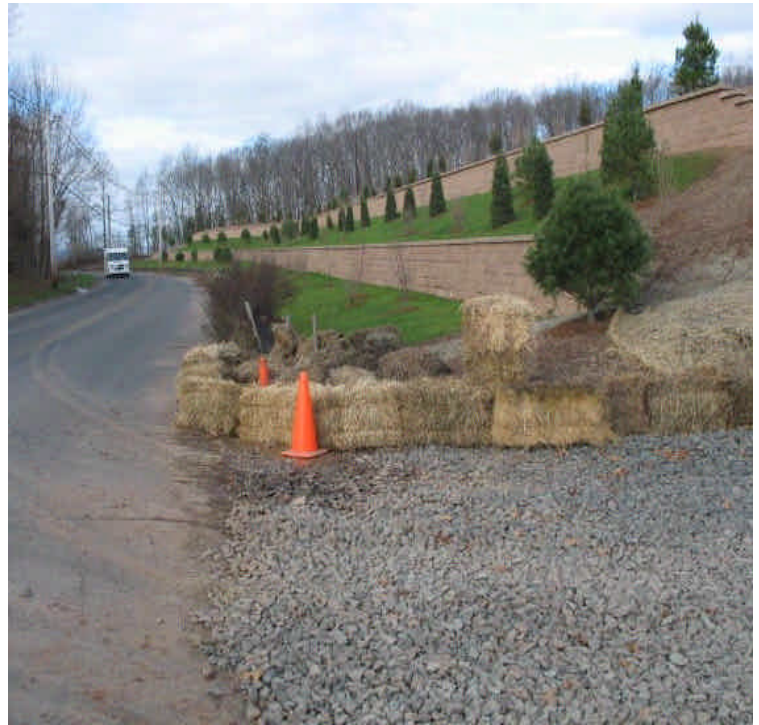
**View of Carpenter Lane and retaining walls. New haybales were installed, the stone entrance was regraded, and the roadway was swept. Minor sediment tracking was noted.**

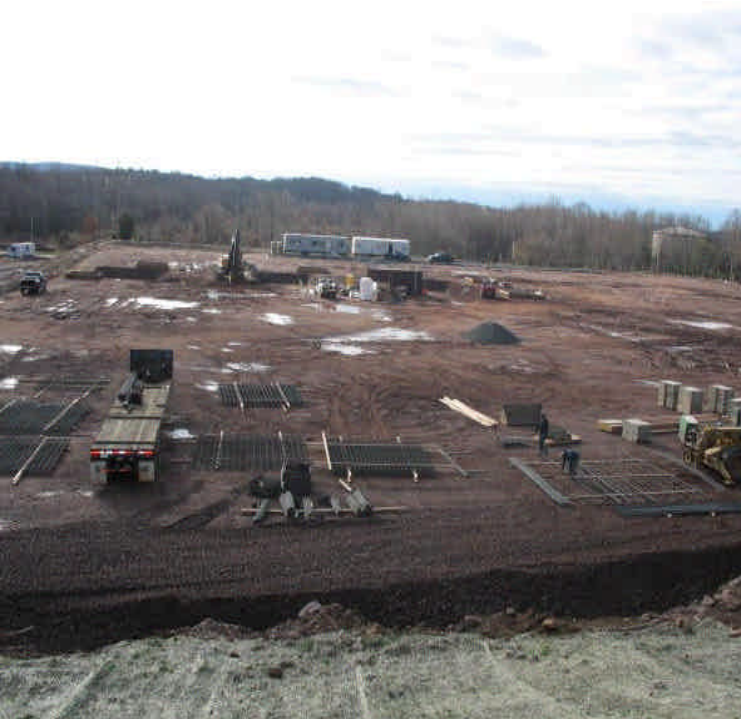
**View of entire site looking from north to south. Foundation excavations are underway.**

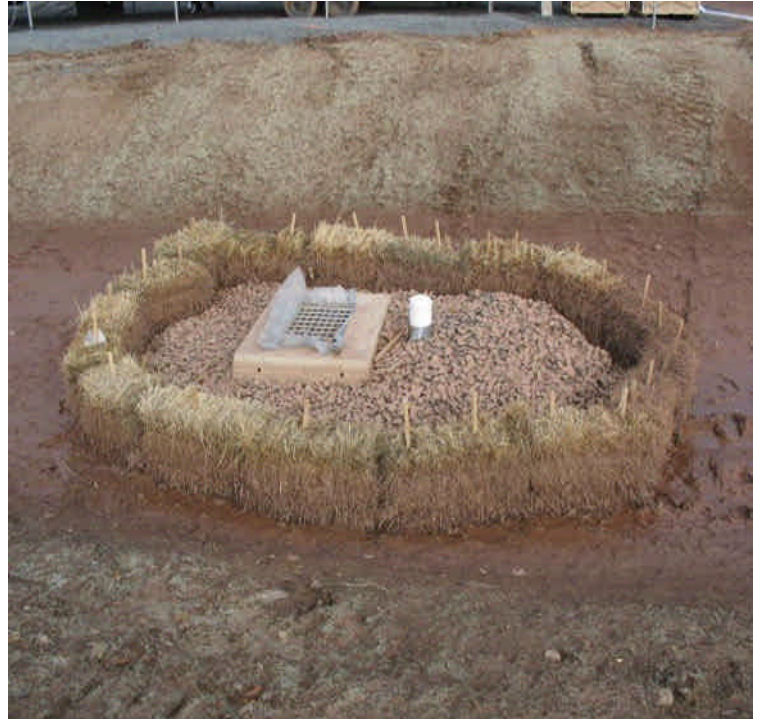
<b>Dewatering</b>	<p><b>Minimal dewatering was noted to remove rainwater from new foundation pits. Water was pumped into the new detention basin. Small, erosive gullies were formed as a result. 11/20/06</b></p> <p><b>Evaluate whether turbid run-off is pooling up and over the controls at the detention basin inlets. This may be the source of sediment in wetlands across Carpenter Lane. 11/20/06</b></p>	<p><b>When dewatering is required, pumping must be monitored to avoid formation of erosive gullies or increased sediment in the basins. Regrade and stabilize gullies. Try pumping water against haybales or stone to slow the velocity. 11/20/06</b></p> <p><b>Additional or alternative controls may be needed to prevent turbid water from entering the riser pipes and getting into the storm water system and wetland. 11/20/06</b></p>	<p><b>Needs attention.</b></p> <p><b>Needs evaluation.</b></p>
<b>Blasting</b>	<b>All blasting was complete as of 9/7/06.</b>	<b>None 11/20/06</b>	<b>NA</b>

**Efforts were made to control the new detention basin inlet until grass cover can establish. However, it appears water is pooling over the controls during large rain events, allowing turbidity to enter the system. Additional/alternative controls are recommended.**

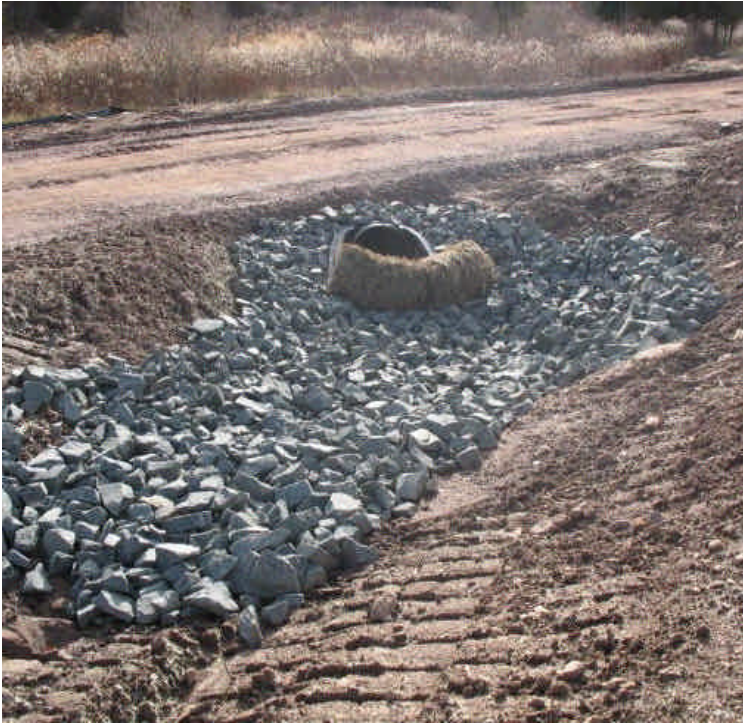
**Culvert inlet at the ROW access road from Beseck. Riprap & haybales were in place to reduce sedimentation.**

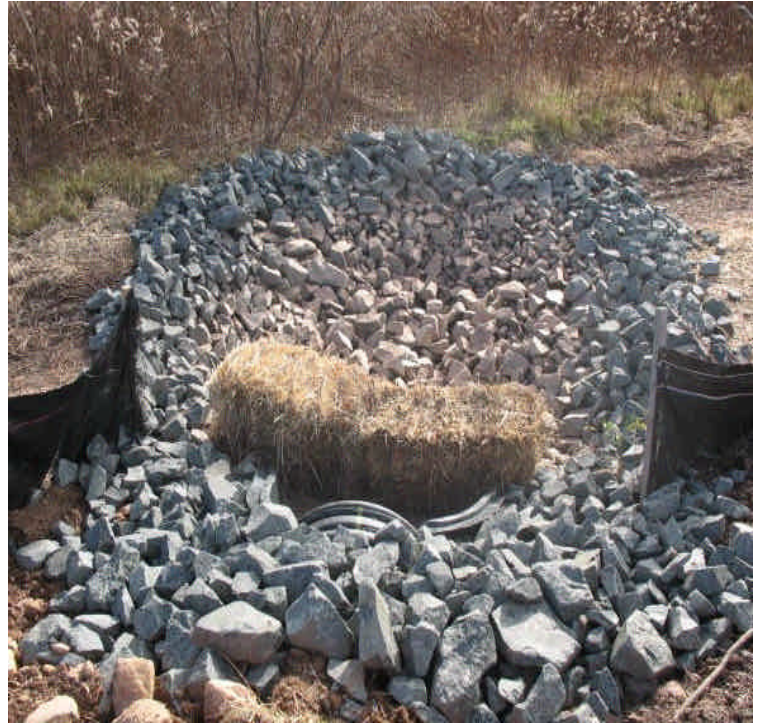
<b>A new riprap sediment trap was installed at the outlet of the culvert under the access road. The old ROW access road is now closed off and the Beseck entrance will be used jointly with segment 1A contractors 11/20/06</b>	<b>This area will still require regular attention by all contractors to reduce sediment tracking. Maintain basin/traps and haybales at the outlet. 11/20/06</b>	<b>Riprap sediment trap was installed and haybales were in place at the inlet and outlet.</b>

**A riprap sediment trap is now in place at the culvert outlet. The old ROW access road is now closed off and contractors share the Beseck entrance. Haybales were installed to control sediment.**

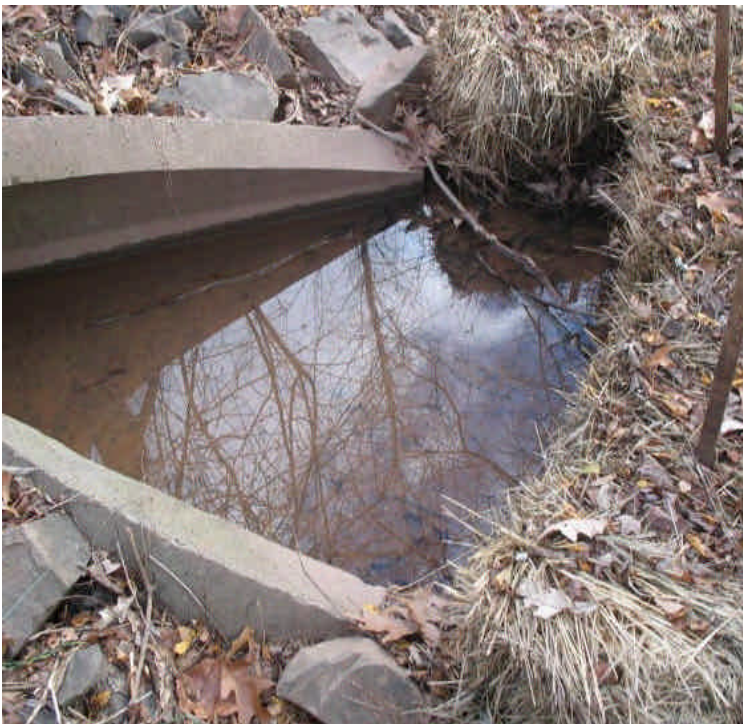
**Storm drain outlet across Carpenter Lane had settled sediment on the bottom with clear water leaving the pipe.**

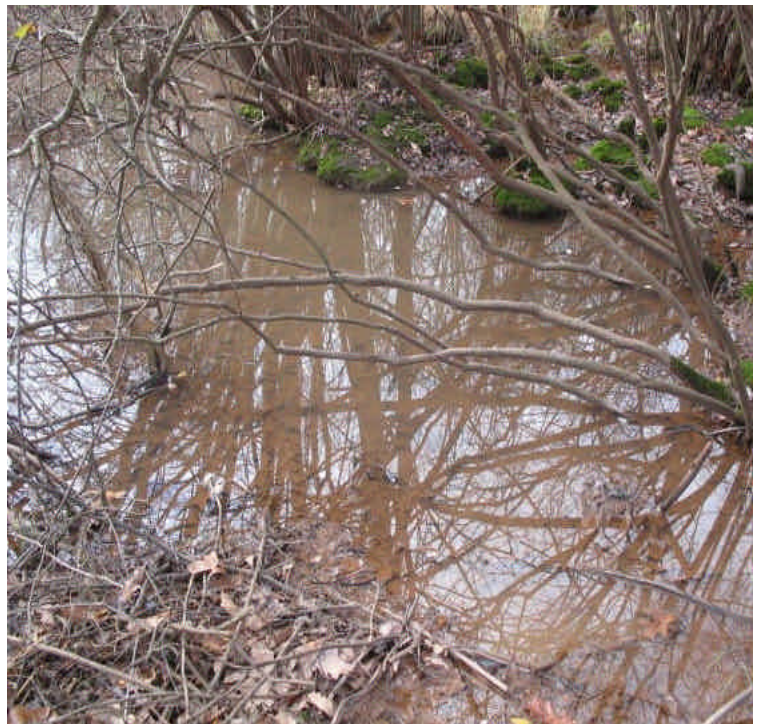
<p><b>Inland Wetland and Watercourse encroachment and mitigation</b></p>	<p>The wetland across Carpenter Lane still contains some standing turbid water but most sediment has settled out. 11/20/06</p> <p>Wetlands on east side of site were clean and well protected. 11/20/06</p>	<p>Evaluate the wetland when sediment fully settles out to determine whether sediment removal will be necessary. Several areas appear to have sediment accumulation. The definite source of turbidity needs to be identified and controlled. 11/20/06</p> <p>Continue to monitor. See segment 1a report for further information.</p>	<p>Needs attention and evaluation.</p> <p>NA</p>

**Some suspended sediment/turbid water was observed in the wetlands. Sediment is beginning to settle out but the area will need to be evaluated to determine if sediment removal is necessary.**
