Docket No. 272 – Development and Management Plan Inspection

Beseck Switching Station Inspection

Date: November 28, 2006

Location: Beseck Switching Station

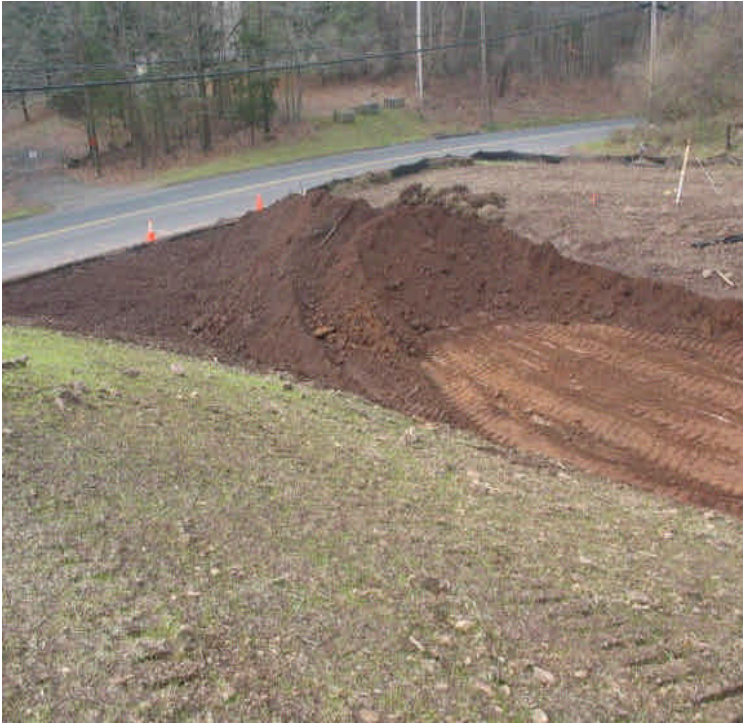
New entrance off Carpenter Lane is being filled and graded.

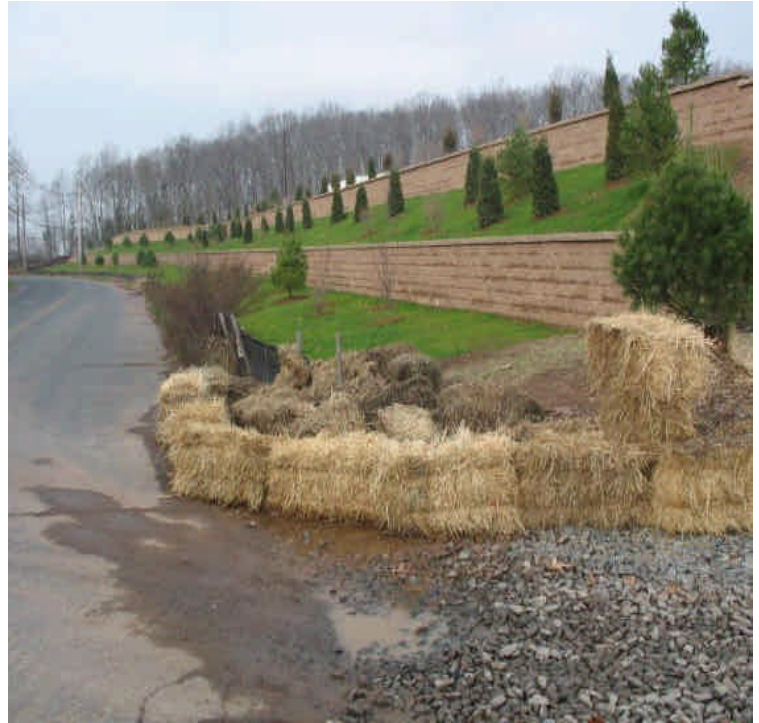
View of Carpenter Lane and retaining walls. Even with recently installed, additional controls, minor amounts of turbid-runoff were still noted leaving the site

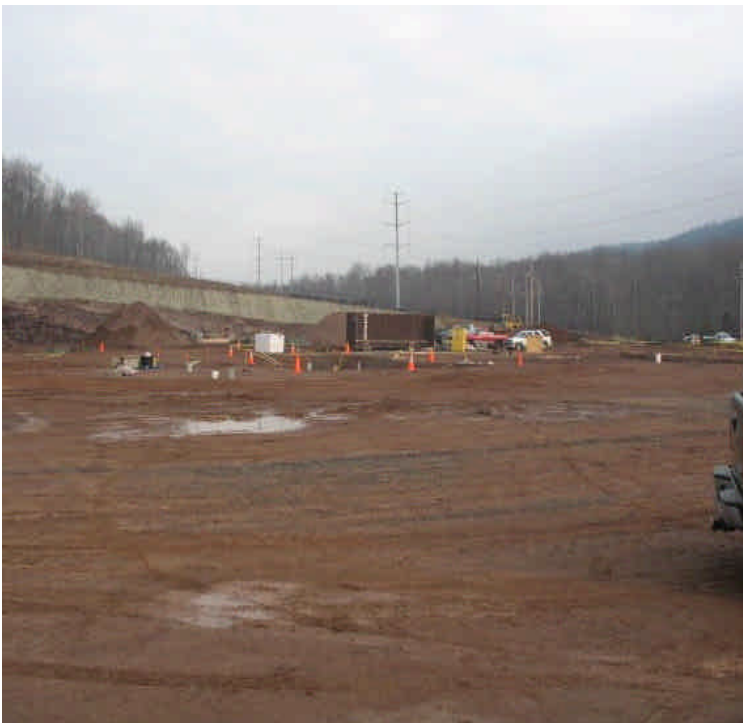
View of entire site looking from south to north. Work on foundations continues.

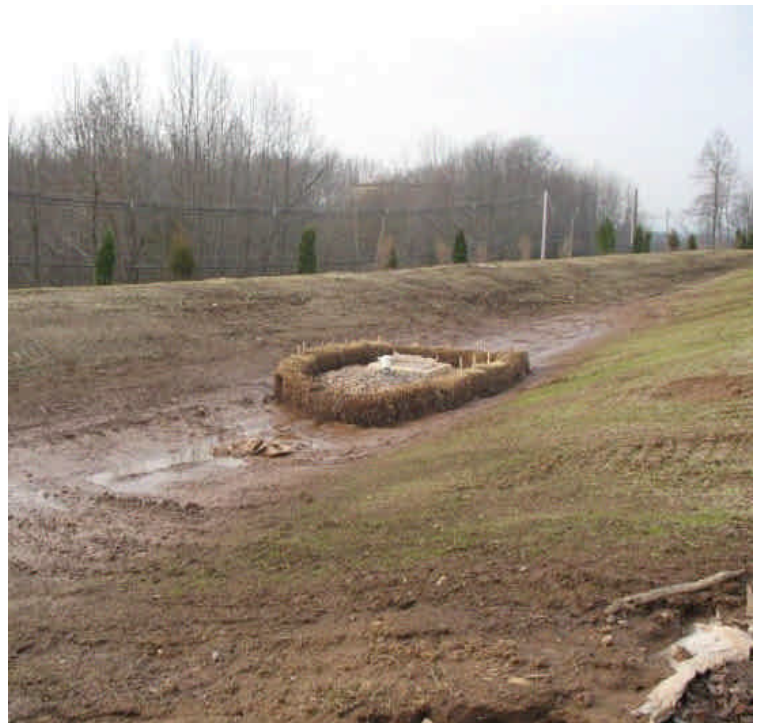
Some grass growth was noted on the seeded slopes of the detention basins due to the warm weather. Additional/alternative controls are still recommended to protect the inlet as turbid water may pool over and into the system.

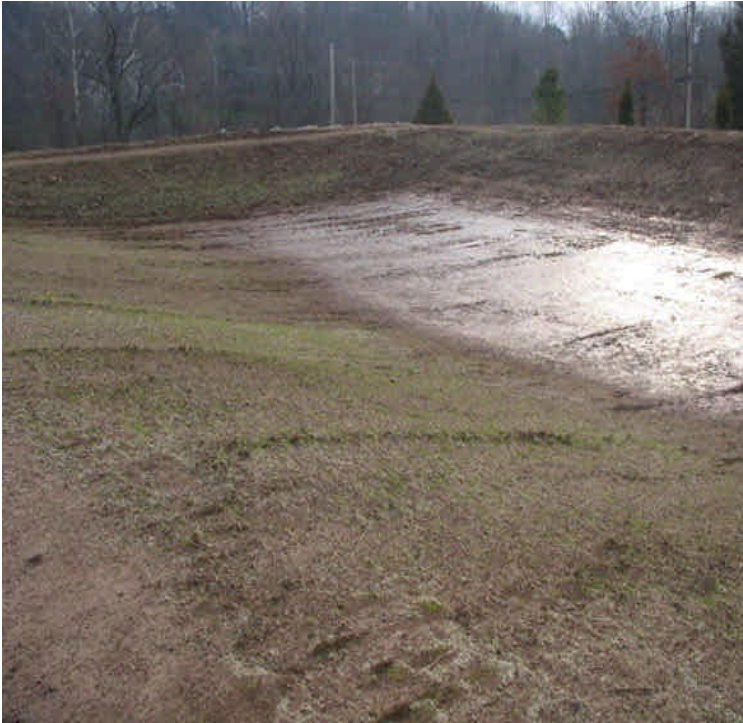
Grass growth noted on detention basin slopes due to the warmer weather. Continue to monitor for stabilization.

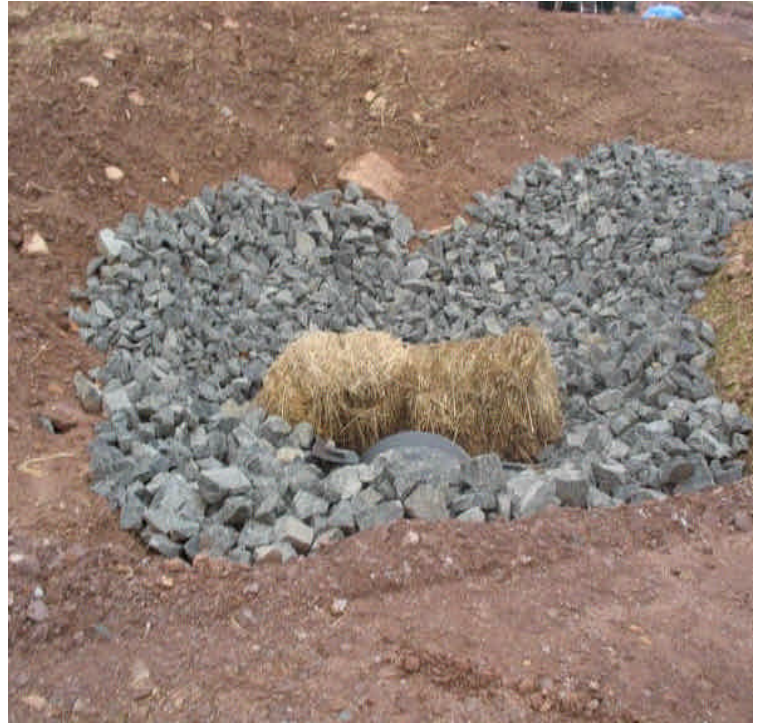
View of the culvert under the new access road. Haybales are still in place and sedimentation was not noted. Beseck and 1A contractors are sharing the joint access road.

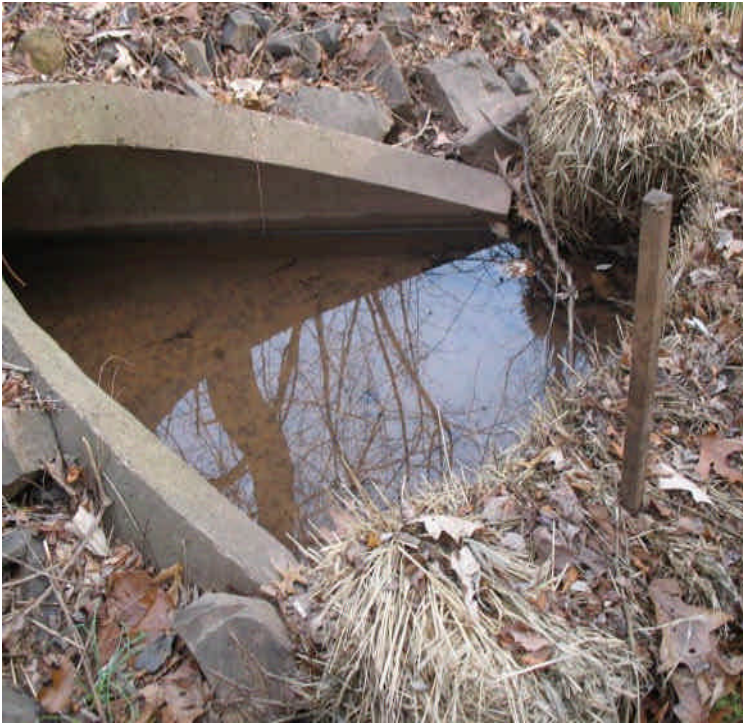
Storm drain outlet across Carpenter Lane contained settled sediment with clear water standing water at the pipe.

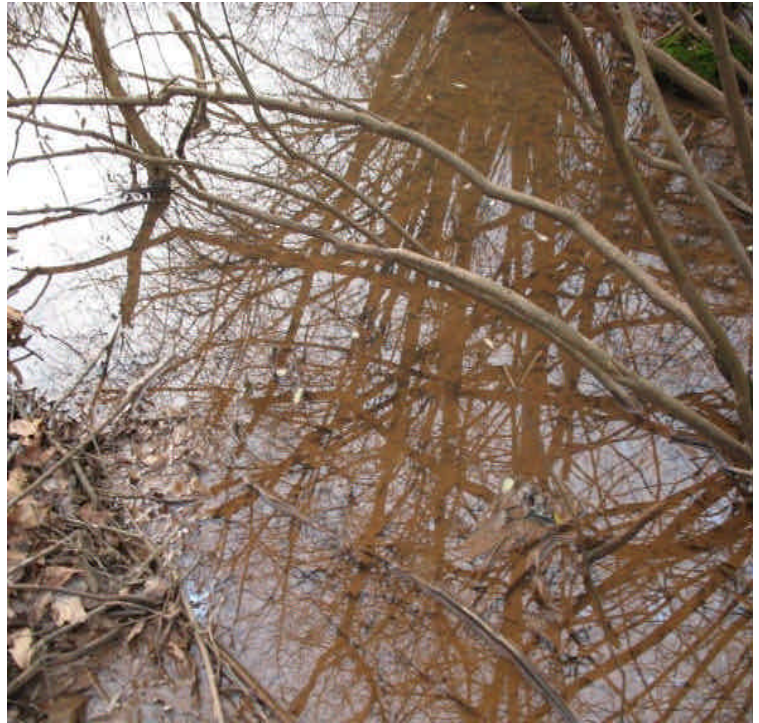
Sediment has completely settled out in the wetlands across Carpenter Lane. A fine layer of sediment has accumulated on the leaf litter. This may be difficult to remove while standing water is present but it may continue to get mixed into the water column during storms. Evaluate what can be removed without causing further impact.
