Docket No. 272 – Development and Management Plan Inspection

Scovill Rock Switching Station Inspection

Date: November 7, 2006

Location: Scovill Rock Switching Station

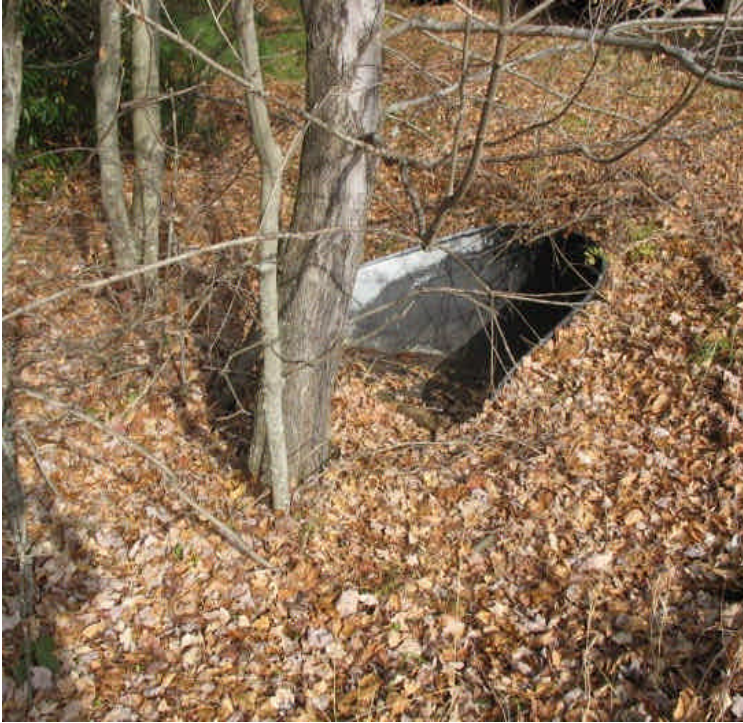
No water was flowing under the access drive, no sediment noted from the rain last week.

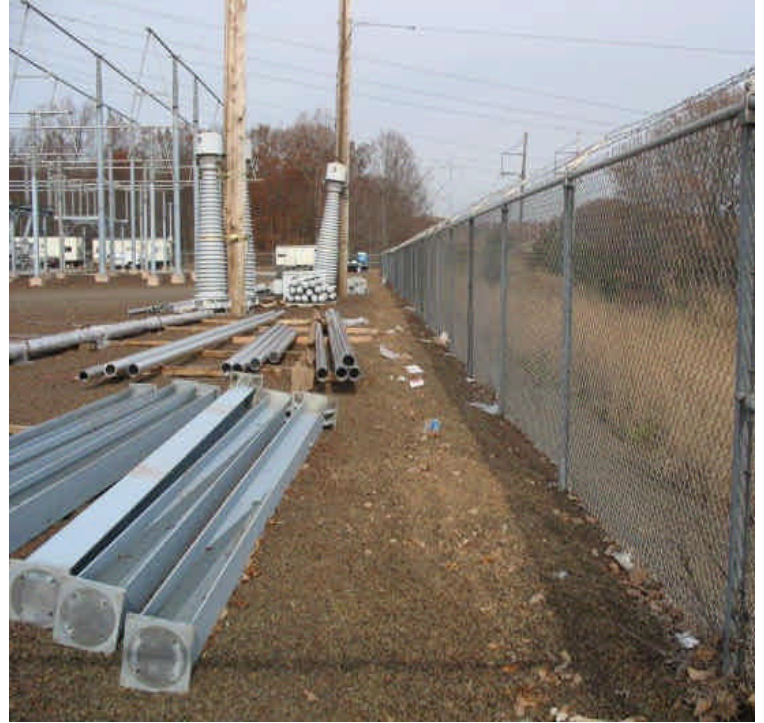
Silt fence was removed from the perimeter and site is stable. Most soil disturbing work on site is complete at this time.

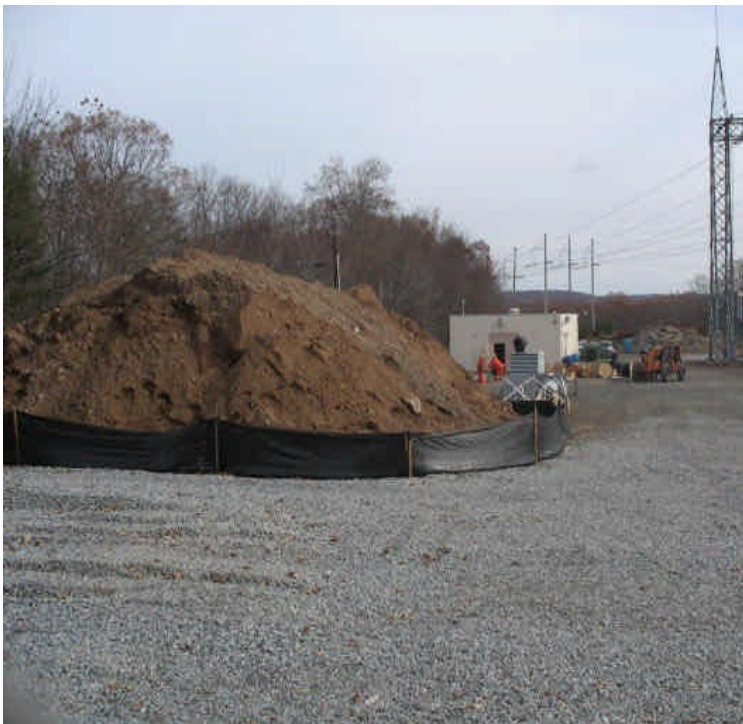
The remaining soil stockpile is surrounded by silt fence.

Only one stockpile remains within the yard. The stockpile is surrounded by silt fence and a flat stone surface. It will be removed from the site as soon as	Once soil analysis is complete, remove soil and dispose of properly. 11/7/06	Silt fence was installed around the remaining soil stockpile.

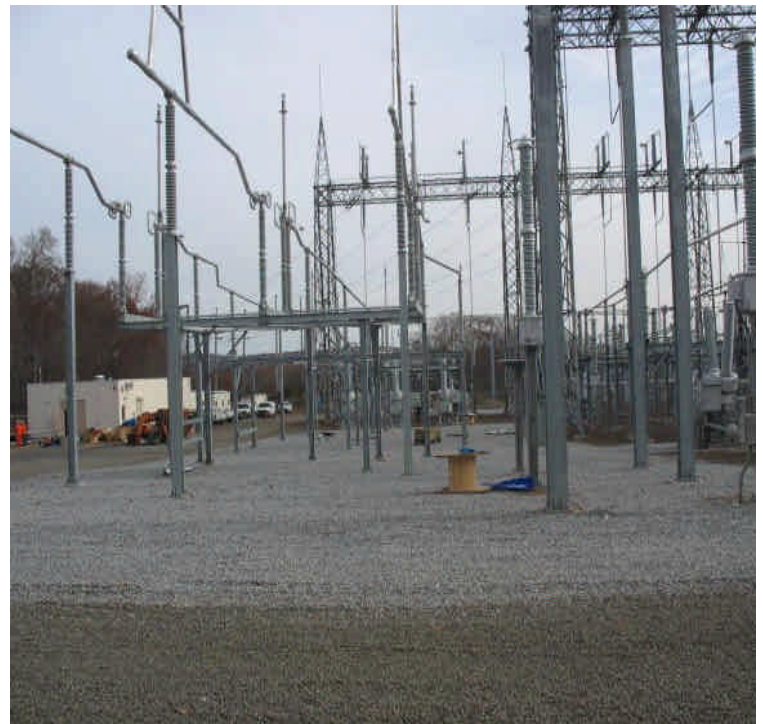
Foundation installation is complete; the site has been graded and stabilized with stone. Work continues on structures.
