Docket No. 272 – Development and Management Plan Inspection

Scovill Rock Switching Station Inspection

Date: November 14, 2006

Location: Scovill Rock Switching Station

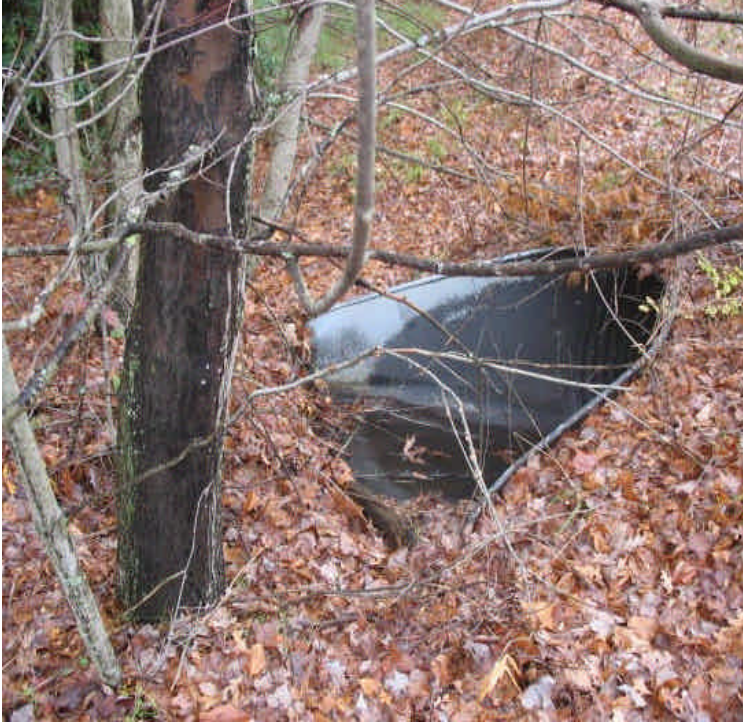
| Areas of Inspection | Observation | Recommended Action | Corrected Action |
|---|--|---|---|
| Erosion and sediment controls (continued) | An existing culvert located off site under the access driveway had some stormwater flow with no sedimentation issues. 11/14/06 | Closely monitor any work done on the access driveway above the culvert. 11/14/06 | NA |

Water flow was noted through the culvert under the access drive due to the recent rains. Sediment issues were not observed.

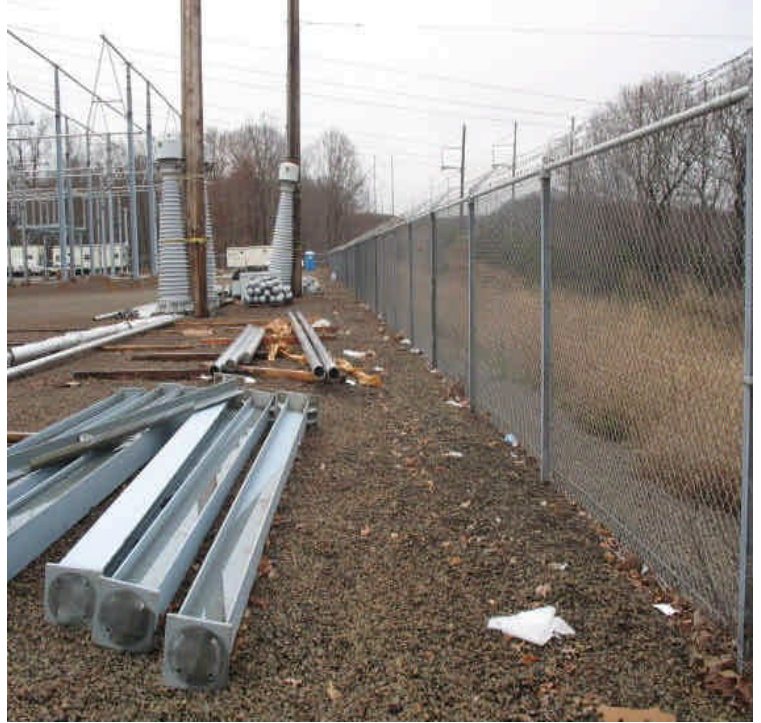
Silt fence was removed from the perimeter and site is stable. Most soil disturbing work on site is complete at this time.

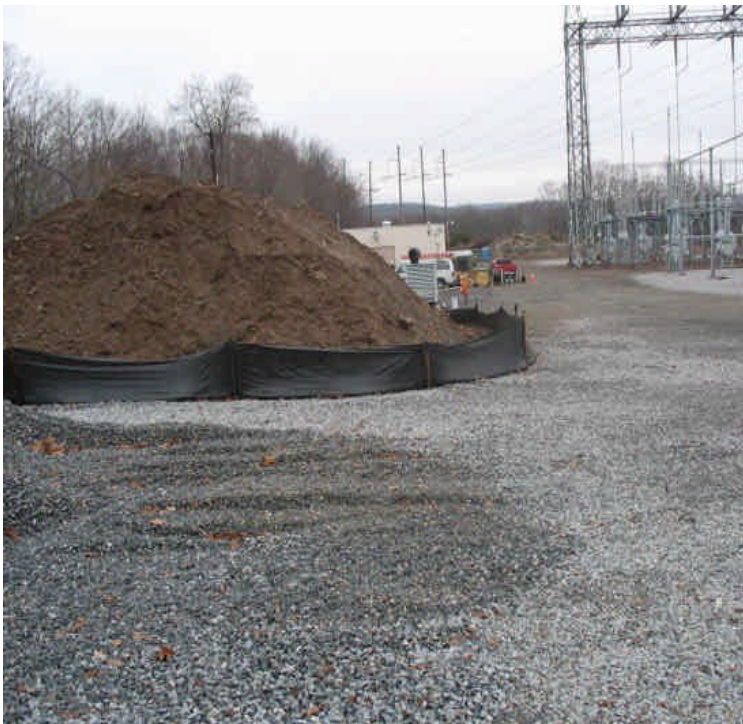
| Areas of Inspection | Observation | Recommended Action | Corrected Action |
|---|--|---|--|
| | Only one stockpile remains within the yard. The stockpile is surrounded by silt fence and a flat stone surface. It will be removed from the site as soon as possible. 11/7-11/14/06 | Once soil analysis is complete, remove soil and dispose of properly. Run-off remains contained to the yard. 11/14/06 | Silt fence remains around the remaining soil stockpile. |

The remaining soil stockpile is surrounded by silt fence. Run-off remains contained by the crushed stone on site.

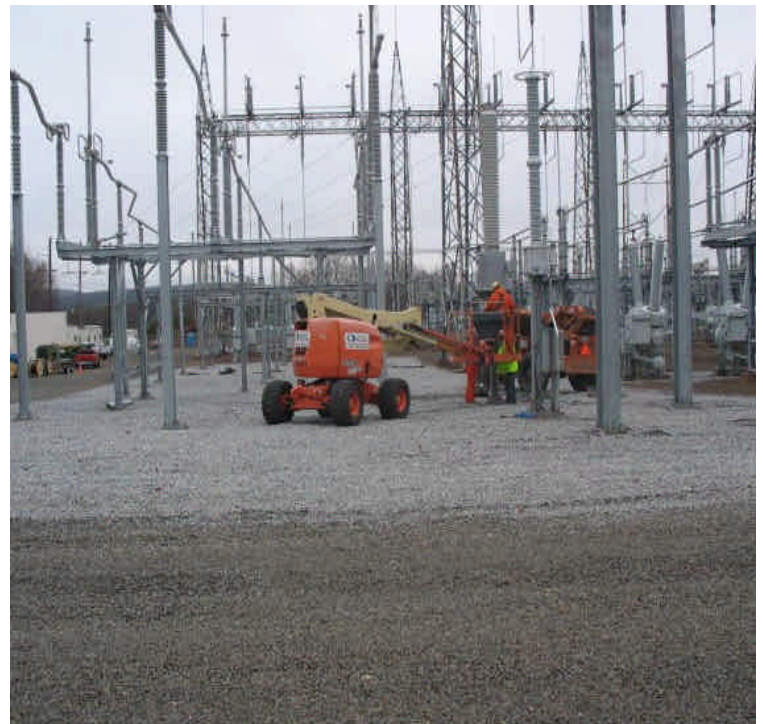
| Areas of Inspection | Observation | Recommended Action | Corrected Action |
|---|--|---|--|
| Foundation and site construction | Installation of concrete footings is complete. Work on structures continues. 11/14/06 | None 11/14/06 | NA |

Foundation installation is complete; the site has been graded and stabilized with stone. Work continues on structures.
