Docket No. 272 – Development and Management Plan Inspection

Scovill Rock Switching Station Inspection

Date: November 28, 2006

Location: Scovill Rock Switching Station

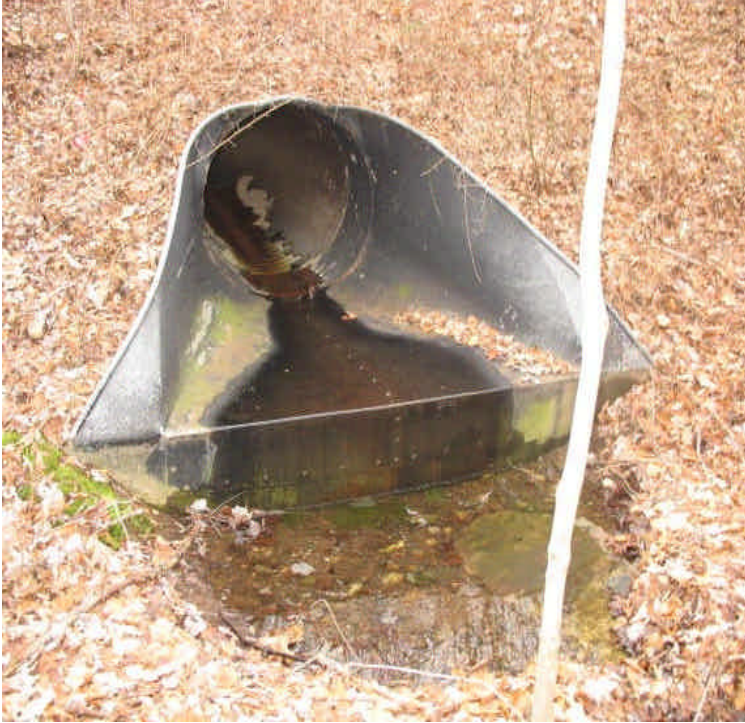
Areas of Inspection	Observation	Recommended Action	Corrected Action
Erosion and sediment controls (continued)	An existing culvert located off site under the access driveway had some stormwater flow with no sedimentation issues. 11/28/06	Closely monitor any work done on the access driveway above the culvert. 11/28/06	NA
Inland Wetland and Watercourse encroachment and mitigation	Wetlands south and northeast remain unaffected by site work. 11/28/06 The haybales at the storm drain outlet can be removed as all soil disturbance on site is complete. Flowing water has not been observed throughout the duration of work. 11/28/06	Continue to monitor the storm drain pipe outlet during rain events. 11/28/06 Remove haybales when feasible. 11/28/06	NA NA
State species of concern, threatened and endangered species.	According to the D&M plan, state-listed species are not located in this work area.	None	NA
Vegetative clearing or stabilization	No vegetative clearing is proposed at this time. 11/28/06	None	NA

Water was noted flowing through the culvert under the access drive due to the recent rains. Sediment issues were not observed.

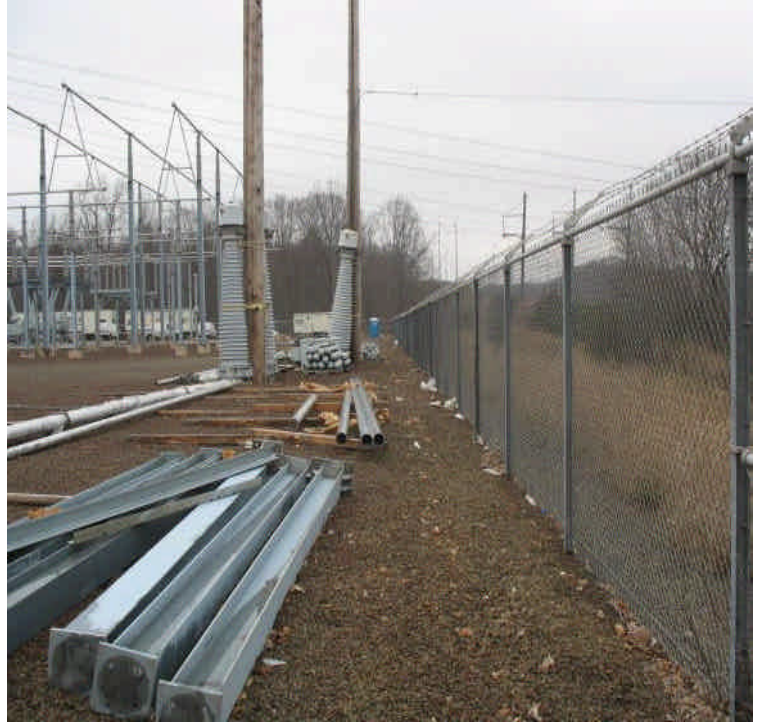
View of the perimeter of the yard. The site is stable and soil disturbing work is now complete.

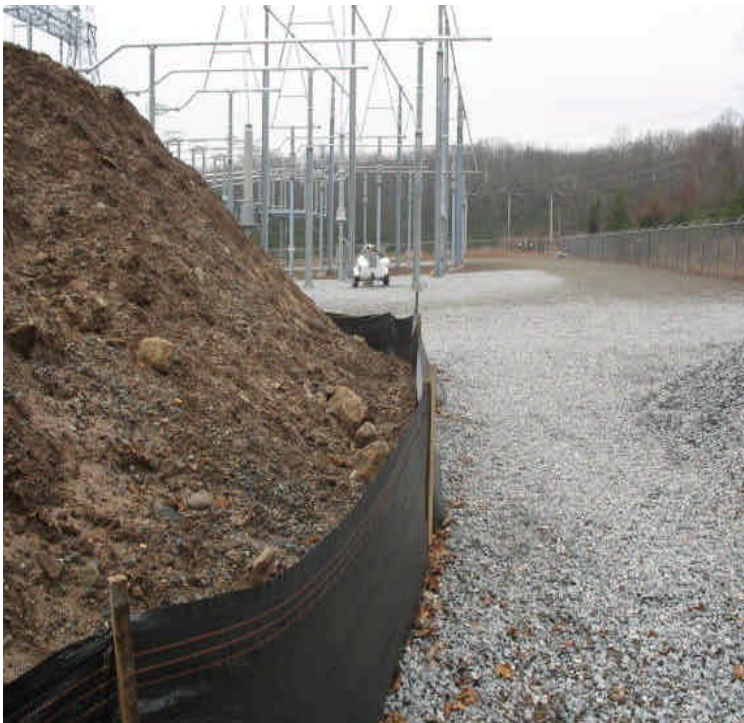
Only one stockpile remains within the yard. The stockpile is surrounded by silt fence and a flat stone surface. It will be removed from the site as soon as possible. 11/7-11/28/06	Once soil analysis is complete, remove soil and dispose of properly. Soils are contained within the yard. 11/21-11/28/06	NA

The remaining soil stockpile is surrounded by silt fence and stone.
