Docket No. 272 – Development and Management Plan Inspection

Segment 1a Inspection

Date: November 7, 2006

Location: Segment 1a – Scovill Rock Switching Station to Chestnut Junction, Oxbow Junction to Beseck Switching Station (excluding Royal Oak Bypass), Black Pond Junction to Beseck Switching Station

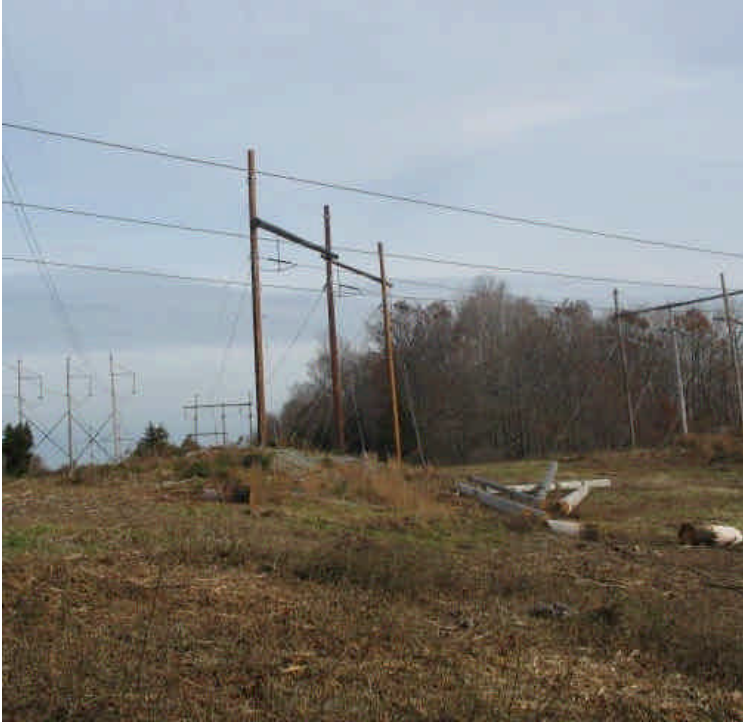
Pole installation complete at Oxbow Junction.

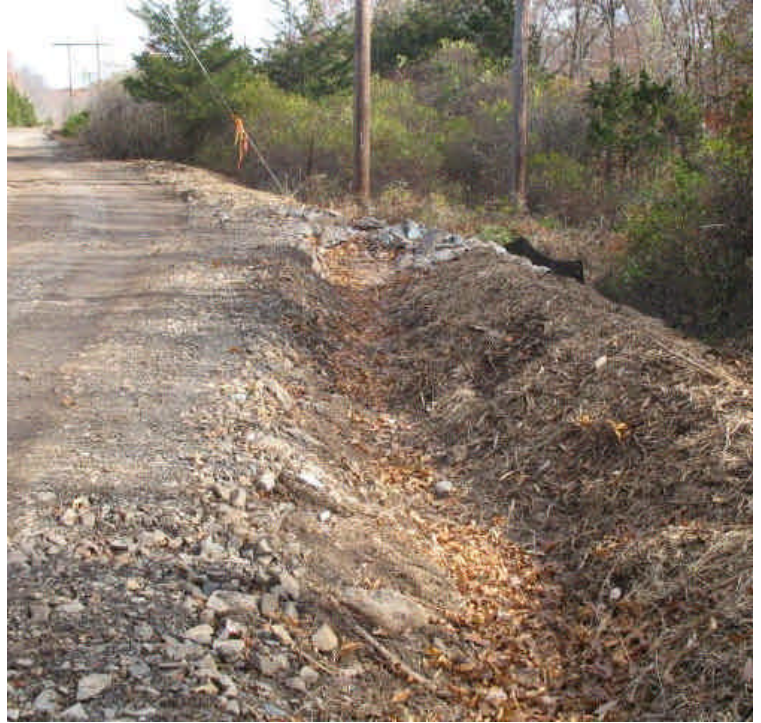
View of the recently installed swale and riprap sediment trap along the access road off Black Walnut Dr.

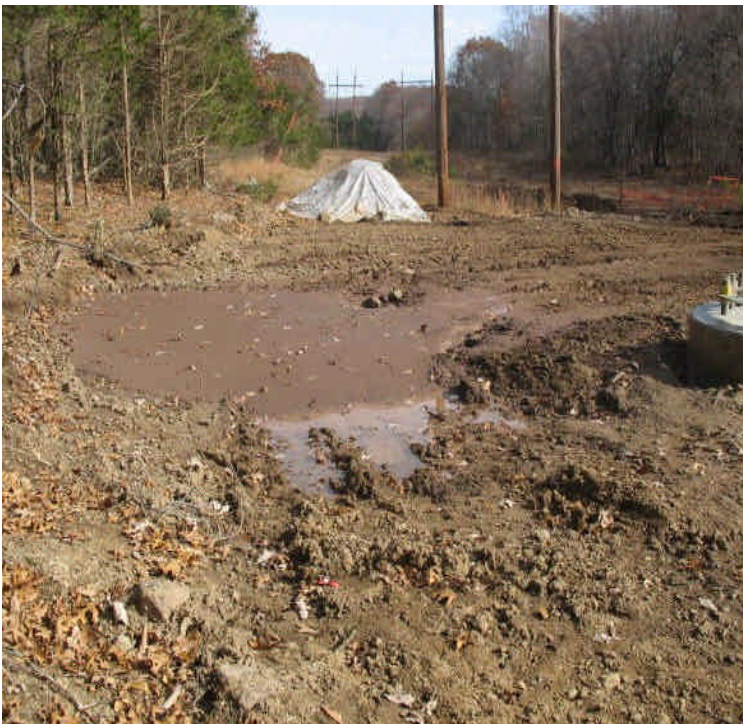
Slurry storage and drying area from foundation drilling/dewatering off Black Walnut Dr.

Dewatering	Dewatering off Black Walnut Dr. is complete. Excavation were dewatered into a slurry pit. The slurry pit was raked in order to dry out the mud quickly. 11/7/06	Additional controls (silt fence) could be used for further containment, as concrete will prevent water from filtering through the fabric. 11/7/06	Dewatering was contained.
Blasting	No blasting is proposed at this time. 11/7/06	None 11/7/06	NA
Spills, soils and material storage			
Black Walnut Dr.	Concrete washout area was installed; fencing is in place to protect the area. 11/7/06	Maintain washout area with safety precautions. 11/7/06	NA
	Spill controls move from site to site with the equipment. 11/7/06	Always use spill control materials when working on equipment and during refueling. Replace as needed. 11/7/06	NA
Contractor Receiving Yard and Staging Area	Materials are being stored and structures staged in this area. All stored materials are located approx. 100 ft away from	Continue to keep potential impact materials, such as soils & fuel, stored away from resource areas. 11/7/06	Sanitary facility was moved.

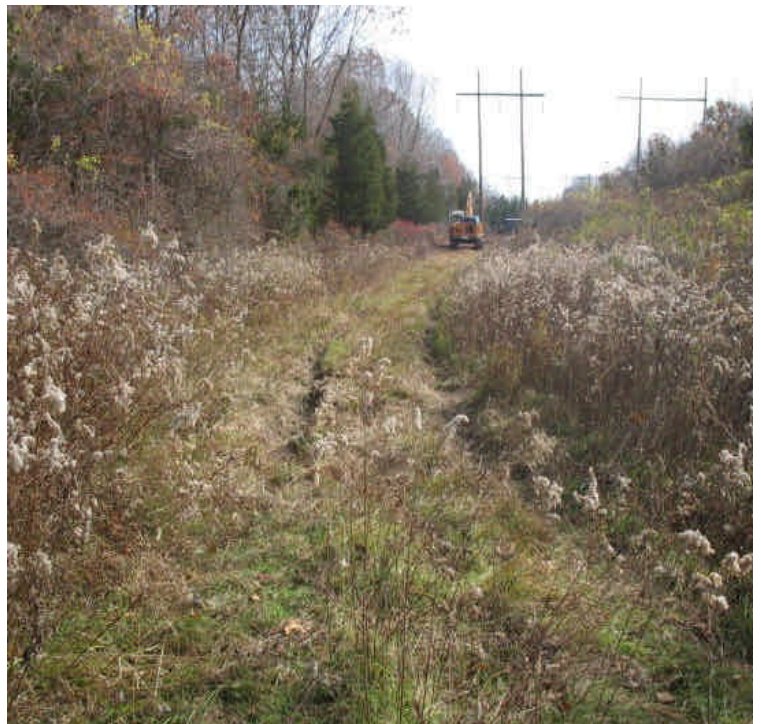
Non-jurisdictional wetland crossing area in the access road off Haddam Quarter Rd.

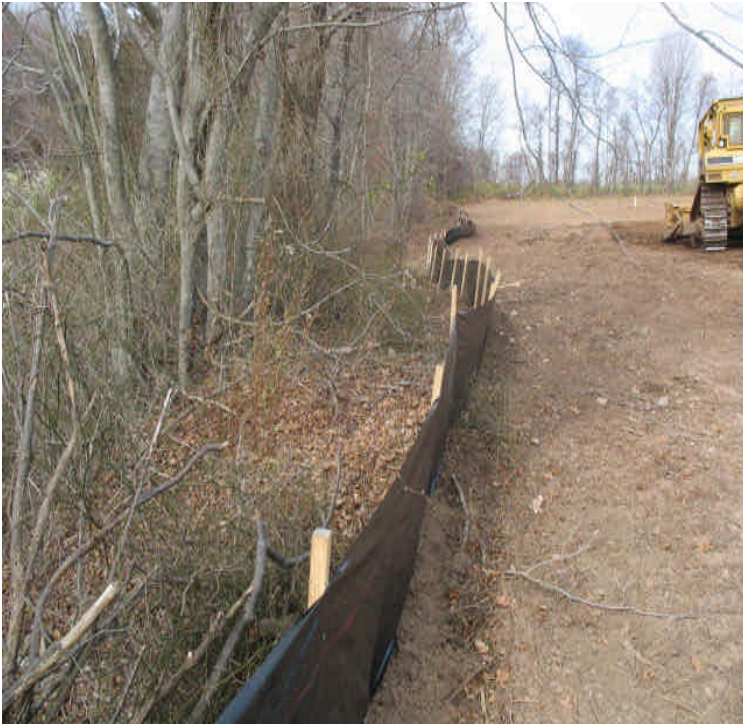
Silt fence was installed along the drainage ditch at the contractor receiving yard & staging area.

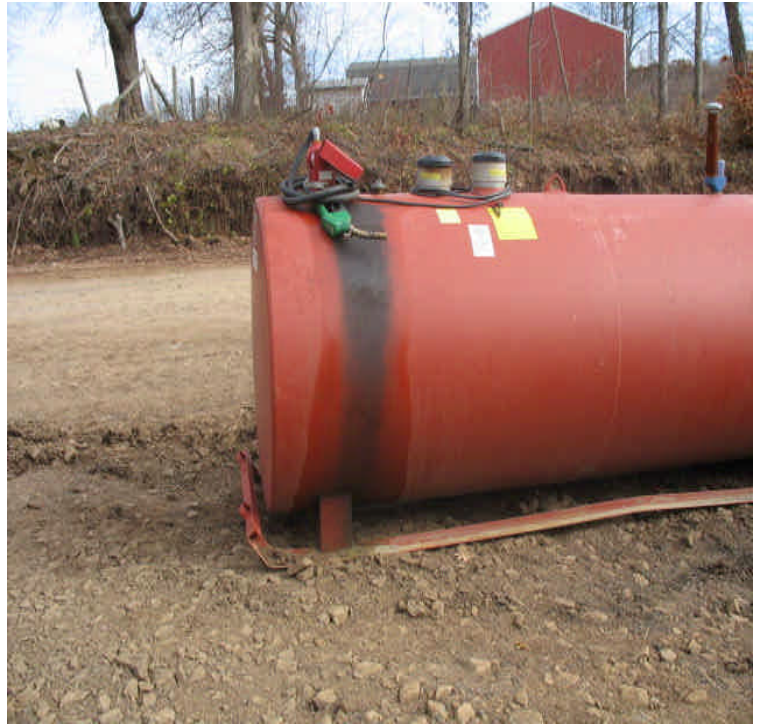
Another fuel tank was being stored at the contractor yard. It was dripping gas along the side with the nozzle facing downward. Consider placing tanks on a liner or similar containment.

Areas of Inspection	Observation	Recommended Action	Corrected Action
<p>Black Walnut Dr.</p>	<p>resource areas. Sanitary facility was moved. 11/7/06</p> <p>Workers are using a large magnet to pick up small pieces of metal at the end of each day. 11/7/06</p> <p>A third re-fueling tank was added to the existing two. While the first two remain empty, the larger tank's nozzle was dripping fuel down the side of the tank. 11/7/06</p> <p>Some materials (structure components, equipment, etc.) are being stored here. These materials are located well away from any resource areas. 11/7/06</p>	<p>Continue to remove debris (including trash) from the site regularly. 11/7/06</p> <p>Ensure spill controls are used during fueling. Consider installing additional spill containment near the tanks even though this is not in RWA boundaries. Install nozzle holsters. 11/7/06</p> <p>Continue to store materials away from resource areas.</p>	<p>Debris is being removed regularly.</p> <p>Continue to install proactive containment. Needs attention.</p> <p>NA</p>

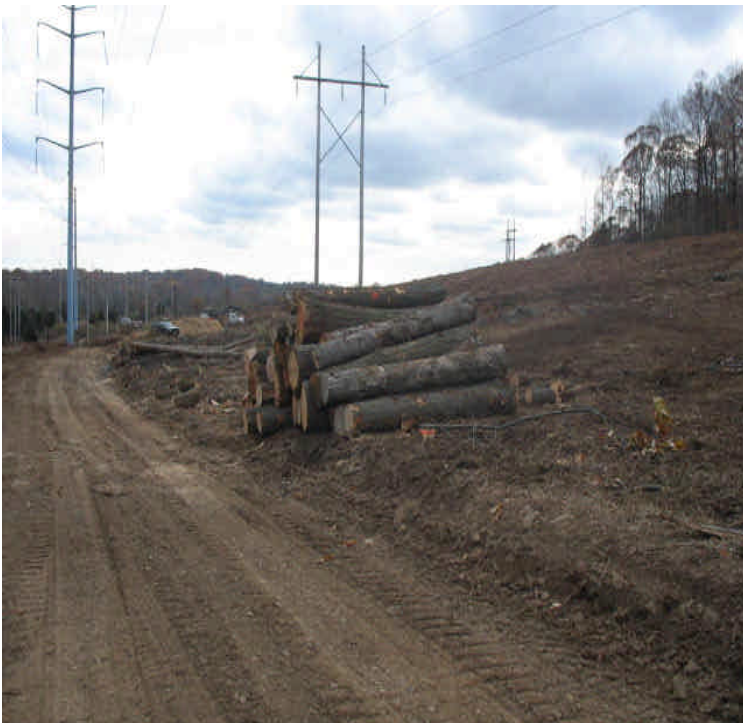
Cleared area north of Beseck SS.

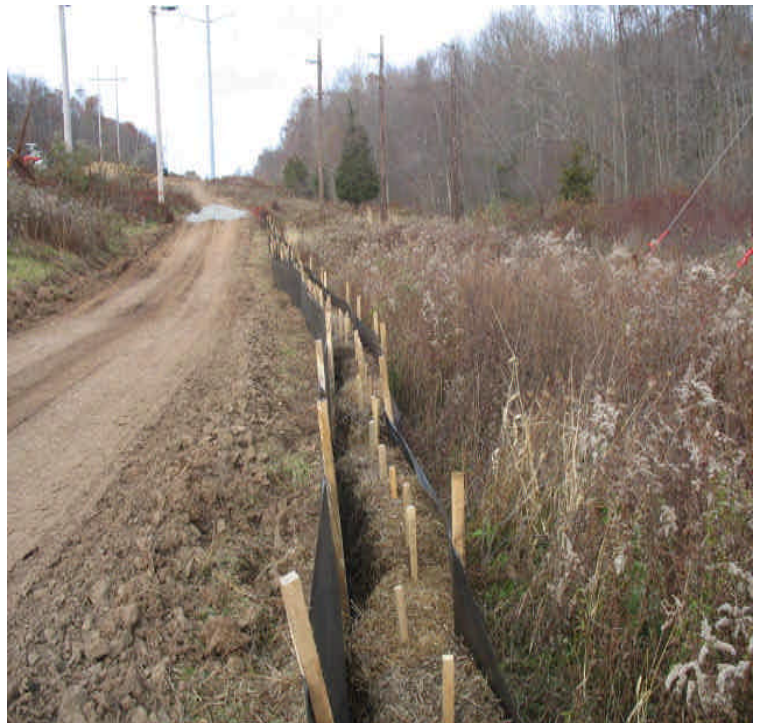
Silt fence/haybale barrier along the access road adjacent to the wetland near Beseck SS.
