**Docket No. 272 – Development and Management Plan Inspection**

**Segment 1a Inspection**

**Date:** November 14, 2006

**Location:** Segment 1a – Scovill Rock Switching Station to Chestnut Junction, Oxbow Junction to Beseck Switching Station (excluding Royal Oak Bypass), Black Pond Junction to Beseck Switching Station

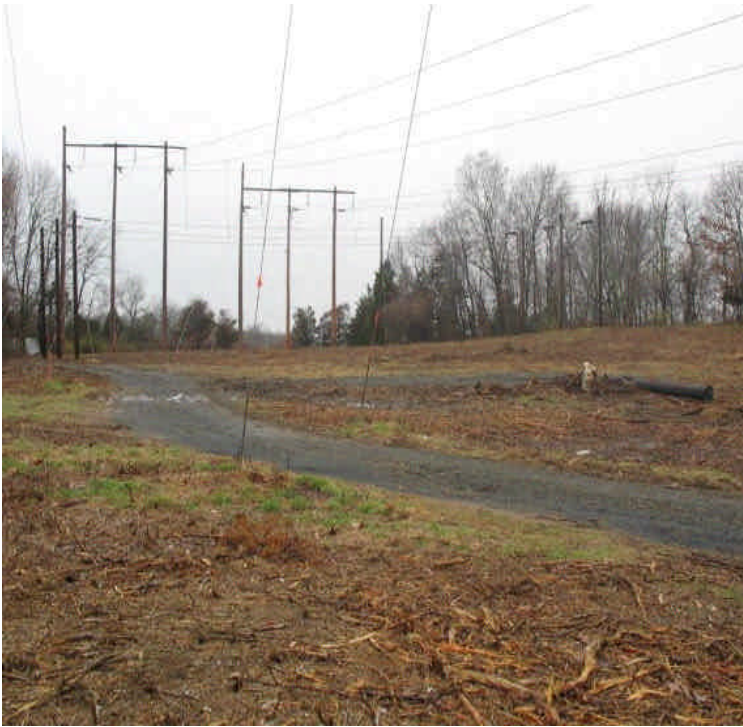
**Pole installation complete at Oxbow Junction.**

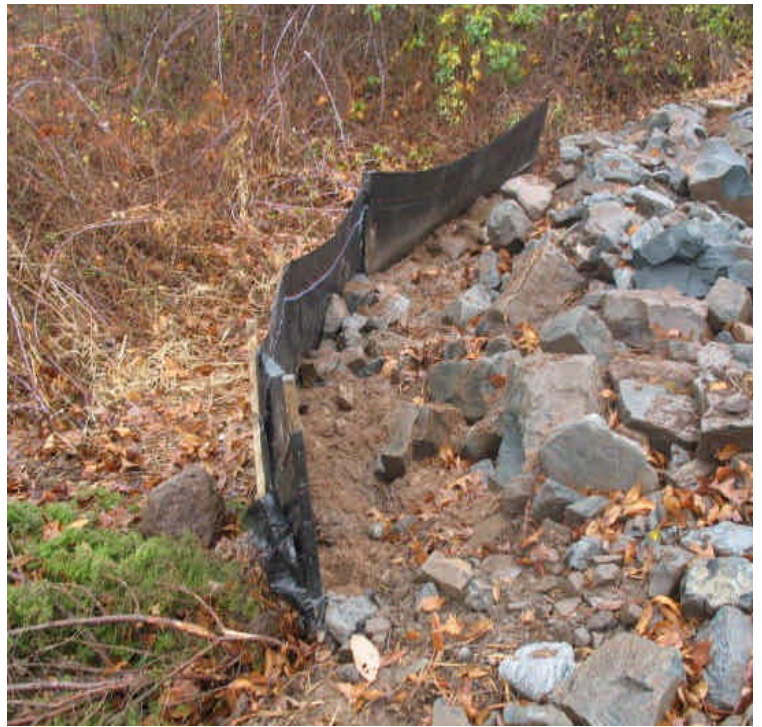
**Riprap sediment trap and silt fence along the access road off Black Walnut Dr. Sediment was cleaned out but should be placed upland, away from the silt fence.**

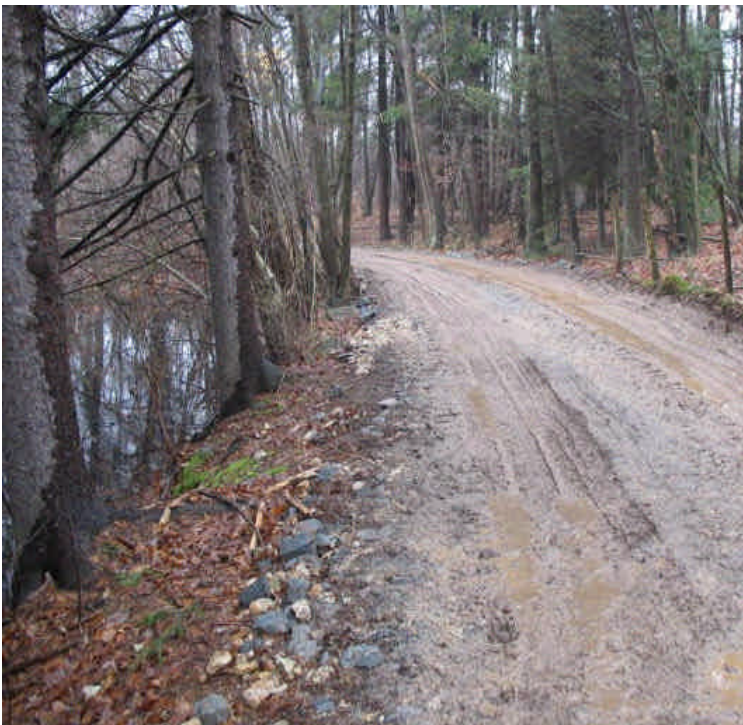
**Add erosion controls between the new access road and the pond off Haddam Quarter Rd. to prevent sedimentation.**

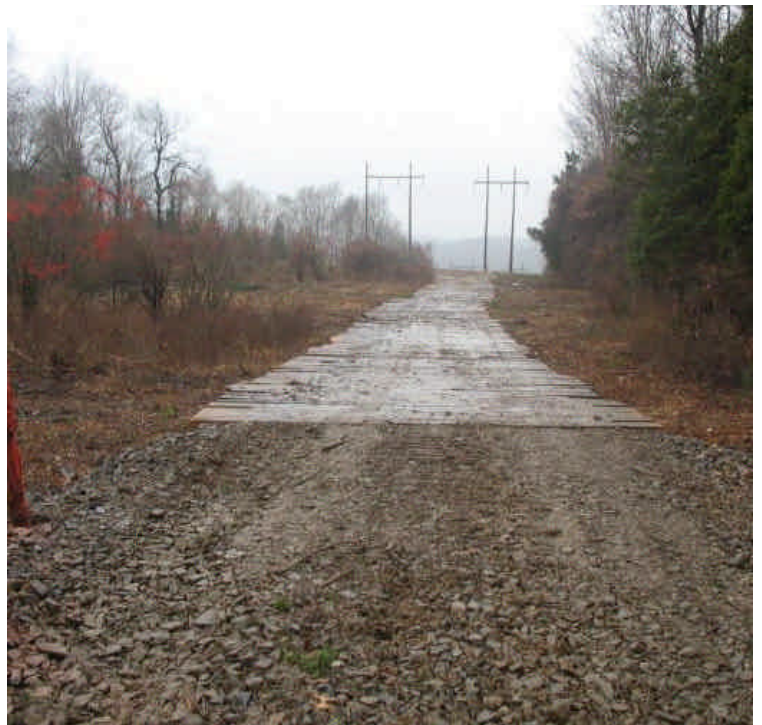
**Non-jurisdictional wetland crossing area in the access ROW off Haddam Quarter Rd.**

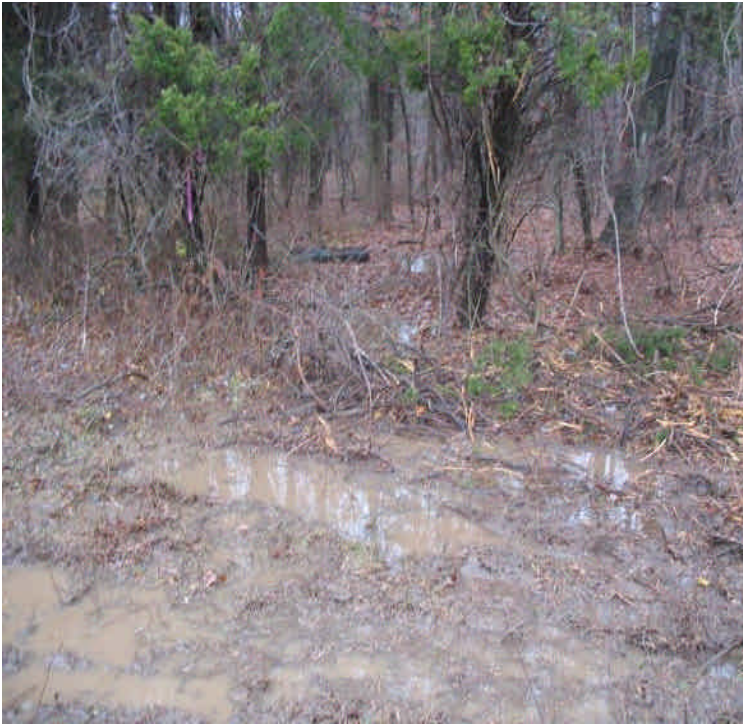
**Turbid run-off was noted flowing off site from the wetland crossing off Haddam Quarter Rd. It filters naturally through the vegetation but controls could be installed.**

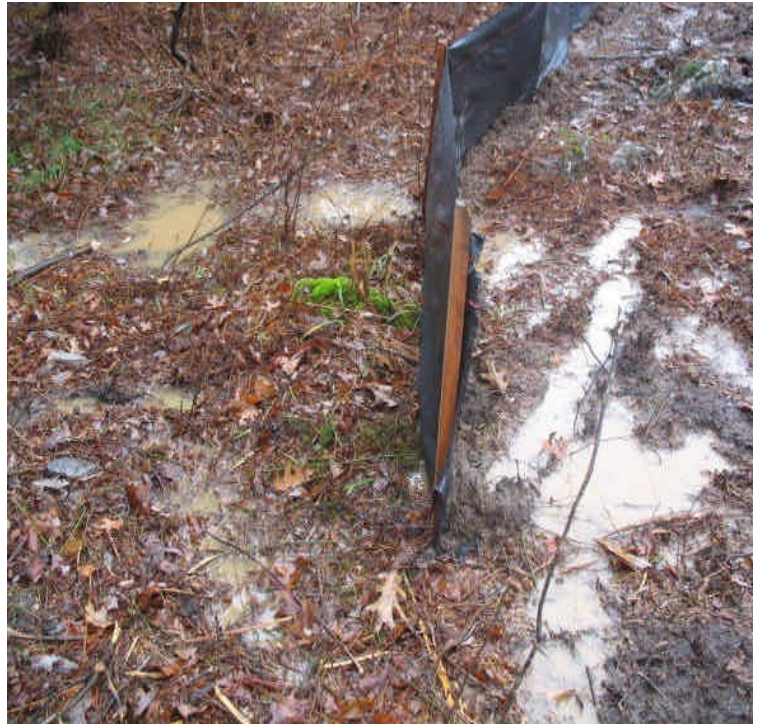
Areas of Inspection	Observation	Recommended Action	Corrected Action
	<p>Silt fence was added at the end of the access road. Turbid water is flowing around the fence and off site. Sediment has not made its way to off-site wetland areas. 11/14/06</p>	<p>Extend silt fence further up slope and provide additional filtration if necessary. Monitor the area and wetlands for sedimentation. 11/14/06</p>	<p>Needs attention.</p>
<p>Black Walnut Dr.</p>	<p>The small isolated wetland in the ROW has mats installed for the crossing but turbid water is flowing off-site. Sediment has not reached off-site wetlands and is mostly filtered by vegetation. 11/14/06</p>	<p>Add controls along the edge of the ROW access to prevent turbid stormwater from flowing towards off-site wetlands if necessary 11/14/06</p>	<p>Needs attention</p>
	<p>Accumulated sediment was removed from the riprap controls/trap but was placed against the toe of the silt fence. 11/14/06</p>	<p>When removing sediment from riprap controls, place in an upland area away from the silt fence to reduce stress on the silt fence. 11/14/06</p>	<p>Sediment buildup was removed but was placed against the silt fence.</p>

**Turbid run-off was noted flowing around the silt fence and off site at Haddam Quarter Rd, at the end of the access road and ROW. Extend silt fence and provide additional filtration.**

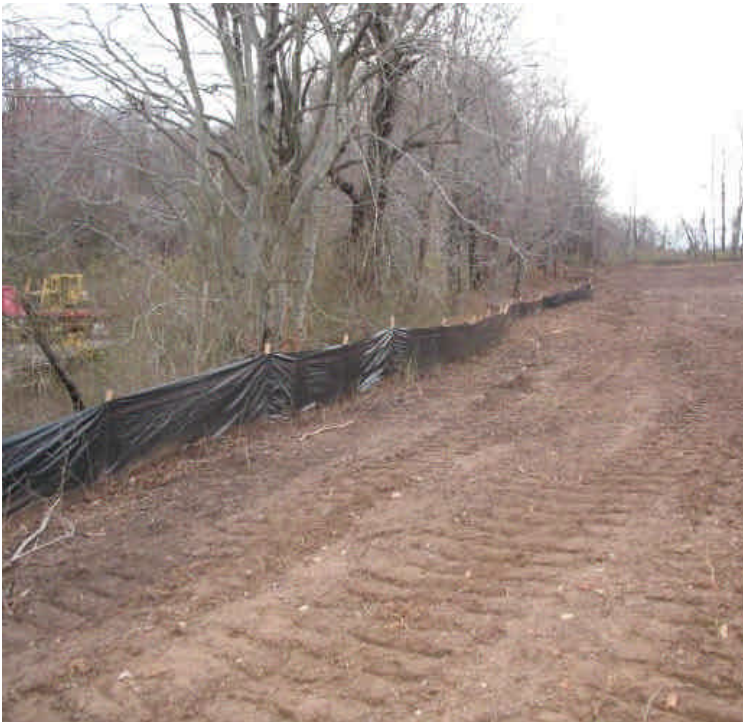
**Silt fence remains in place along the drainage ditch at the contractor receiving yard & staging area.**

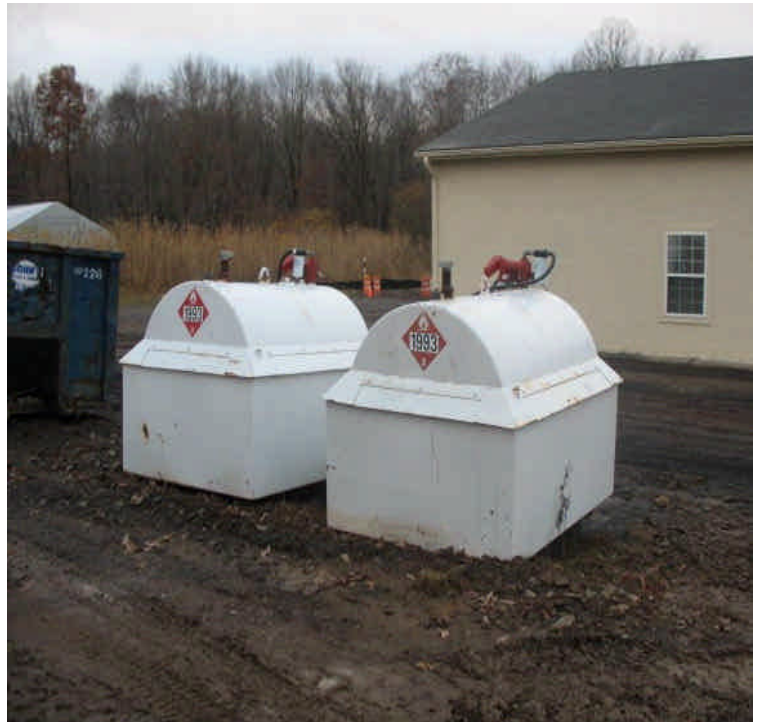
**Fuel tanks stored at the contractor yard. The third tank noted last week had been removed.**

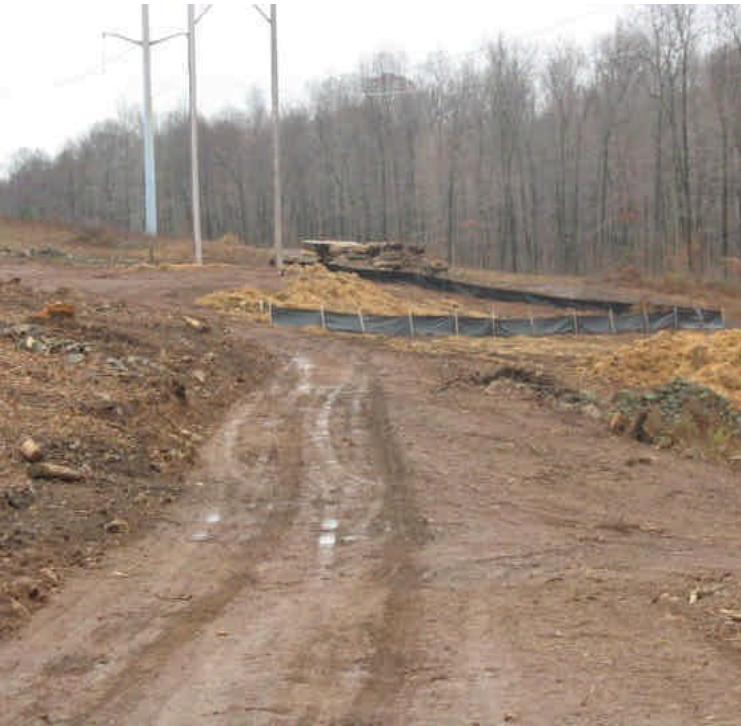
**Cleared area north of Beseck SS. New silt fence added at drill sites in preparation for the work.**

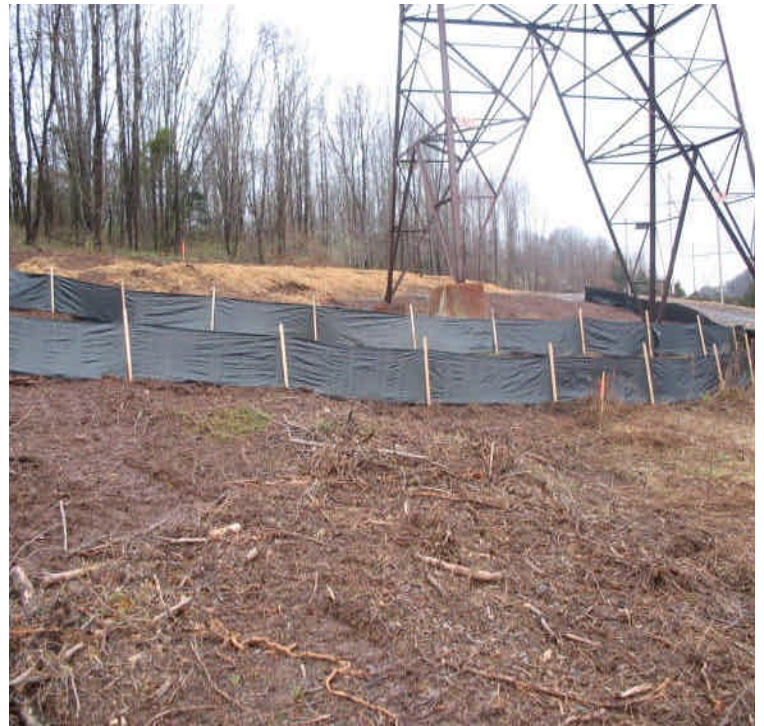
**Silt fence/haybale barrier along the access road adjacent to Black Pond in preparation for drilling in the area.**

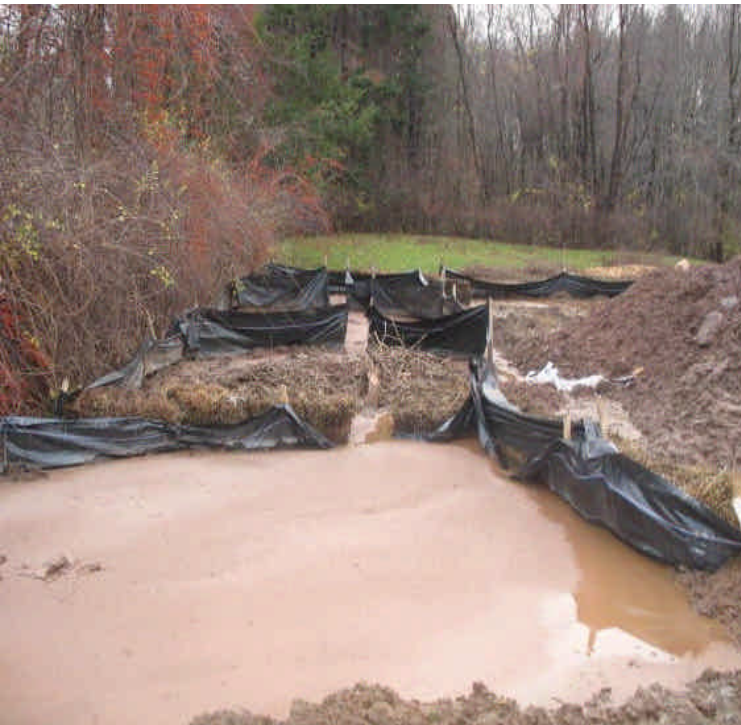
<p>Dewatering</p> <p>North of PAR Receiving Yard Along Rte. 17</p>	<p>Dewatering off Rte 17 is complete. Excavations were dewatered into a series of slurry pits. The silt fence was overwhelmed but additional barriers installed to prevent muds from reaching off-site wetlands. 11/14/06</p>	<p>Monitor silt fences and slurry area for stabilization. Mud should be dried and removed or used onsite and stabilized as soon as possible. 11/14/06</p>	<p>Dewatering was contained.</p>
<p>Blasting</p>	<p>No blasting is proposed at this time. 11/14/06</p>	<p>None 11/14/06</p>	<p>NA</p>
<p>Spills, soils and material storage</p> <p>Black Walnut Dr.</p> <p>Contractor Receiving Yard and Staging Area</p>	<p>Spill controls move from site to site with the equipment. 11/14/06</p> <p>Concrete washout area was installed; fencing is in place to protect the area. 11/14/06</p> <p>Materials are being stored and structures staged in this area. All stored materials are located approx. 100 ft away from resource areas. 11/14/06</p>	<p>Always use spill control materials when working on equipment and during refueling. Replace as needed. 11/14/06</p> <p>Maintain washout area with safety precautions. 11/14/06</p> <p>Always use spill control materials when working on equipment and during refueling. Replace as needed. 11/14/06</p>	<p>NA</p> <p>NA</p> <p>NA</p>

**Slurry containment areas located in the ROW north of the contractor yard along Rte 17. Additional silt fence barriers were added to contain escaping sediment.**

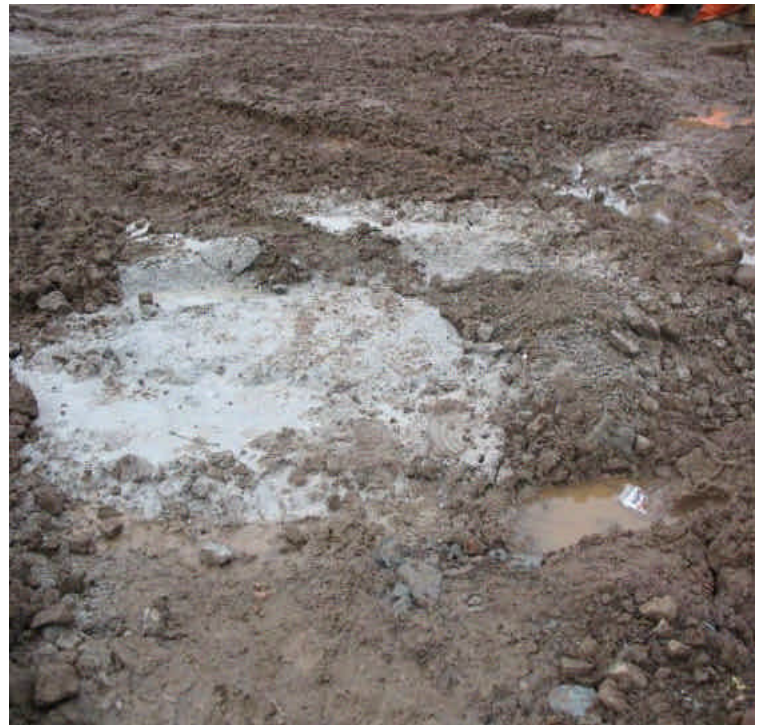
**A small concrete washout was noted outside the designated washout area along Rte. 17. The concrete should be removed and disposed of**
