**Docket No. 272 – Development and Management Plan Inspection**

**Segment 1a Inspection**

**Date:** November 21, 2006

**Location:** Segment 1a – Scovill Rock Switching Station to Chestnut Junction, Oxbow Junction to Beseck Switching Station (excluding Royal Oak Bypass), Black Pond Junction to Beseck Switching Station

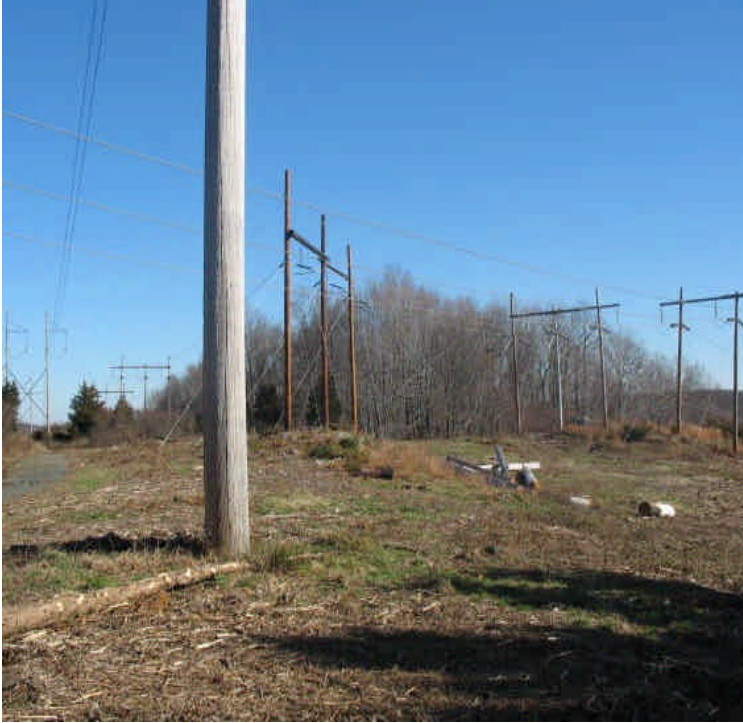
**Pole installation complete at Oxbow Junction.**

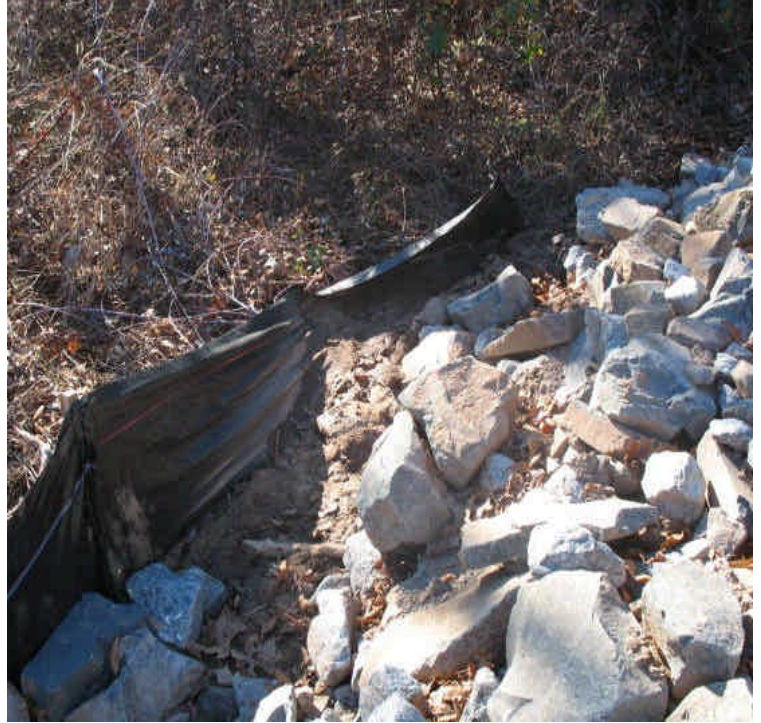
**Riprap sediment trap and silt fence along the access road off Black Walnut Dr. Accumulated sediment should be removed and the silt fence maintained.**

<p><b>Dewatering</b></p> <p><b>Black Walnut Dr</b></p>	<p>A slurry area remains here to dry out mud from dewatering the foundation excavations. 11/7-11/21/06</p>	<p>Slurry mud was raked and thinned so it dries. Monitor area for run-off and consider using silt fence to contain the area, if needed. 11/7-11/21/06</p>	<p>NA</p>

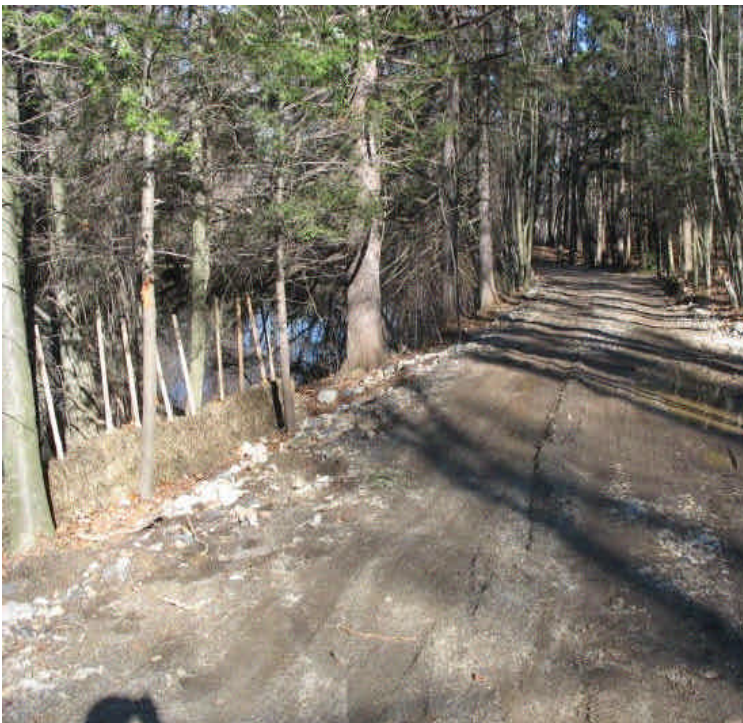
**Erosion controls may need to be extended between the new access road and the pond off Haddam Quarter Rd. to prevent sedimentation.**

<b>Erosion and sediment controls</b>  <b>Oxbow Junction</b>  <b>Haddam Quarter Rd. To Foot Hills Rd.</b>	<b>Very little potential for soil erosion exists in this area. 11/21/06</b>  <b>New haybales were installed along the access road entrance near the pond. Controls may still need to be extended to encompass more areas. 11/21/06</b>	<b>Continue to selectively cut vegetation in accordance with the D&amp;M plan. 11/21/06</b>  <b>More controls, i.e. mulch, check dams, silt fence, haybales, etc., are needed to prevent erosion along the access road slopes and prevent sediment tracking onto Haddam Quarter Rd. 11/14-11/21/06</b>	<b>NA</b>  <b>Haybales were added, more controls are needed.</b>

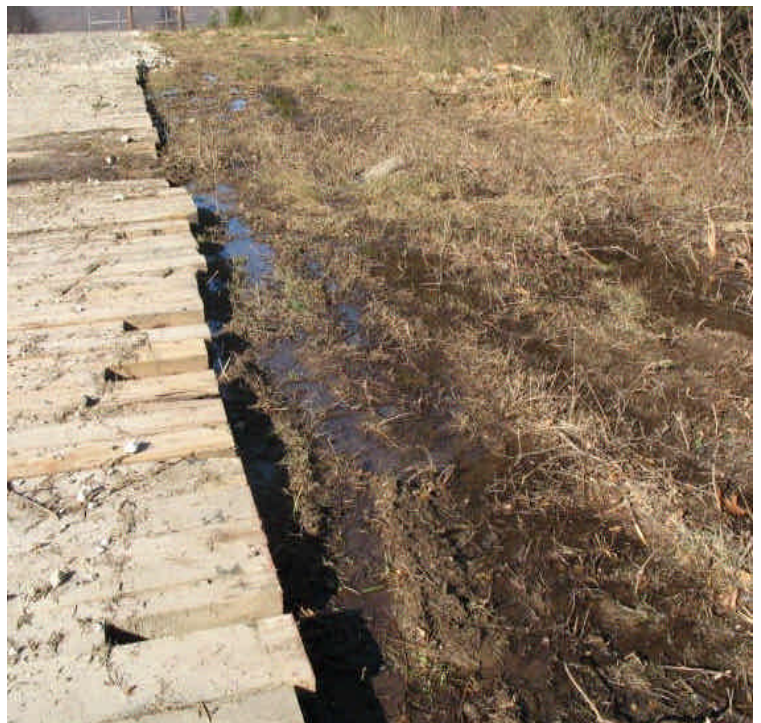
**Non-jurisdictional wetland crossing area in the access ROW off Haddam Quarter Rd. Mats are in place and clean water was leaving the site.**

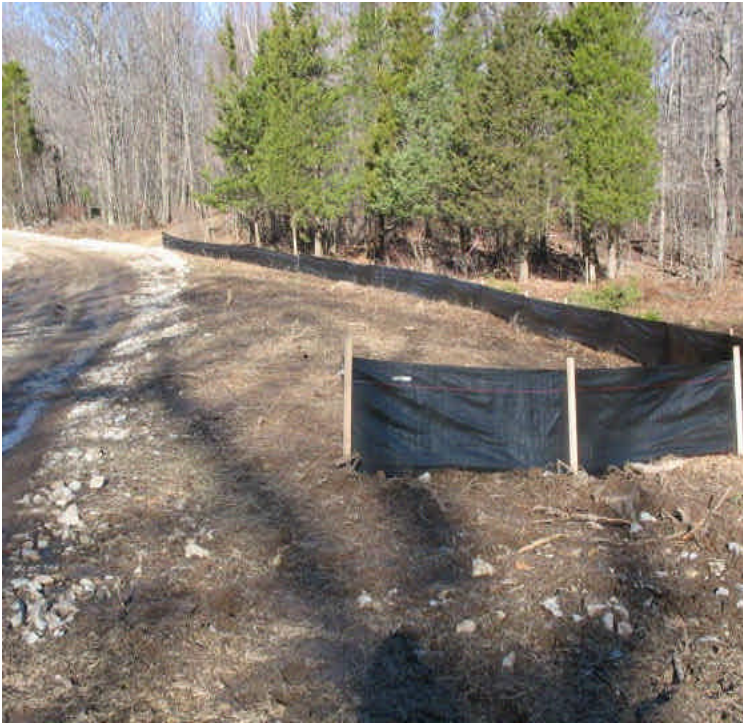
**Silt fence was extended off Haddam Quarter Rd, at the end of the access road and ROW. Extended silt fence will provide additional stormwater filtration.**

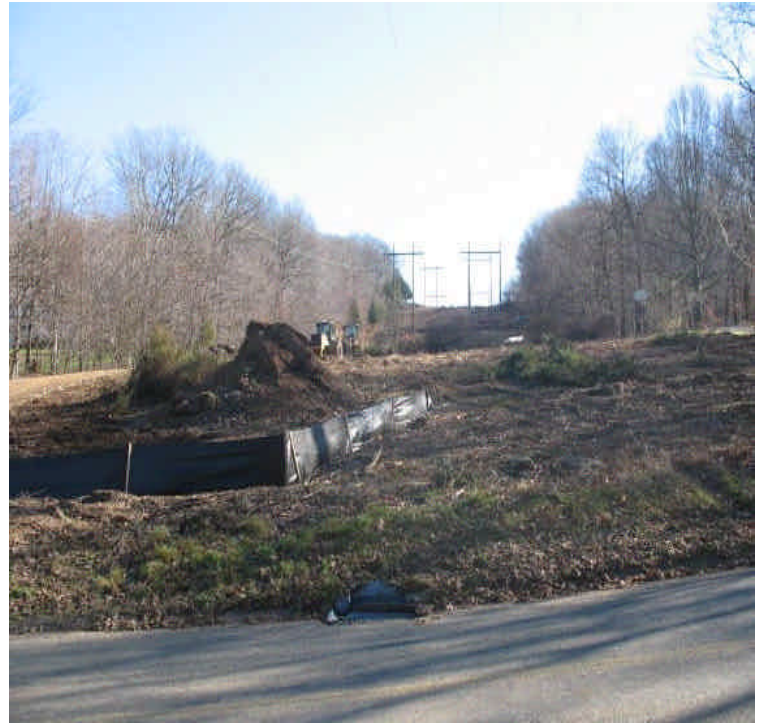
**Silt fence installation, clearing and grading off Arbutus Street.**

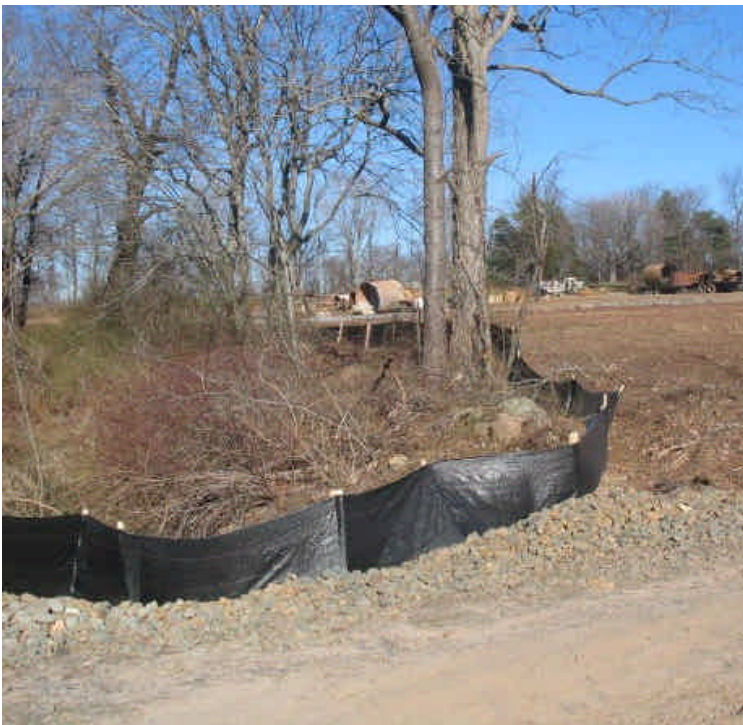
**Silt fence remains in place along the drainage ditch at the contractor receiving yard & staging area.**

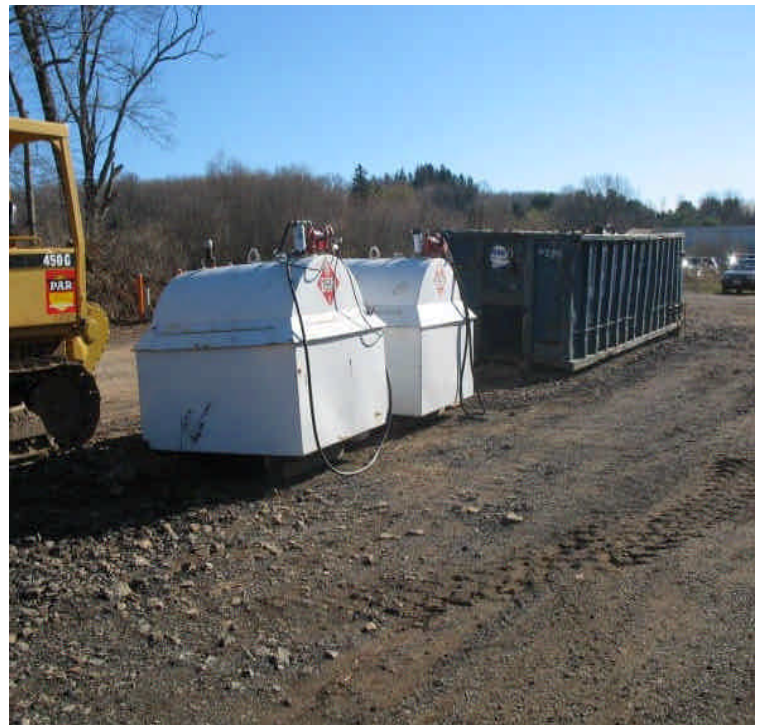
**Fuel tanks stored at the contractor yard. Relocate dumpster within the yard to an area greater than 100-feet from the wetland if feasible.**

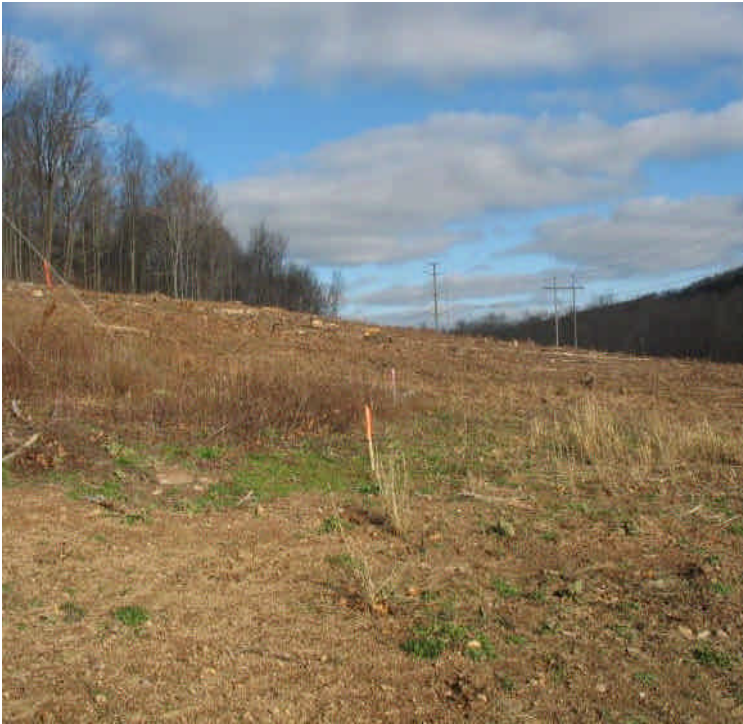
**Cleared area north of Beseck SS, prepared for foundation installation.**

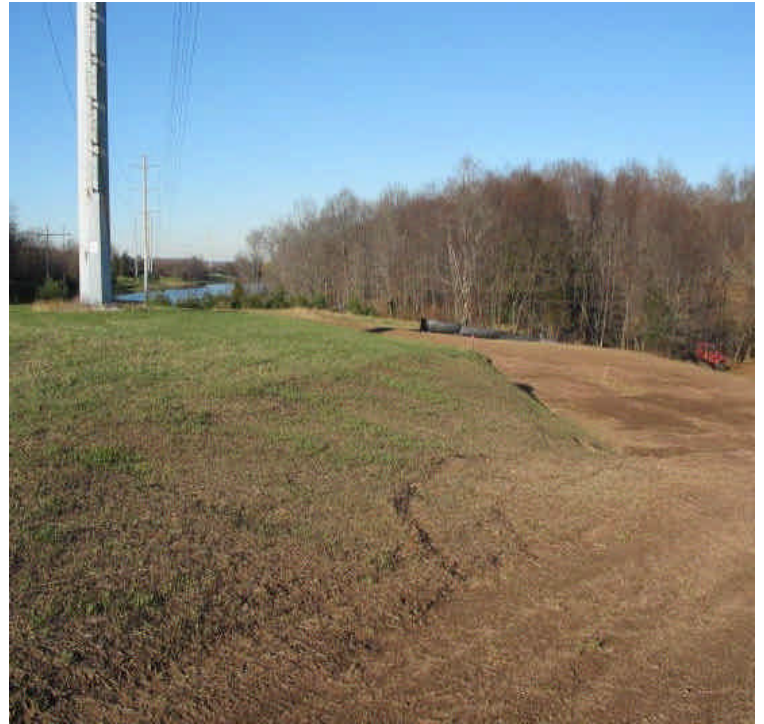
**Grass growth noted along cleared slopes north of Beseck SS.**

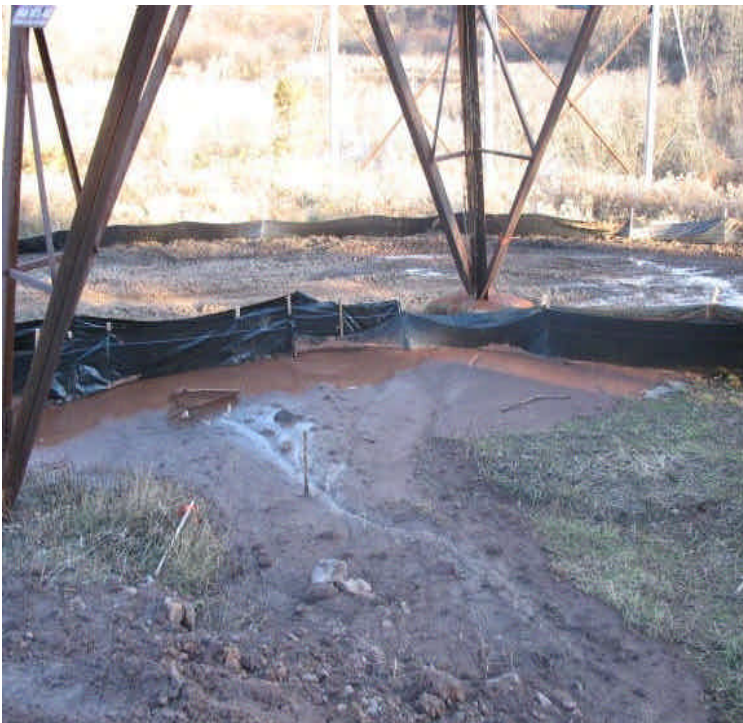
**Silt fence/haybale barrier along the access road adjacent to Black Pond, used for dewatering slurry.**

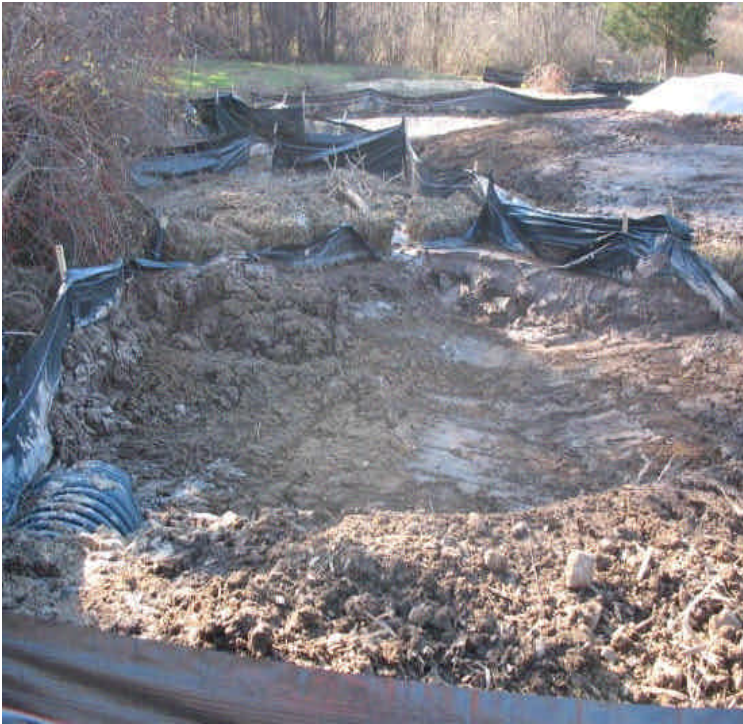
Areas of Inspection	Observation	Recommended Action	Corrected Action
<p>North of PAR Receiving Yard Along Rte. 17</p> <p>Black Pond</p>	<p>Dewatering off Rte 17 is complete. Excavations were dewatered into a series of slurry pits with additional silt fence barriers. Slurry has been spread in some areas to dry it out. 11/21/06</p> <p>Dewatering controls at Black Pond includes using bio-socks as terraces to slow and filter sediment. Several layers of silt fence, haybales, and mulch were also used to contain the slurry. Some of the controls are stressed by heavy accumulation of slurry and are at maximum capacity. 11/21/06</p>	<p>Monitor silt fence and slurry areas for stabilization. Mud should be dried and removed or used onsite and stabilized as soon as possible. 11/21/06</p> <p>Monitor controls; remove or spread slurry to reduce the stress on existing controls. Stabilize exposed surfaces as soon as possible. 11/21/06</p>	<p>Dewatering was contained.</p> <p>Dewatering was contained. Needs evaluation.</p>

**Slurry containment areas located in the ROW north of the contractor yard along Rt 17. Additional silt fence barriers were installed to contain sediment. Sediment is being removed and spread to dry. Ensure that future run-off over the dried, exposed soil is controlled.**

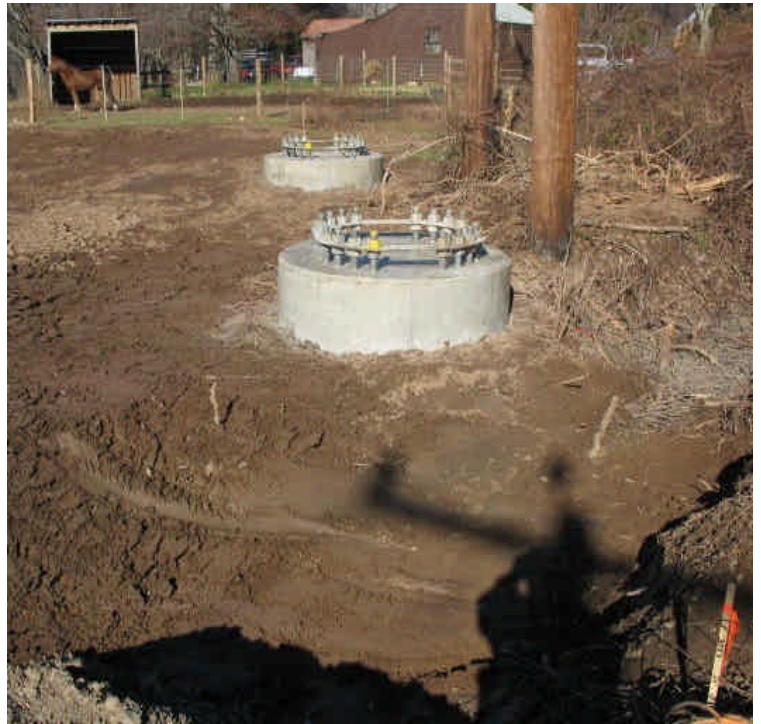
**Newly installed foundations off Rt 17 with slurry removal area.**

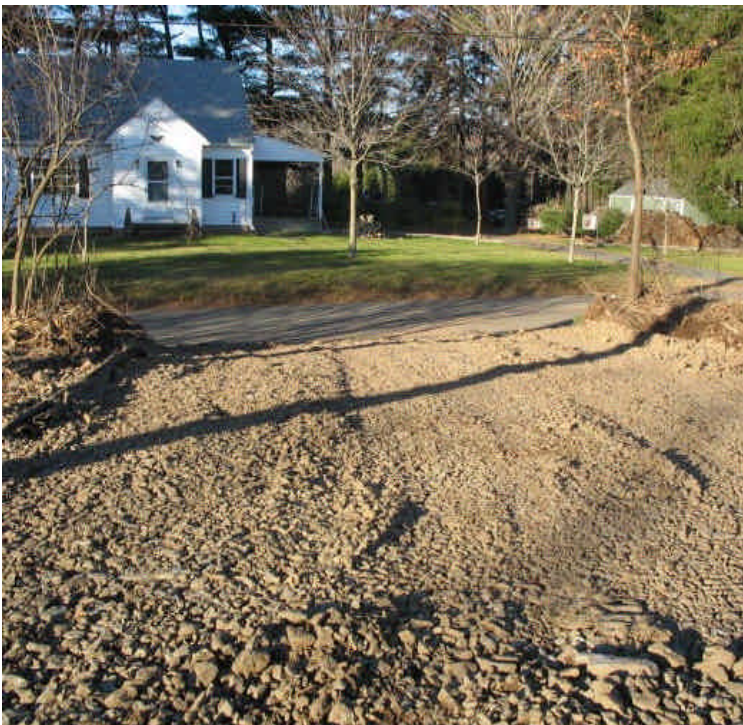
**Entrance off Little Lane. No sediment tracking was noted. Continue to monitor stone pad and roadway.**

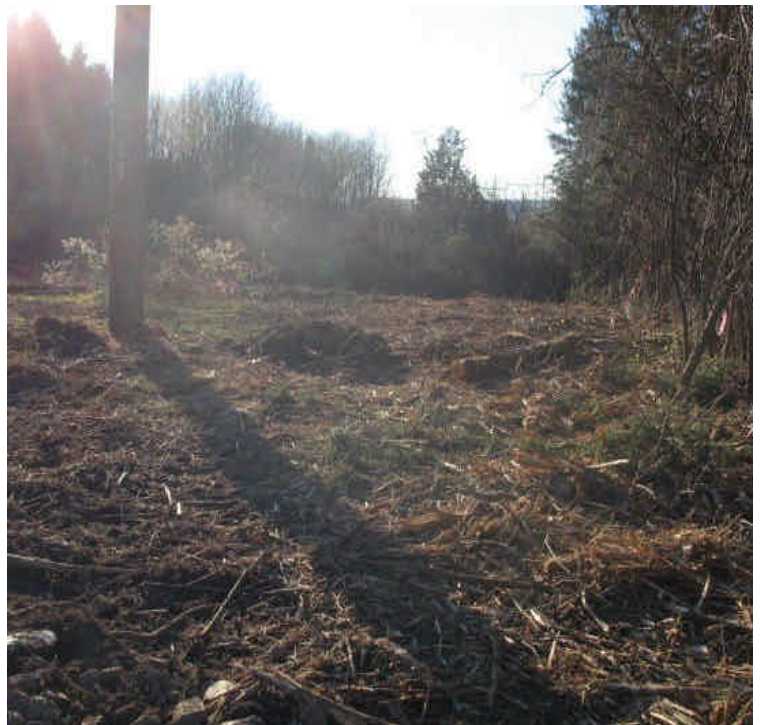
**View of clearing activities off Little Lane. Continue to retain vegetation whenever feasible based on the D&M plan.**
