Docket No. 272 – Development and Management Plan Inspection

The Connecticut Light and Power Company Certificate of Environmental Compatibility and Public Need for the construction of a new 345-kV electric transmission line and associated facilities between Scovill Rock Switching Station in Middletown and Norwalk Substation in Norwalk, Connecticut, including reconstruction of portions of existing 115-kV and 345-kV electric transmission line, the construction of Beseck Switching Station in Wallingford, East Devon Substation in Milford, (and Singer Substation in Bridgeport), modifications at Scovill Rock Switching Station and Norwalk Substation, and the reconfiguration of certain interconnections.

Segment 1a Inspection

Date: November 28, 2006

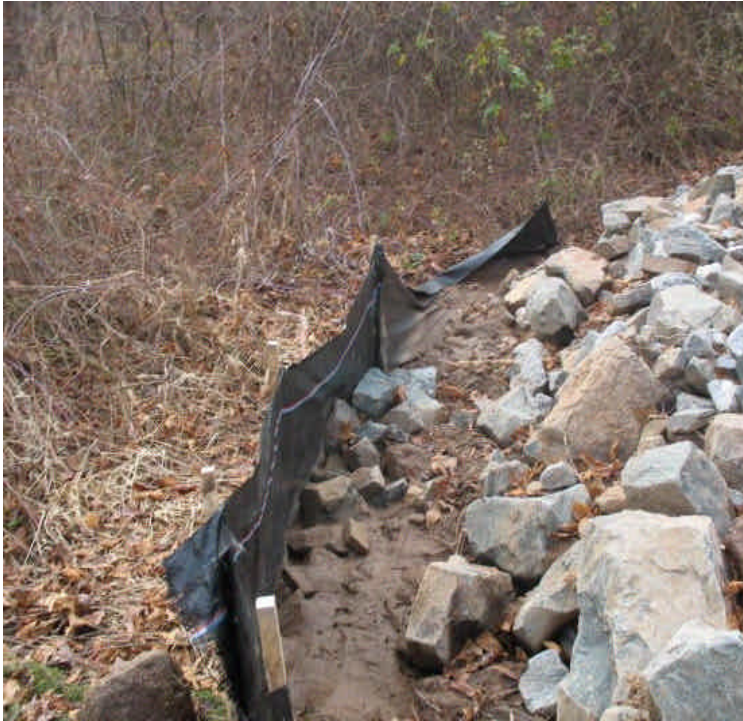
Riprap sediment trap and silt fence along the access road off Black Walnut Dr. Accumulated sediment should be removed and the silt fence maintained.

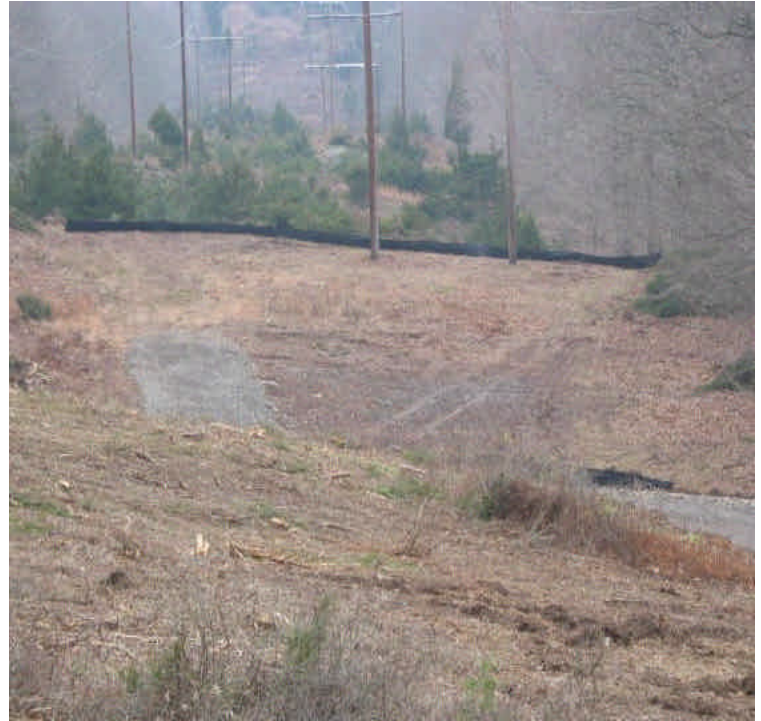
Silt fence, clearing and grading off Arbutus Street.

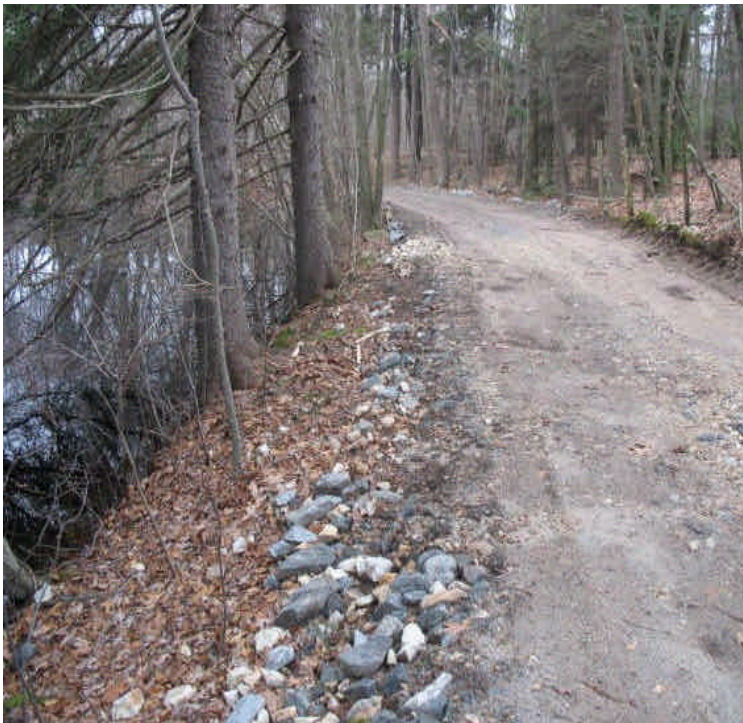
Erosion controls may need to be extended between the new access road and the pond off Haddam Quarter Rd. to prevent potential sedimentation.

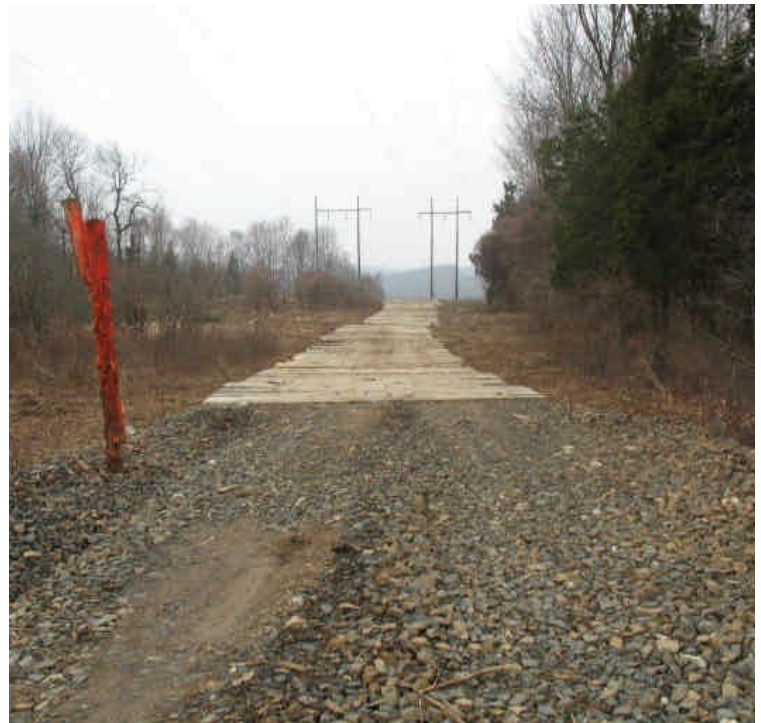
Non-jurisdictional wetland crossing area in the access ROW off Haddam Quarter Rd. Mats are in place and clean water was leaving the site.

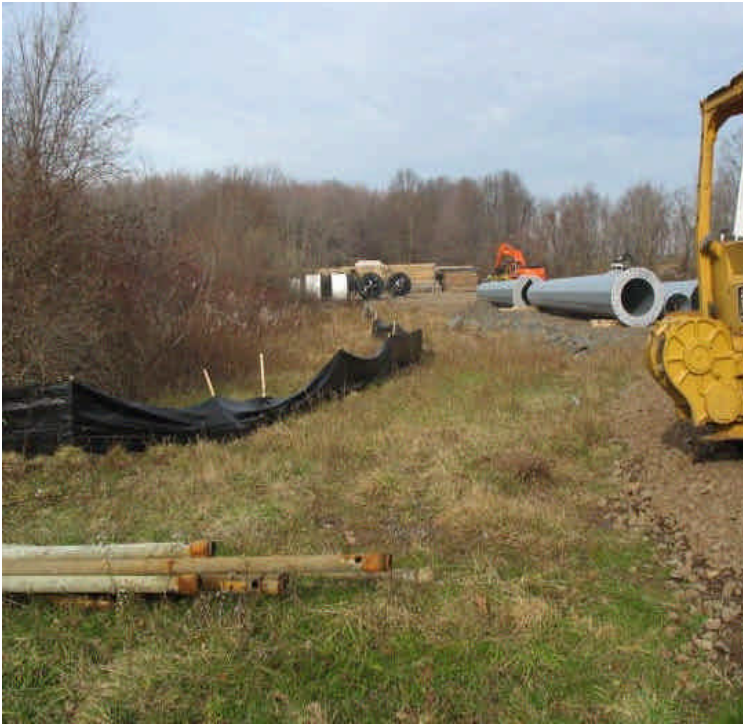
Silt fence should be re-stapled along the pond in the contractors receiving yard. Equipment should be parked/stored as far from wetlands as feasible (100ft if possible).

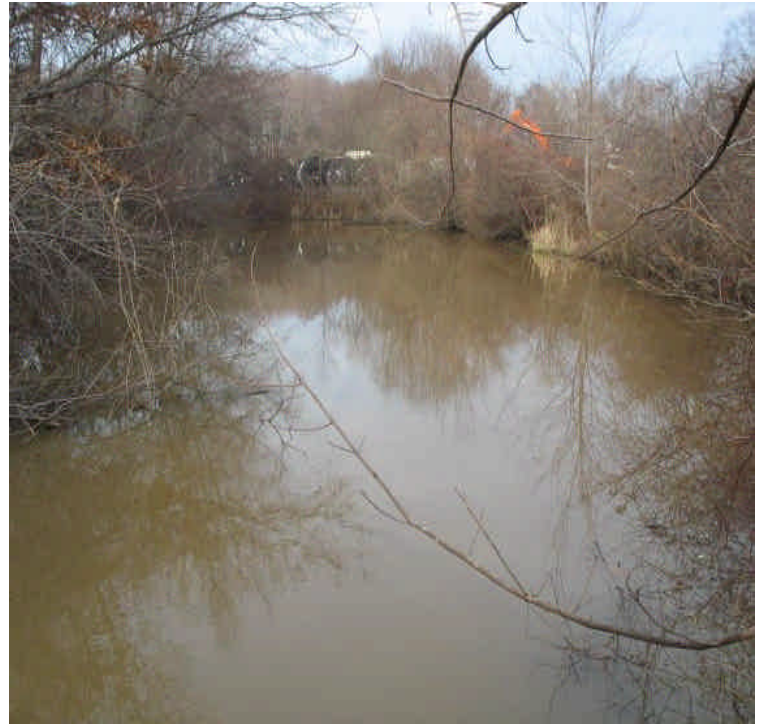
Pond west of the contractors receiving yard was noticeably turbid. This will be evaluated to determine whether this is an existing/natural condition or if sediment is entering from the yard. A source was not obvious.

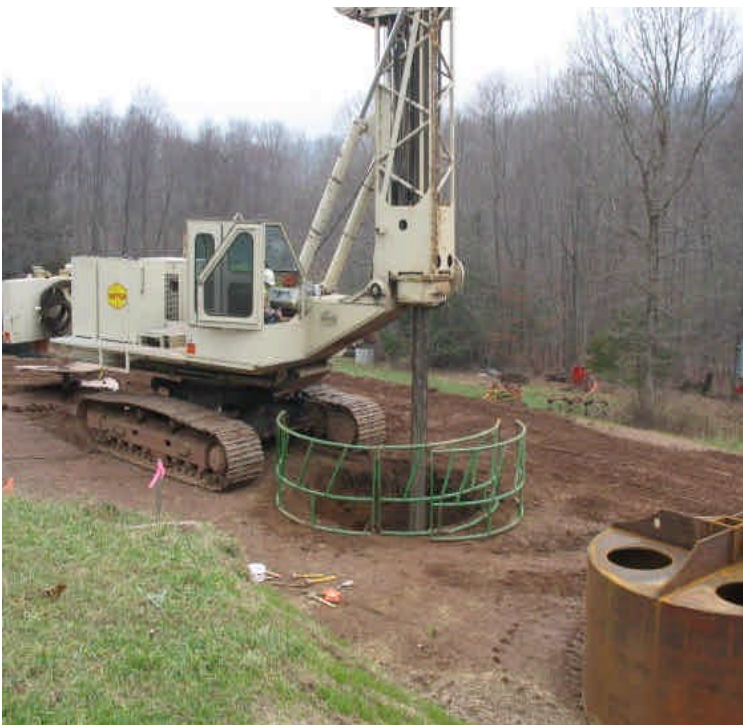
Foundation drilling north of Beseck SS.

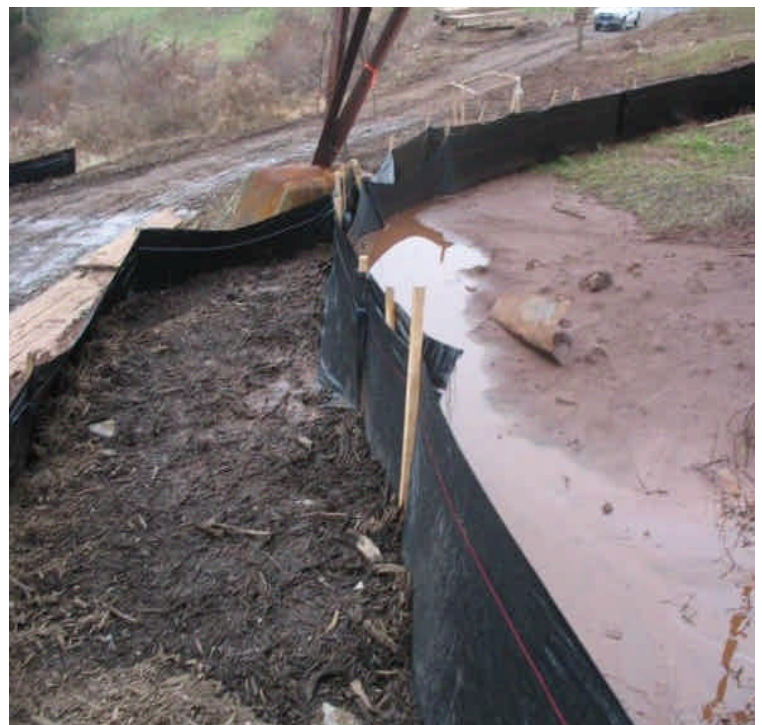
Silt fence/haybale barrier along the access road adjacent to Black Pond used for dewatering slurry.

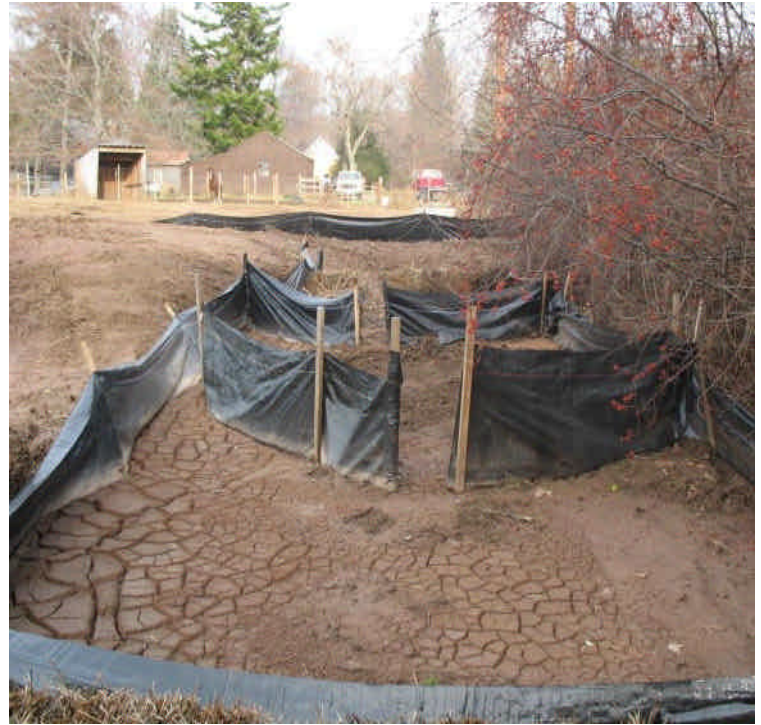
Slurry containment areas located in the ROW north of the contractor yard along Rte 17. Additional silt fence barriers were added to contain escaping sediment. Sediment is being removed and spread to dry.

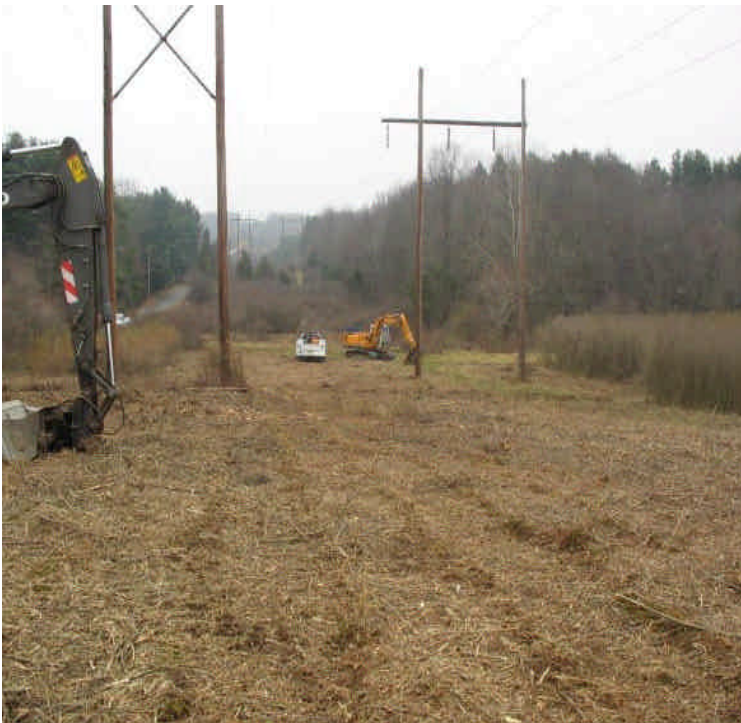
View of clearing activities off Little Lane. Continue to retain vegetation whenever feasible based on the D&M plan.

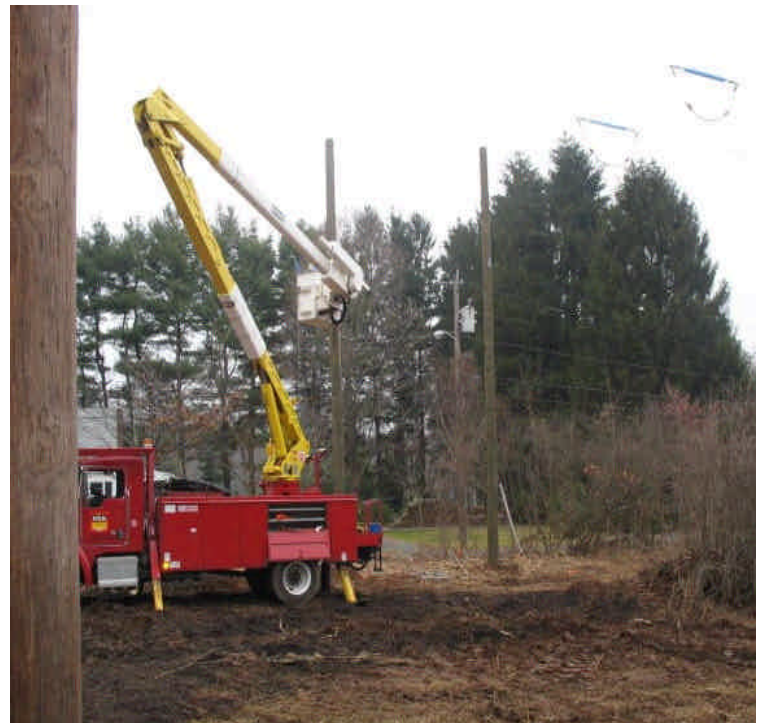
Pole installation and line work off Little Lane.
