Docket No. 272 - Development and Management Plan Inspection

Segment 2a Inspection

Date: November 20, 2006

Location: Segment 2a – Beseck Switching Station to Cheshire/Hamden Town Line

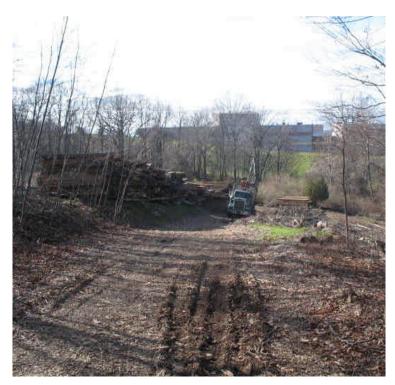
Wetland crossing mats stored off High Hill Rd.

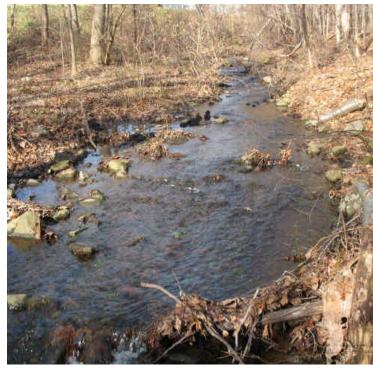
Muddy River off High Hill Rd., located downgradient of the work at Beseck Switching Station. No sedimentation issues were observed at this time.

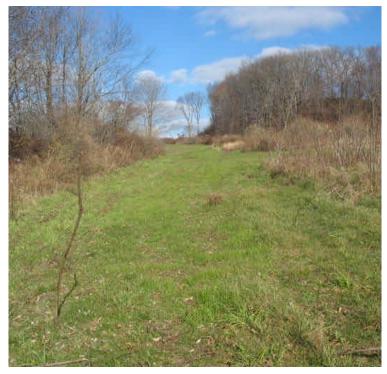
Site entrance off Stony Brook Rd. with well established grass cover.

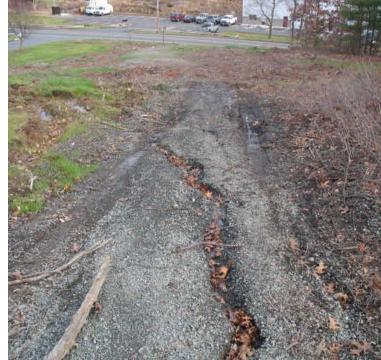
S. Tumpike + Merritt Parkway Area	No sediment tracking noted on S. Turnpike. No new work performed in this area. Some washouts/ erosive gullies continue to form along the access road slope. 10/31-11/20/06	Continue to monitor the entrances and sweep as needed. Road will need to be regraded and stabilized. Stormwater diversion may be needed 10/31-11/20/06	Needs attention when feasible.
Mansion Rd	No sediment tracking noted on Mansion Rd. No new work performed	Continue to monitor and sweep entrance as needed. 11/20/06	NA.

Erosive gully/washouts remain in the stone access road off South Tumpike.

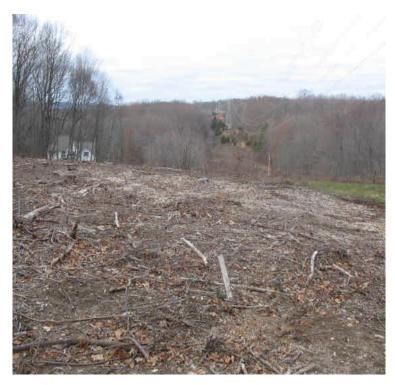
View of clearing previously completed off Mansion Rd.

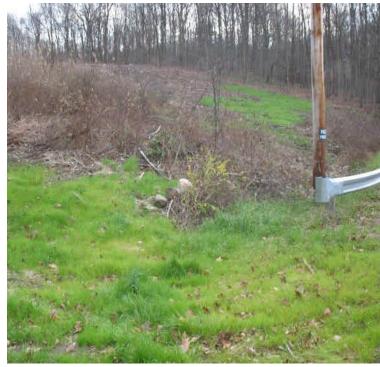
Well established grass cover at the Mansion Rd. entrance to the ROW

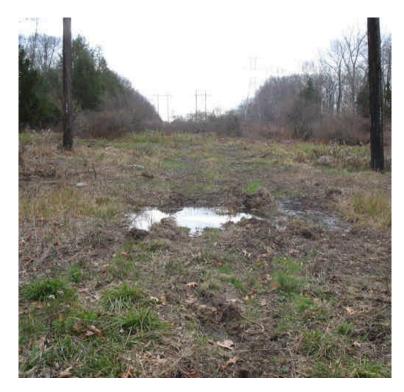
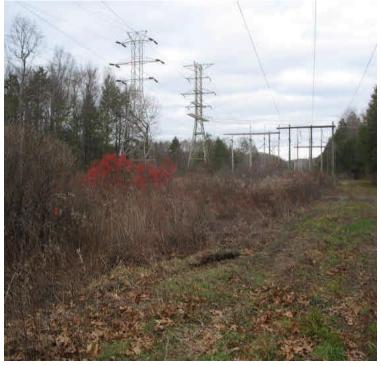
Old Farm Rd.	The majority of the vegetation remains intact here. Very little potential for erosion exists in this area. 11/20/06	Continue to selectively cut vegetation in accordance with the D&M plan if needed. 11/20/06	NA
Inland Wetland and Watercourse encroachment and mitigation	Jurisdictional wetlands and buffers will not be accessed until the ACOE permit is in hand. 8/24- 11/20/06	Continue to monitor wetlands and erosion controls. 11/20/06	NA
	Wetlands were flagged at the 100' buffer prior to work starting in each area. These buffers have been retained. 11/20/06	Continue to maintain buffer zone until ACOE permits allow access. 11/20/06	Buffer zones are established and retained.
State species of concern, threatened and endangered species.	According to the D&M plan, state-listed species are not located in the current work areas. 11/20/06	None 11/20/06	NA
	Vegetation clearing is presently on hold	Continue to retain appropriate vegetation for	NA.

Vegetation left in place for stabilization off Old Farm Rd.
