Docket No. 272 – Development and Management Plan Inspection

Segment 4a Underground Line

Date: November 8, 2006 (Evening inspection)

Location: Singer Substation to Fairfield/Westport Town Line

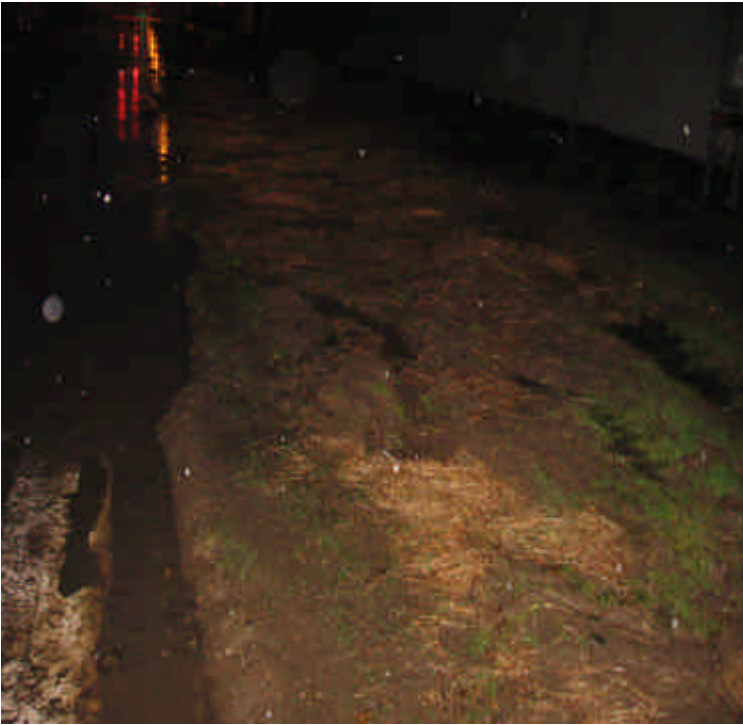
Former location of tire ruts along Railroad Ave. The surface was regraded for the most part.

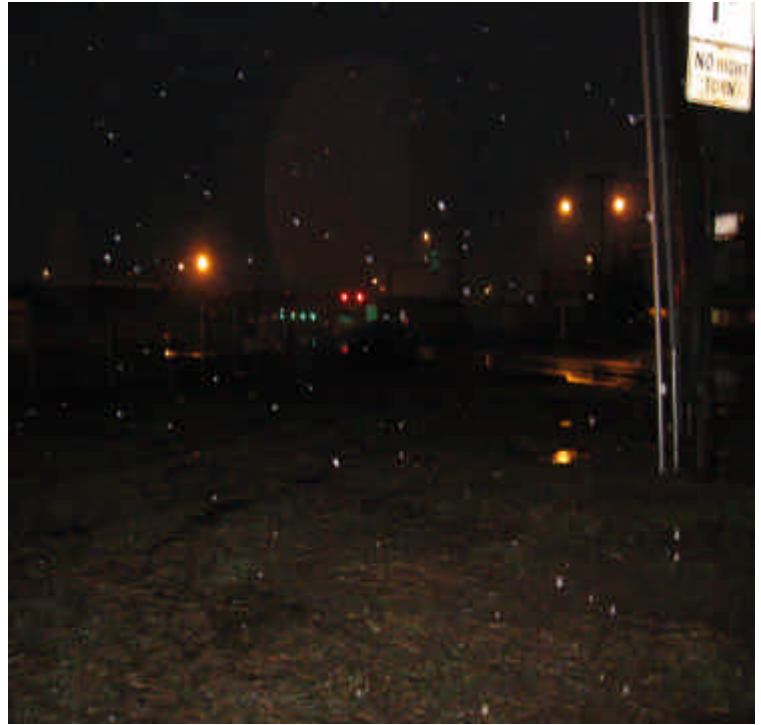
Photo of the intersection of Railroad Ave. with Wordin Ave. The soil pile in this location, noted in last week's inspection, has been removed.

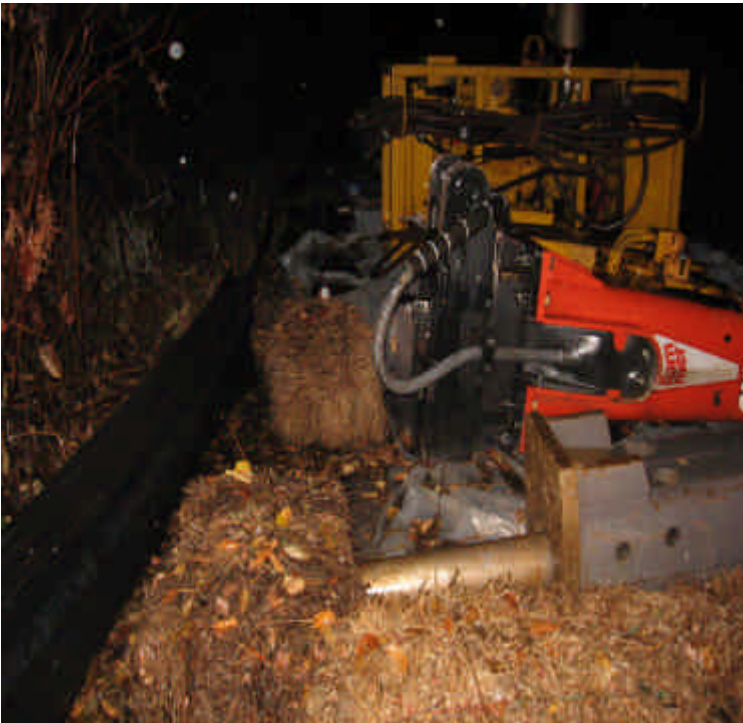
Photo of one of the attachment equipment storage area in the the King's Highway Laydown Yard. Please note that the containment area is not fully enclosed.

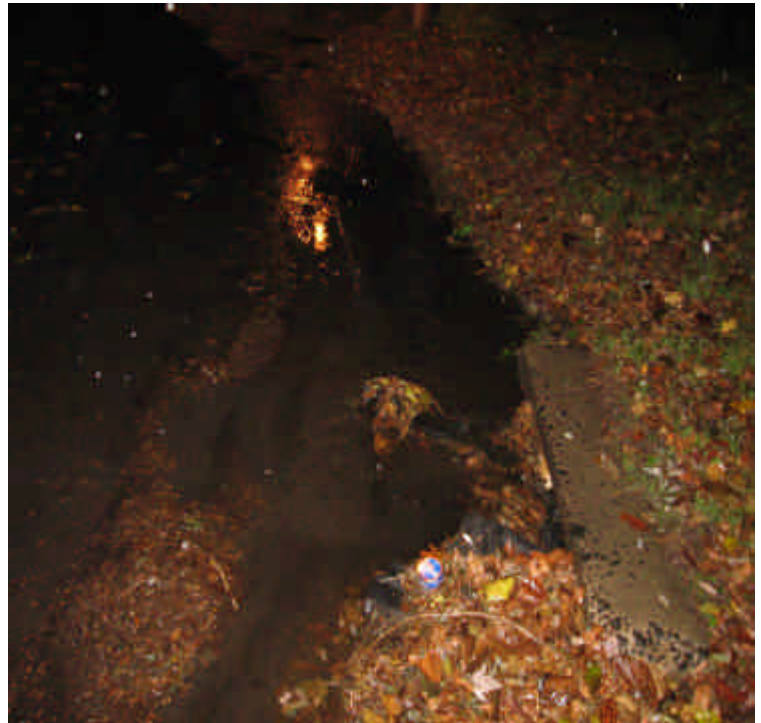
Photo of the catch basin located on Old Post Rd. that receives stormwater from the Fairfield Inn area. Please note that the runoff flowing into the catch basin contains no observable sediment.
