Docket No. 272 – Development and Management Plan Inspection

Segment 4a Underground Line

Date: November 15, 2006

Location: Singer Substation to Fairfield/Westport Town Line

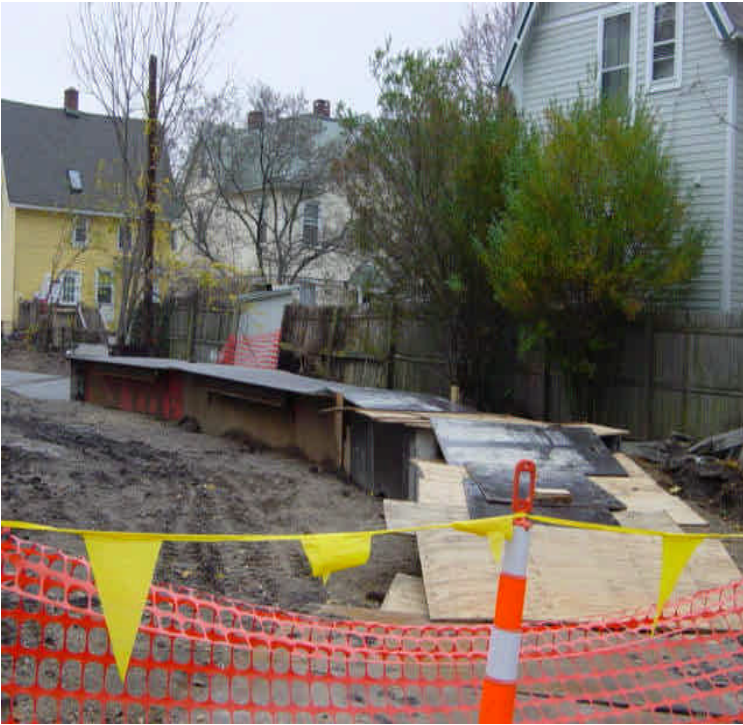
Photo of trenching activities between Broad St. and Main Ave.

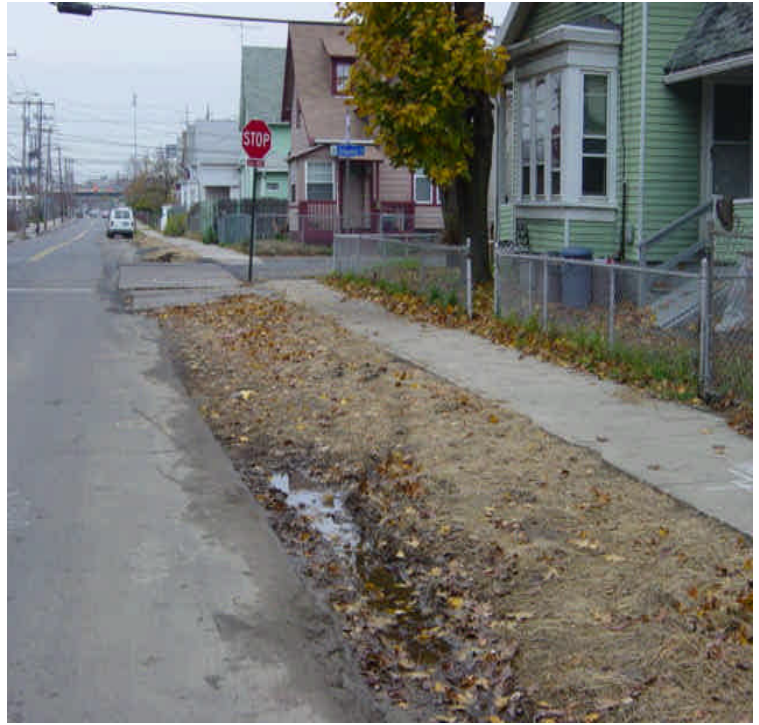
Photo of trenching location on Broad St. at its intersection with Atlantic Ave. that had adjacent tire ruts. Repair as needed.

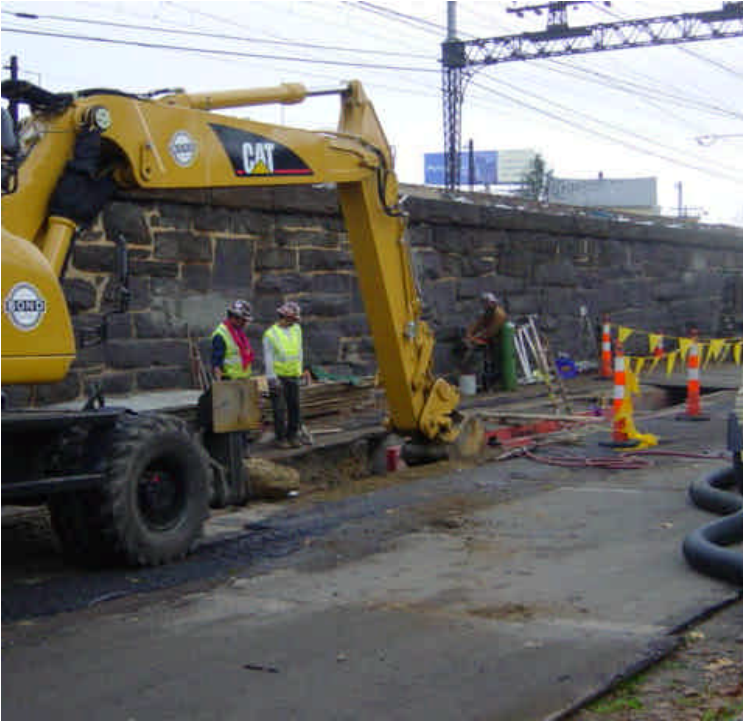
Trenching activities on Railroad Ave. near its intersection with Park Ave. Loose sediment was being swept from the roadway.

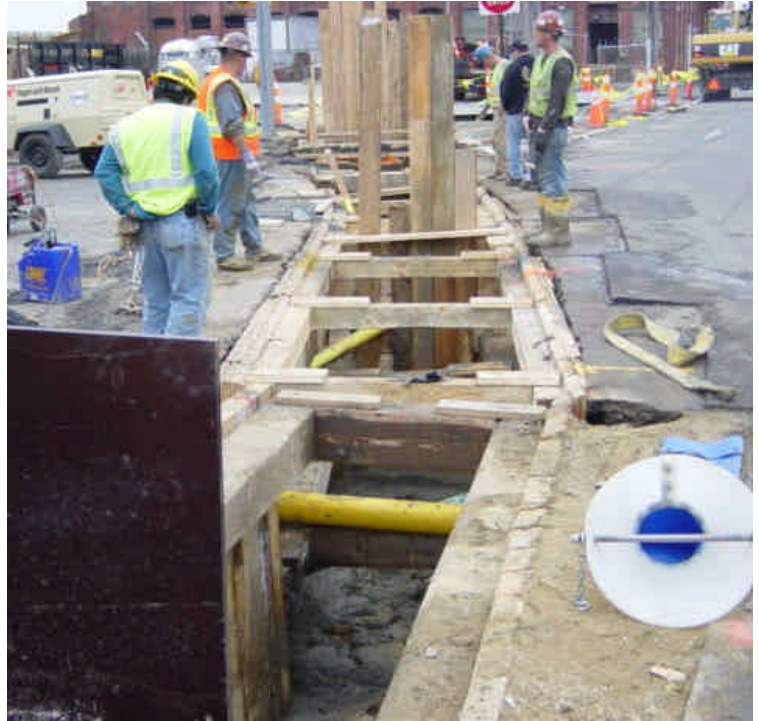
Trenching activities at the intersection of Railroad Ave. and Bostwick Ave.

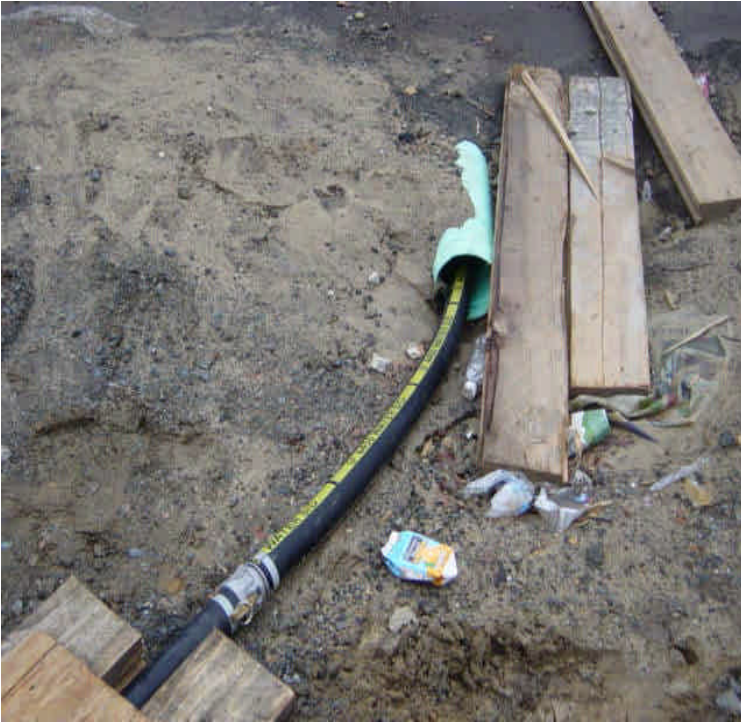
Filtered water from frac tanks is being discharged to sanitary sewer system via PVC pipe. The PVC pipe inlet does not have controls in place, potentially allowing sediment into the system.

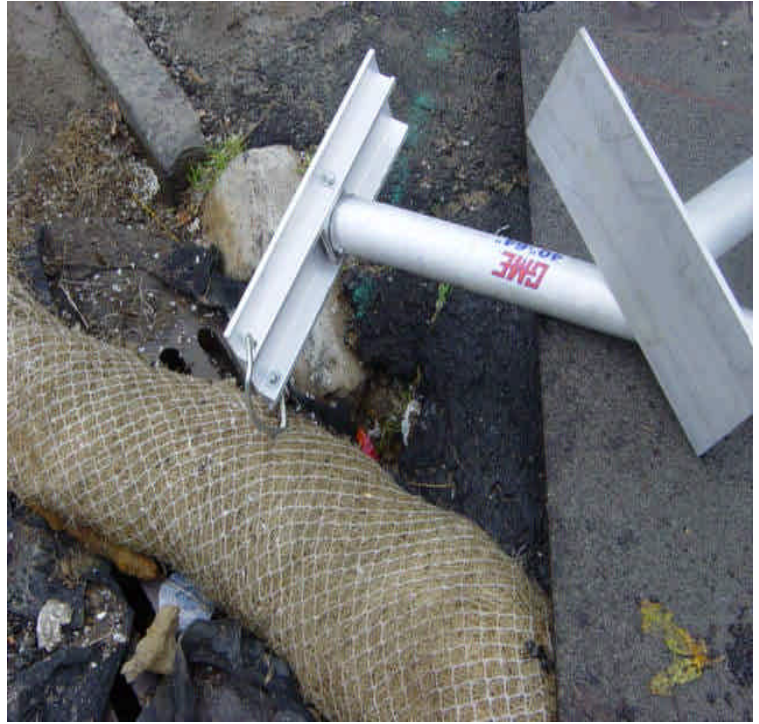
A catch basin located at the intersection of Railroad Ave. and Bostwick Ave. appears to be collapsing. Evaluate whether nearby trenching activities are responsible.

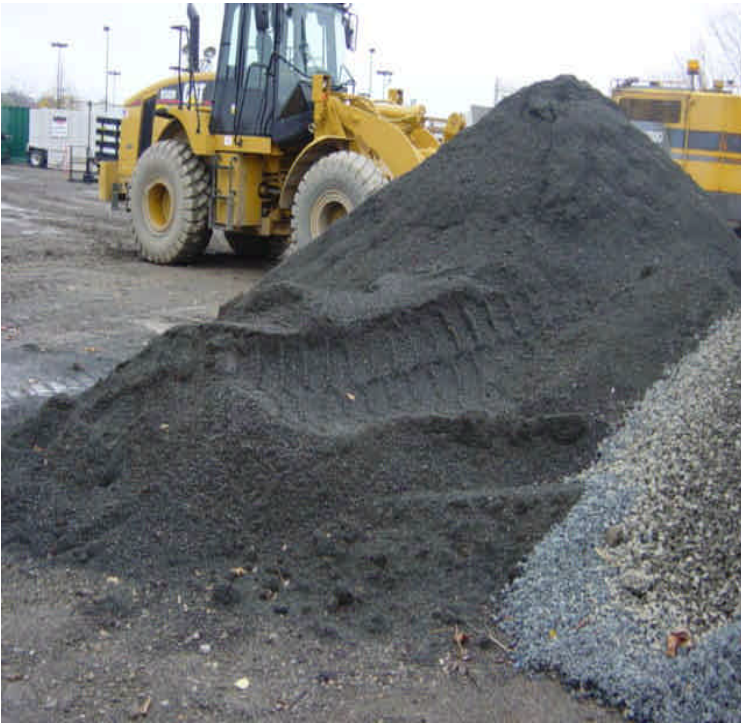
Material pile within the Kings Highway Laydown yard that is in close proximity to the adjacent resource area. Runoff from the pile contains a sheen and was collecting against the controls.

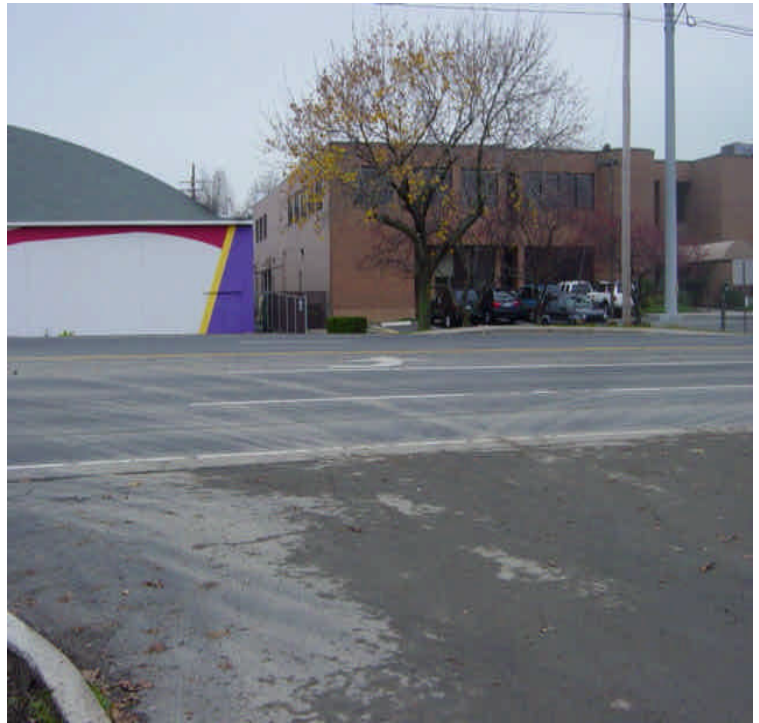
Entrance to the Kings Highway Laydown Yard. Some minor sediment tracking from the yard was noted on the roadway.

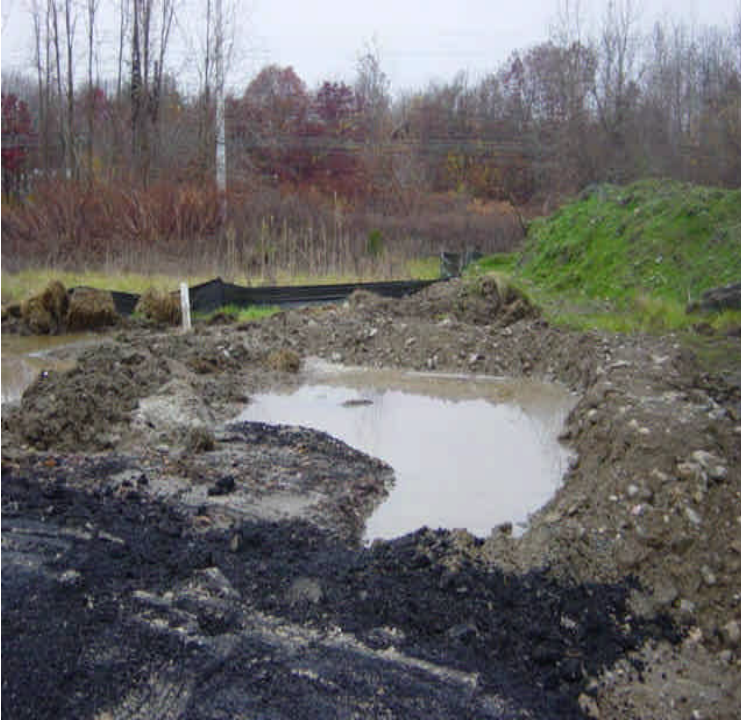
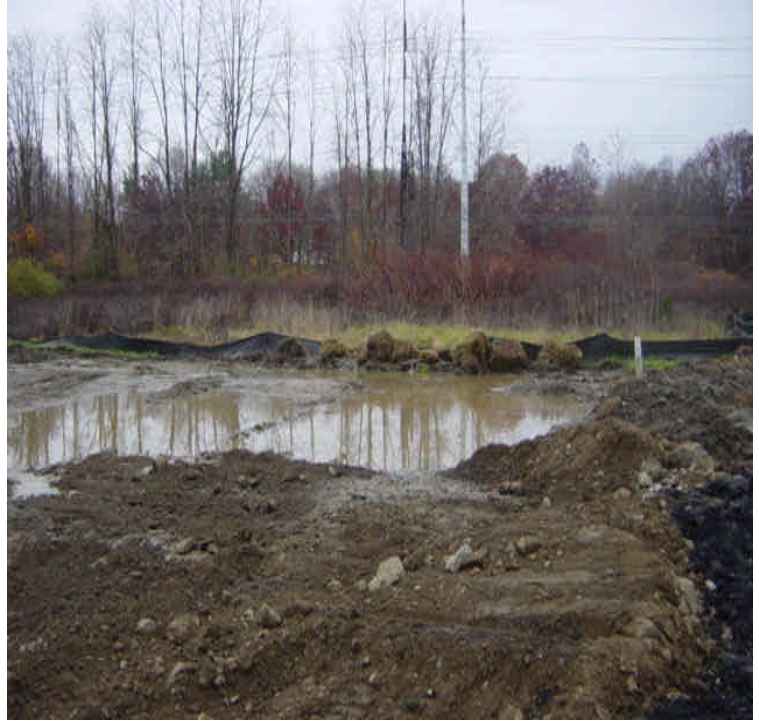
Both photos are of the former concrete washout basin and sweeper washout area in the Kings Highway Laydown Yard. The concrete basin has been removed and the sweeper washout area remains, (shown to the left). Continue to effectively contain the run-off to the yard.

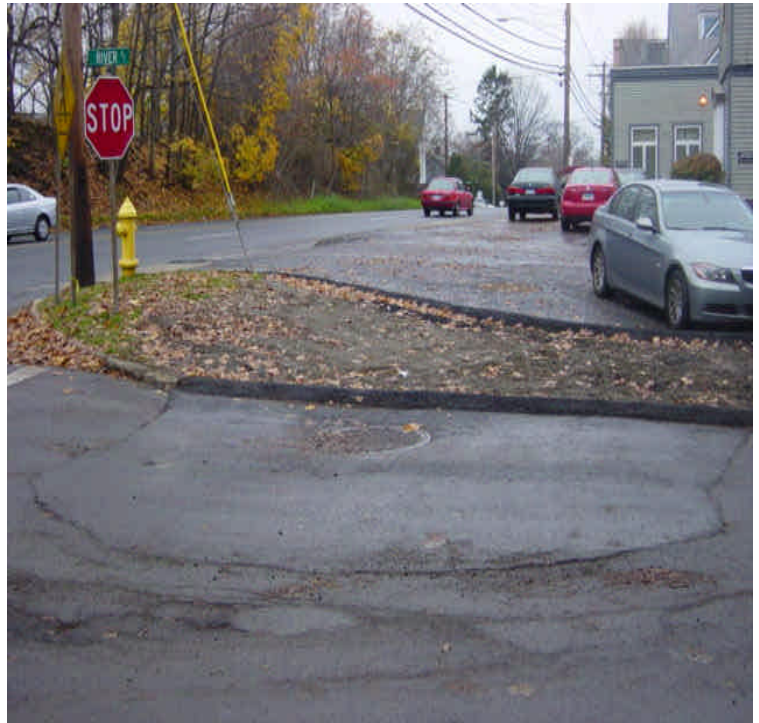
Location of Vault # 5430. Vault installation appears to be complete. Disturbed soils should be temporarily stabilized.
