Docket No. 272 – Development and Management Plan Inspection

Segment 4a Underground Line

Date: November 29, 2006

Location: Singer Substation to Fairfield/Westport Town Line

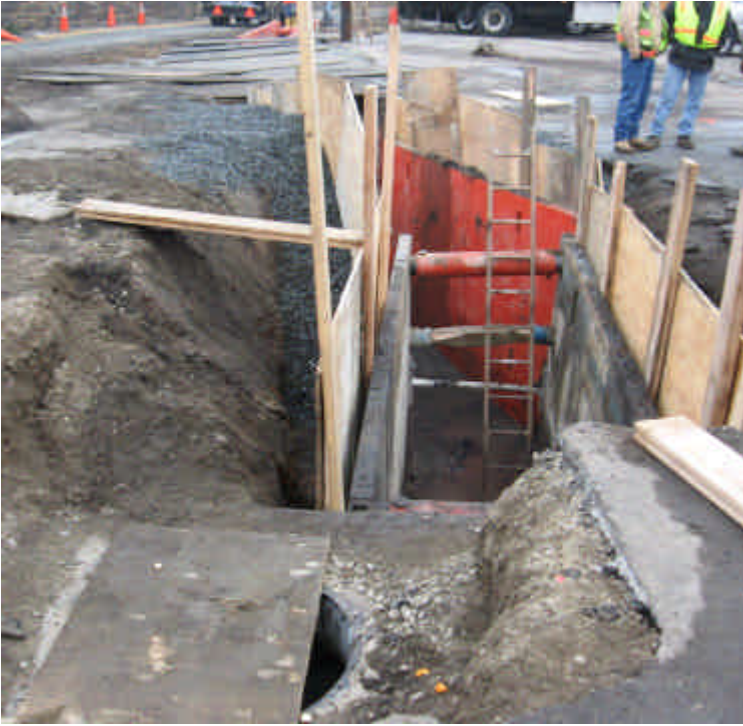
Photo of trenching activities at the intersection of Railroad Ave. and Howard Ave.

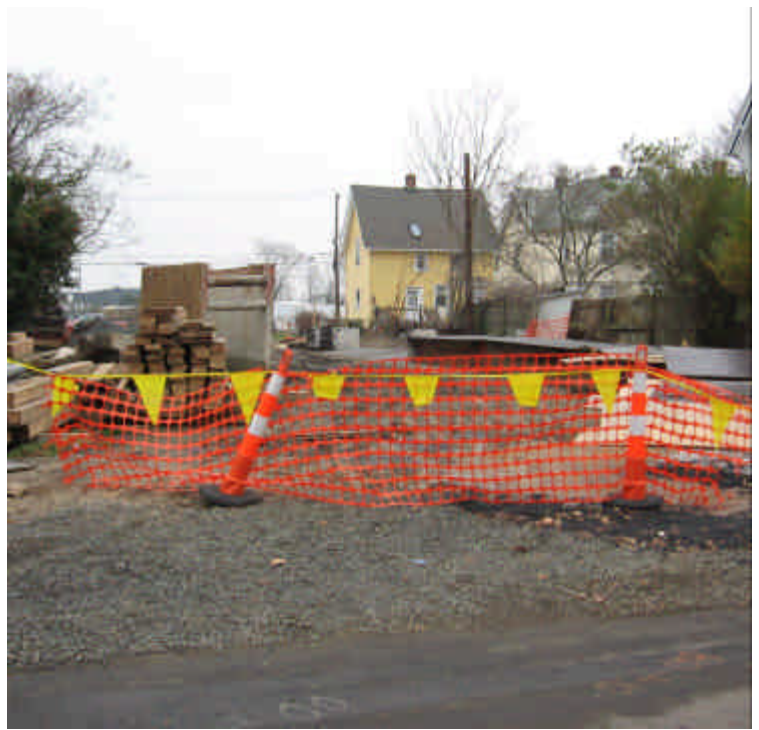
Photo of trenching activities located between Broad St. and Main St.

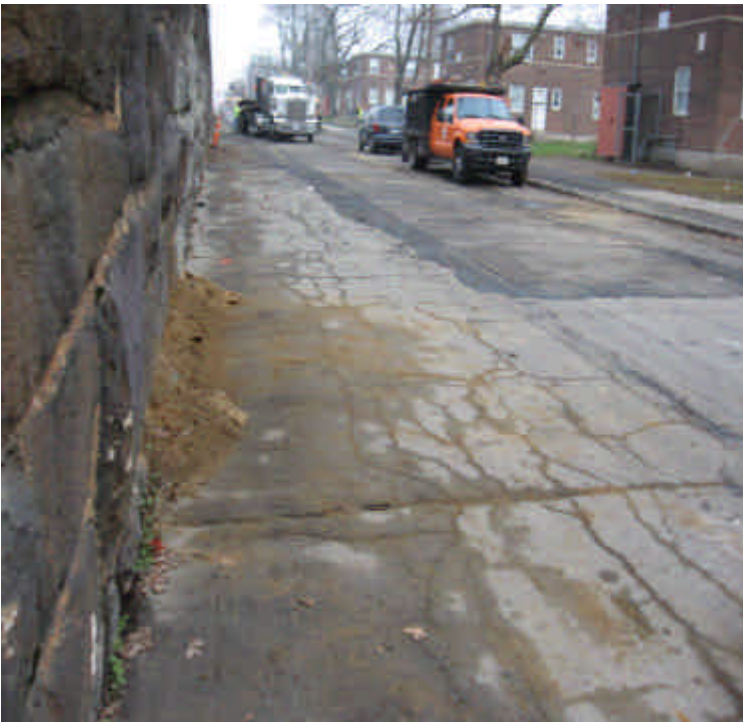
Photo of trenching activities on Railroad Ave. north of South St. Sediment in roadway should be removed as feasible.

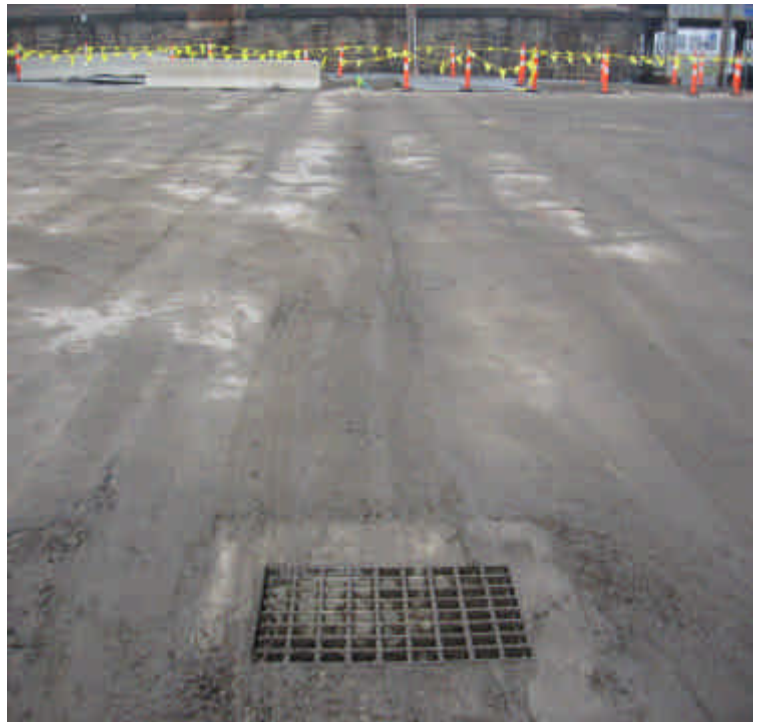
Photo of privately owned yard located immediately adjacent to trenching activities on Railroad Ave., south of Bostwick Ave. There is potential for sediment from construction activities to enter the catch basin.

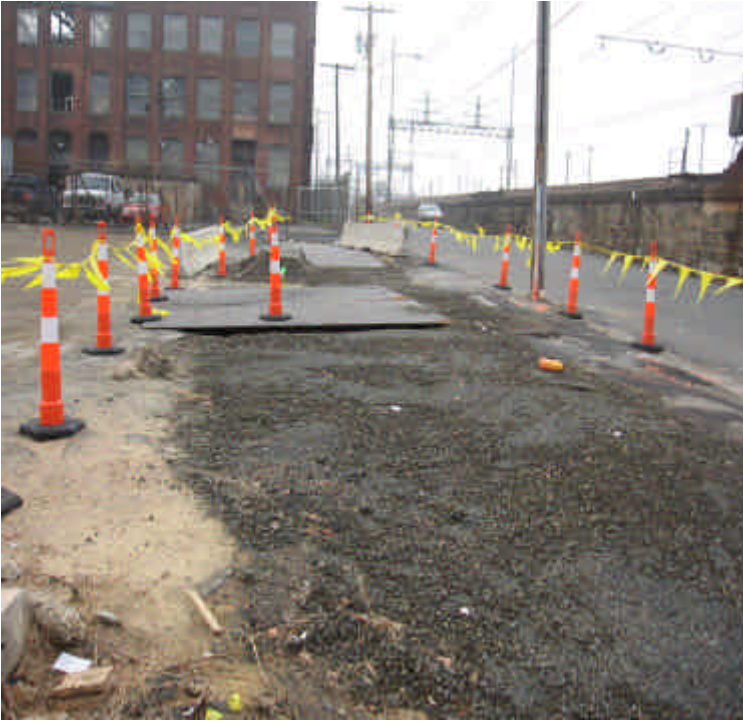
Photo of trenching activities located along Railroad Ave. at its intersection with Bostwick Ave. Catch basin shown in previous photo is located to the left of this view.

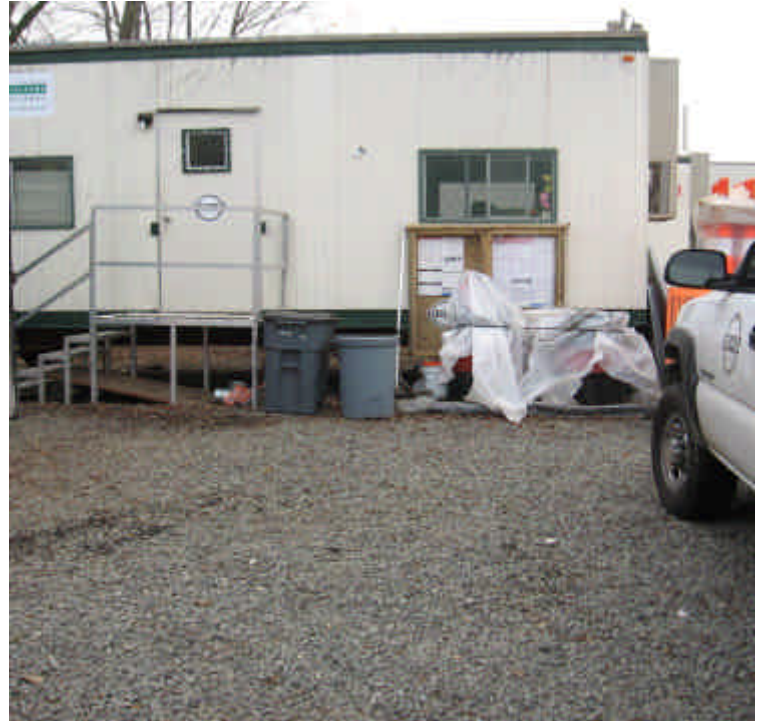
Photo of the contractor trailer and covered oil containment area at the contractor storage yard on Bostwick Ave.

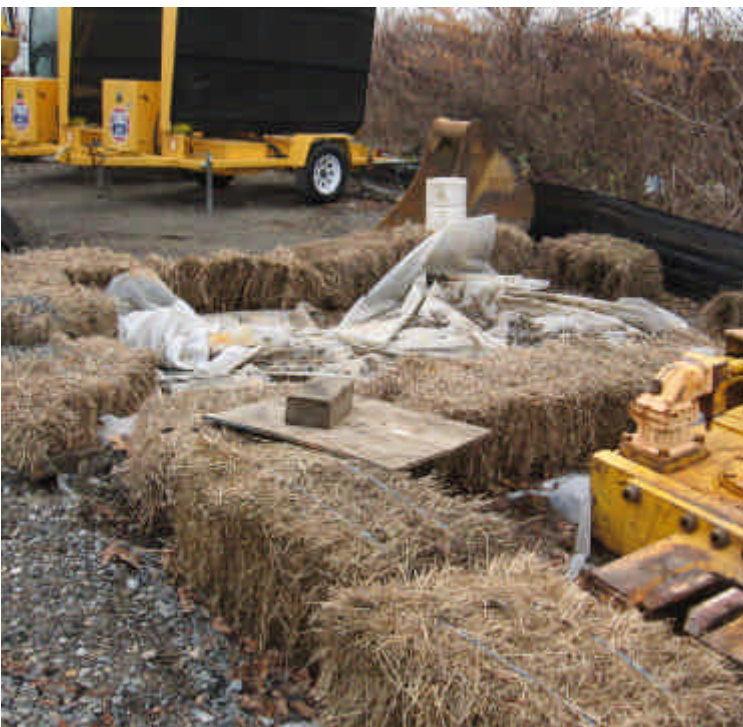
Attachment containment area in western side of the yard is not fully enclosed with controls.

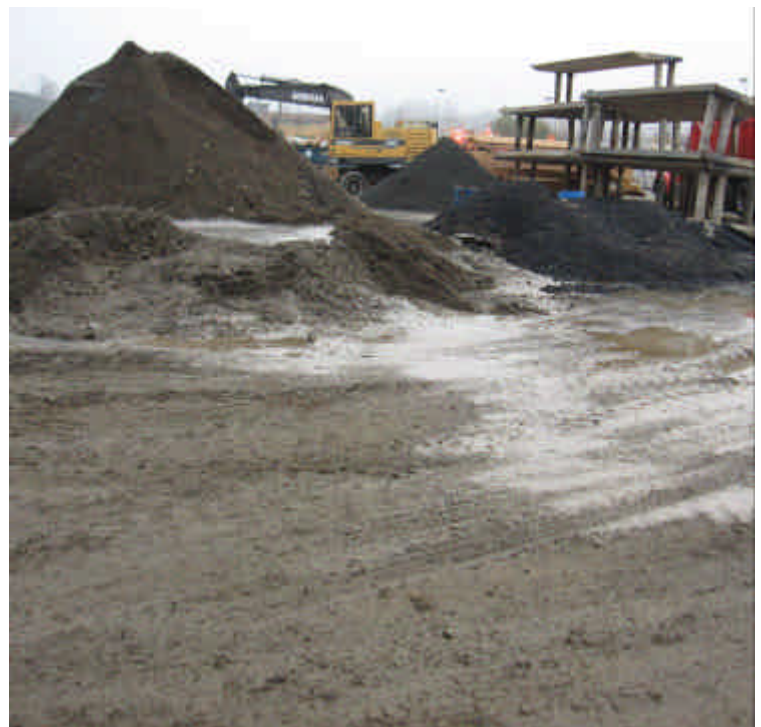
Photo of the concrete washout basin. The basin is not lined to isolate the washout from underlying soils, and it appears to be inadequately sized for storage.

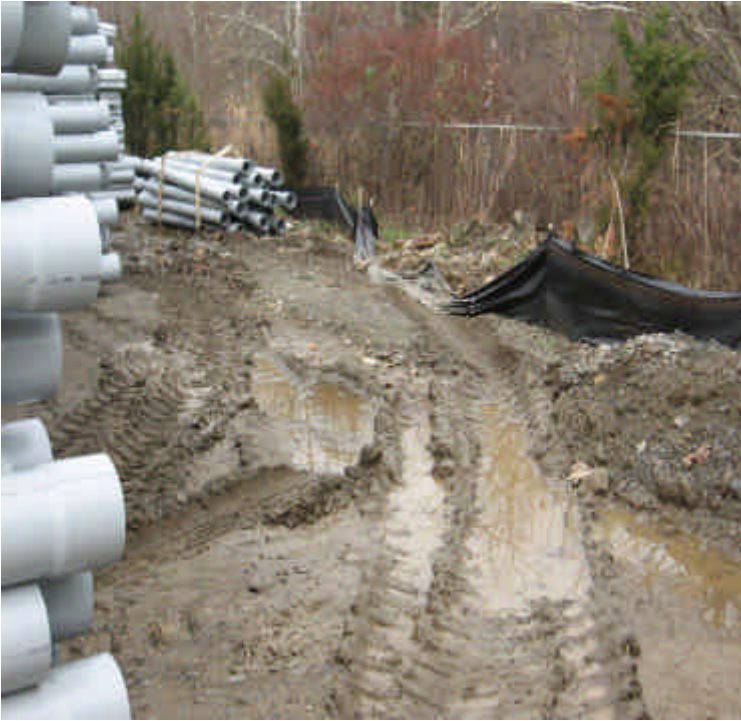
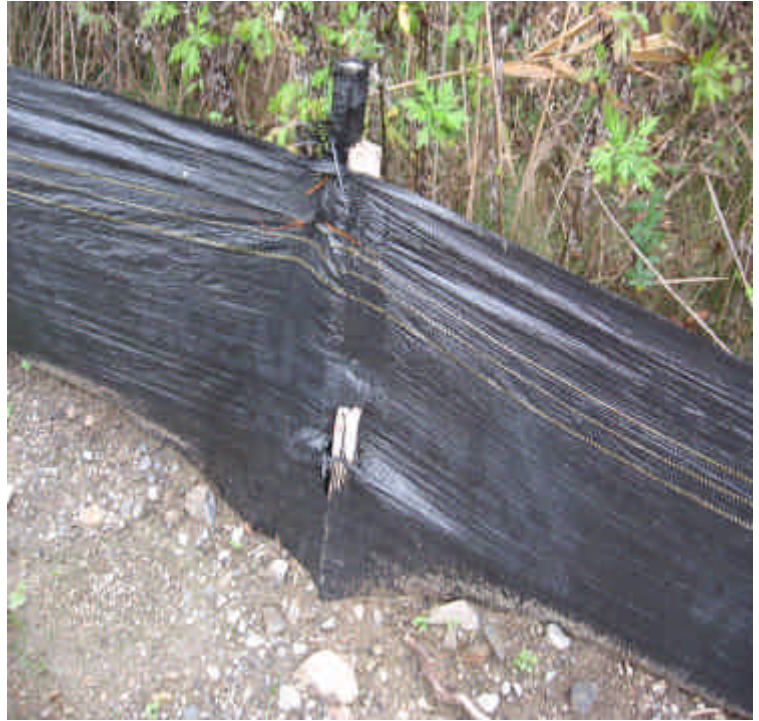
Both photos show areas along the perimeter silt fence which are in need of repair. This is along the edge of the yard adjacent to the sensitive areas.

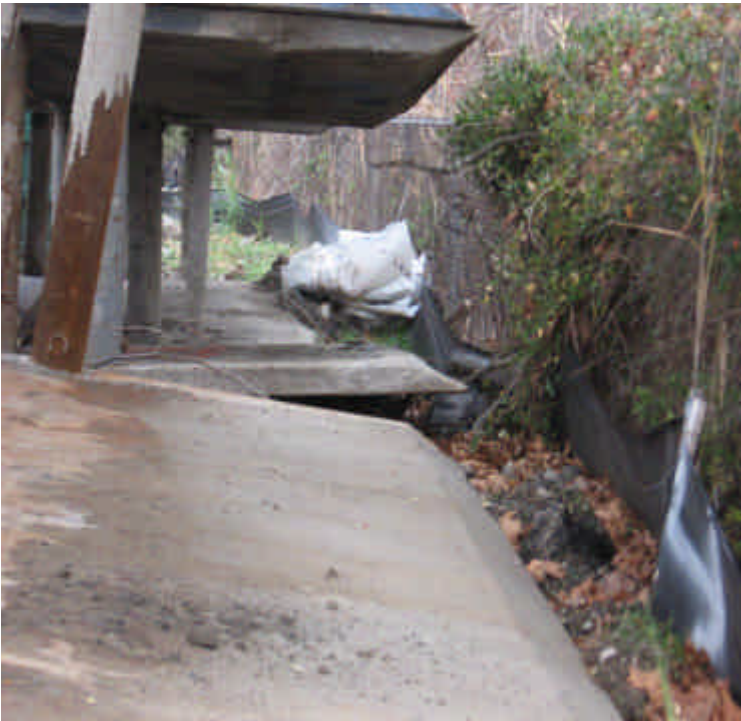
A portion of the perimeter controls on the side of the yard to adjacent to sensitive areas were overwhelmed by construction materials.

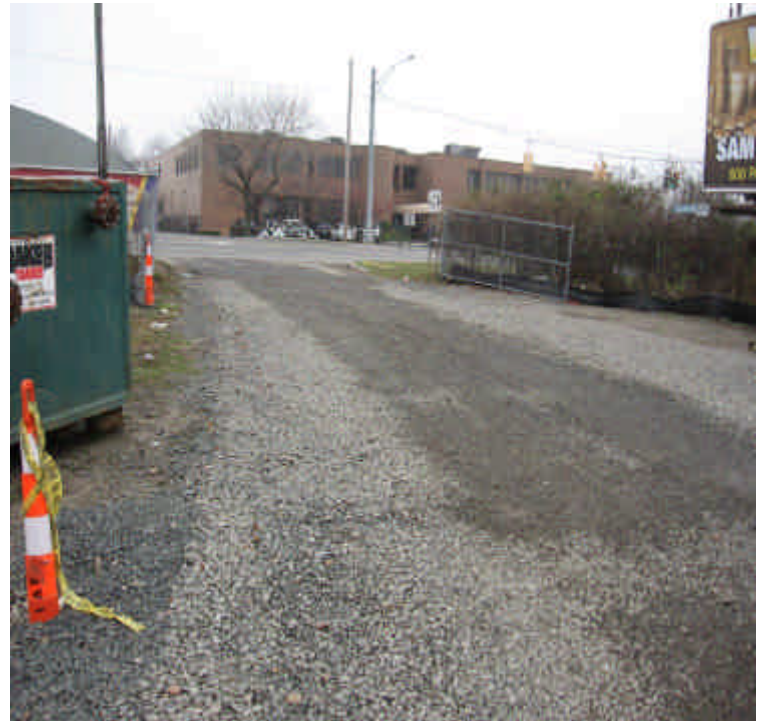
The construction entrance is well maintained and no evidence of sediment tracking was observed.

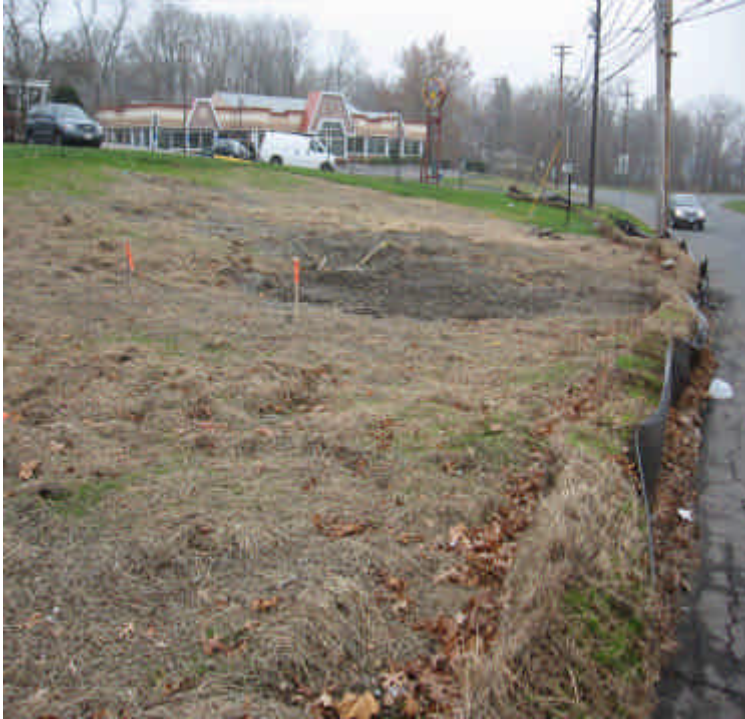
Photo of vault # 7537 location in front of the Fairfield Inn. No evidence of erosion was noted.

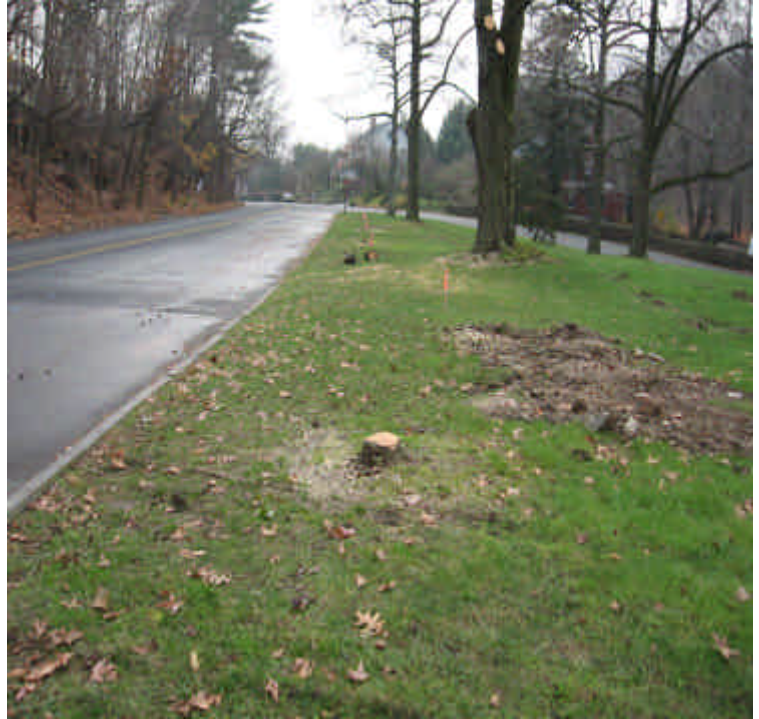
Four trees have been removed along Pequot Ave in Fairfield. This is reflected in the 8/15/06 version of the D&M plans.

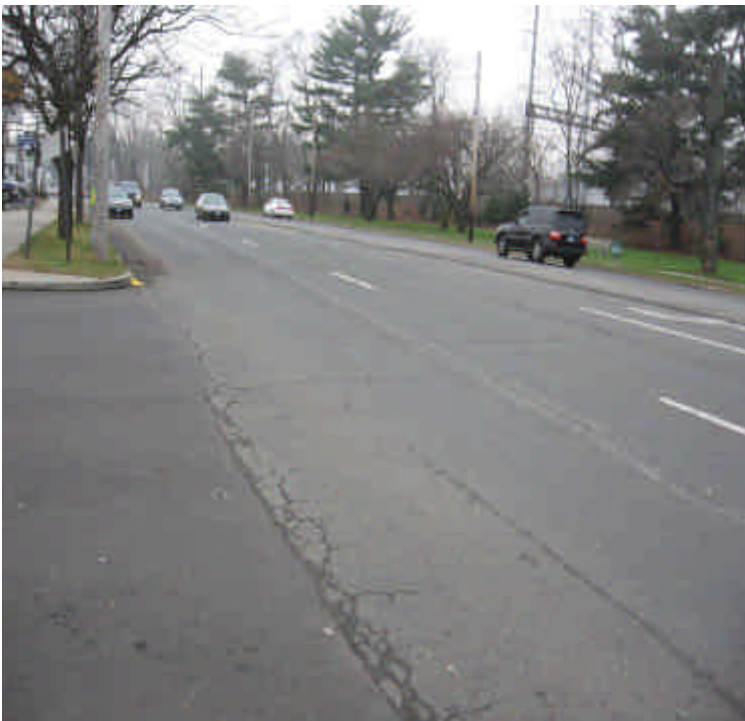
Trenching activities along Rt. 1 near its intersection with Mill Plain Rd.

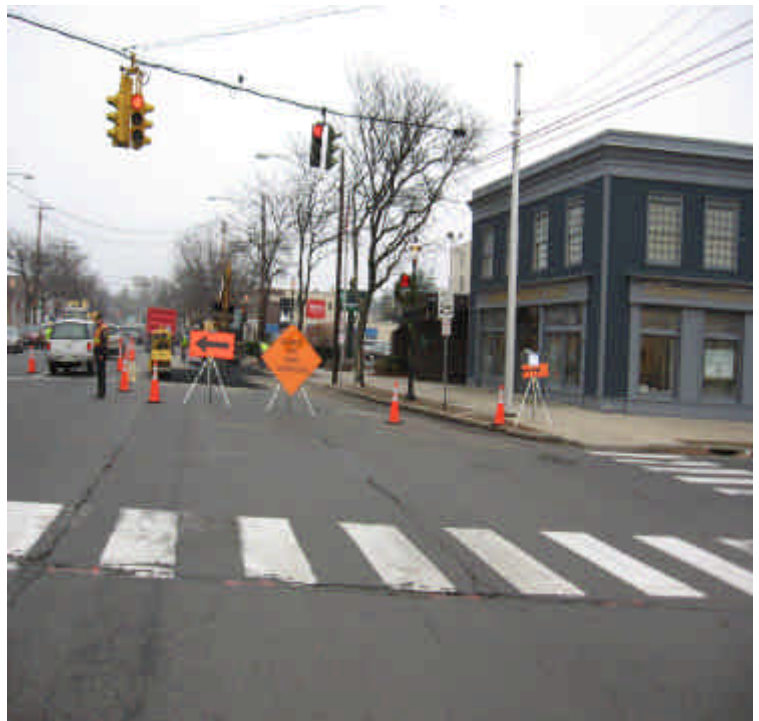
Construction activities on Rt. 1 at its intersection with Ruane St. The crews are applying asphalt to what appears to be the area excavated for the installation of Vault # 7533. This vault location is reflected in the 8/15/06 version of the D&M plans.
