**Docket No. 272 – Development and Management Plan Inspection**

**Segment 4b Underground Line**

**Date:** November 15, 2006

**Location:** Fairfield/Westport Town Line to Westport Avenue in Norwalk

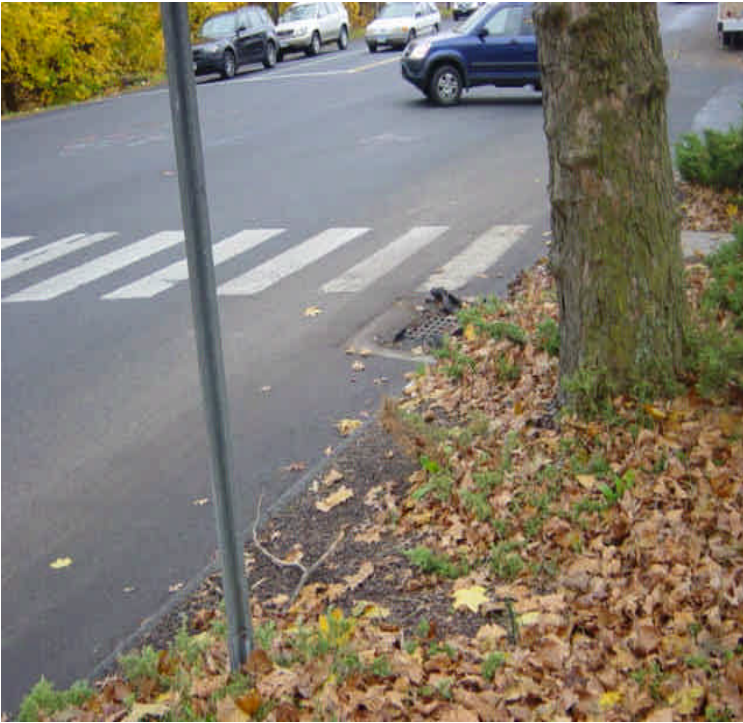
**Photo of catch basin located near the intersection of Rt. 1 and Cedar St. with controls in place**

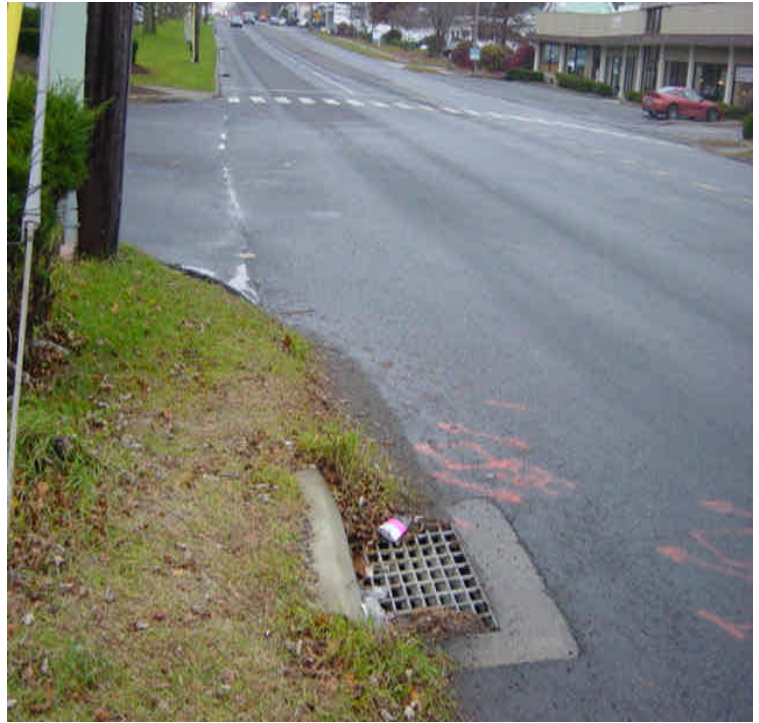
Catch basin located downgradient of construction activities at the intersection of Rt. 1 and Buckley Ave. is unprotected. 11/15/06	Protect catch basin from sediment. 11/15/06	Needs attention.

**Photograph of an unprotected catch located downgradient of construction activities on Rt. 1 at the intersection with Buckley Ave.**

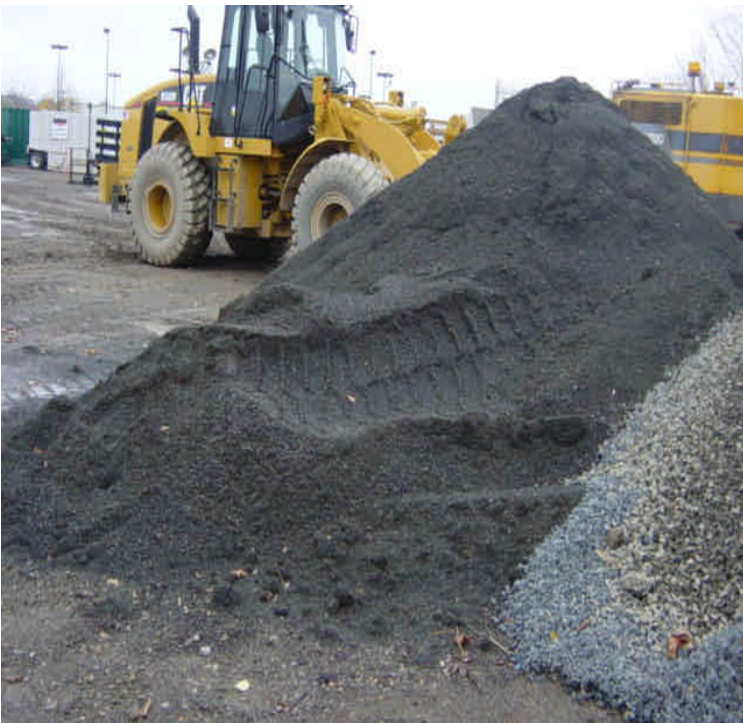
**Material pile within the Kings Highway Laydown yard that is in close proximity to the adjacent resource area. Runoff from the pile contains a sheen and was collecting against the controls.**

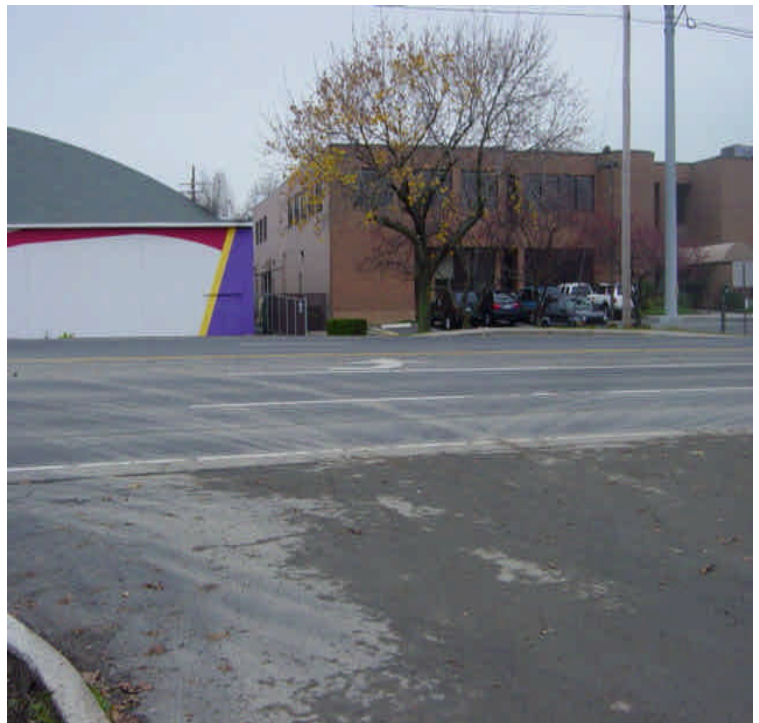
**Entrance to the Kings Highway Laydown Yard. Some minor sediment tracking from the yard was noted on the roadway. This yard is also covered by the 4a report.**

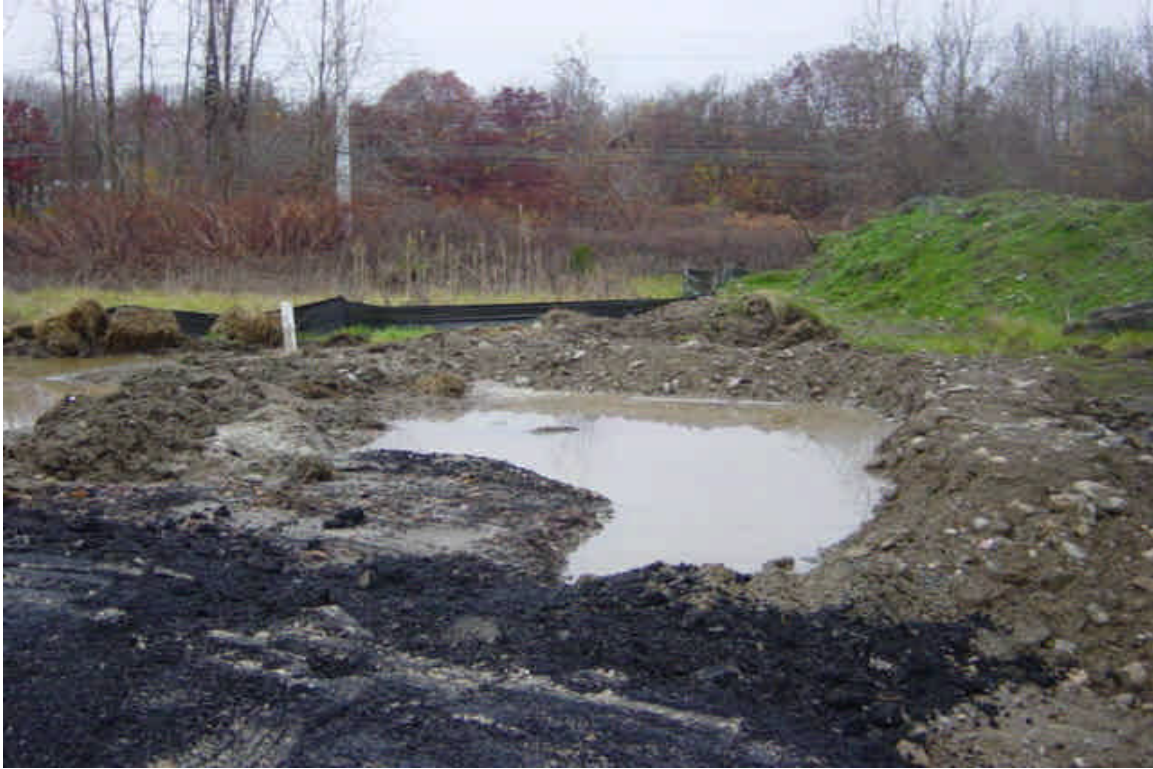
**Photo of area**

**used in the King's Highway Laydown Yard for collecting concrete washout water.  
It does not appear that the area is lined.**

**being**

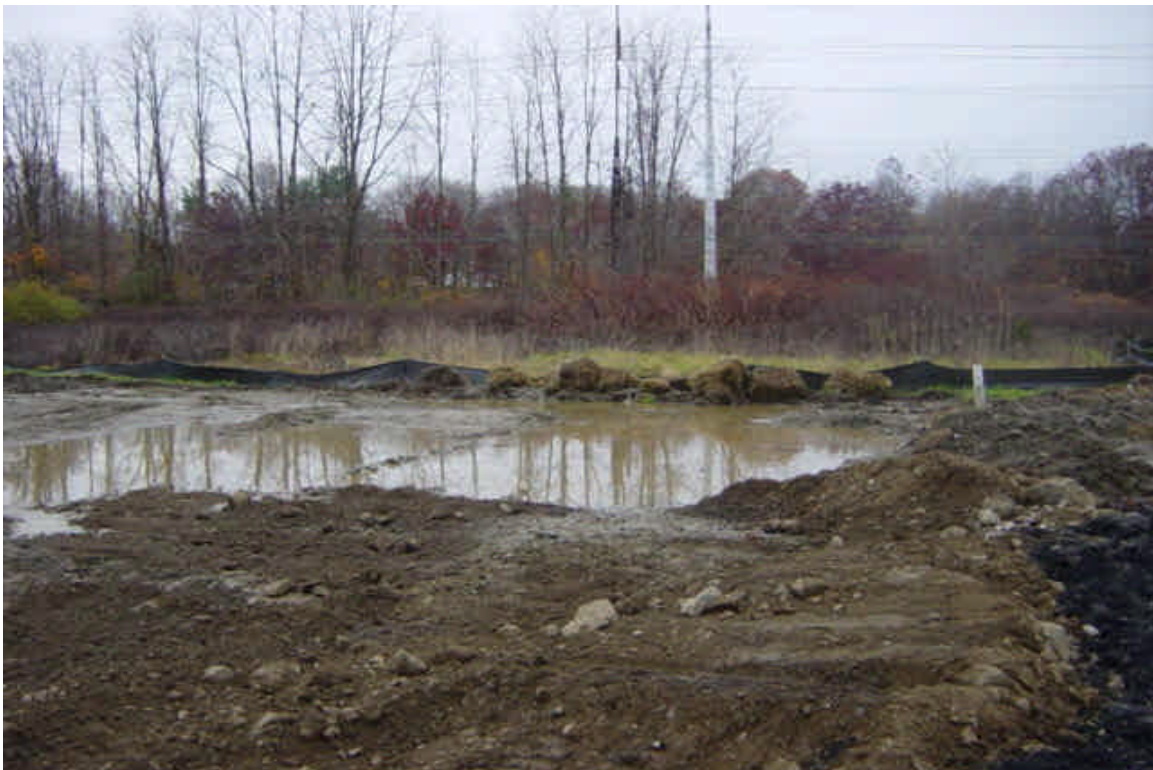
Areas of Inspection	Observation	Recommended Action	Corrected Action
<p><b>Kings Highway Lay-down Yard (Off Kings Highway, near Rt. 1 rotary in Fairfield) –</b></p> <p><b>(Currently being used for Segment 4a and 4b operations.)</b></p>	<p><b>Concrete washout basin was removed. Sweeper washout water is still being retained. 11/15/06</b></p> <p><b>Minor sediment tracking was observed on the roadway from the yard. 11/15/06</b></p> <p>Some of the perimeter silt fence is not at its full height (stormwater run-off was almost able to overtop), and a small gap was noted along the fence near the resource area. 11/15/06</p>	<p><b>Continue to contain washout area as necessary. 11/15/06</b></p> <p><b>Sediment in roadway should be swept. Continue to work on containing sediment to the yard. 11/15/06</b></p> <p><b>Maintain the integrity and stability of the perimeter controls in the yards. 11/15/06</b></p>	<p><b>Basin has been removed.</b></p> <p><b>Needs attention. (The yard is also covered in the 4a report)</b></p> <p><b>Needs attention (The yard is also covered in the 4a report)</b></p>

**Location of**

**concrete washout basin. The area is still used for sweeper washout water.  
Again, this yard is also covered in the 4a report**

**former**
