**Docket No. 272 – Development and Management Plan Inspection**

**East Devon Substation Inspection**

**Date:** November 2, 2007

**Location:** East Devon Substation

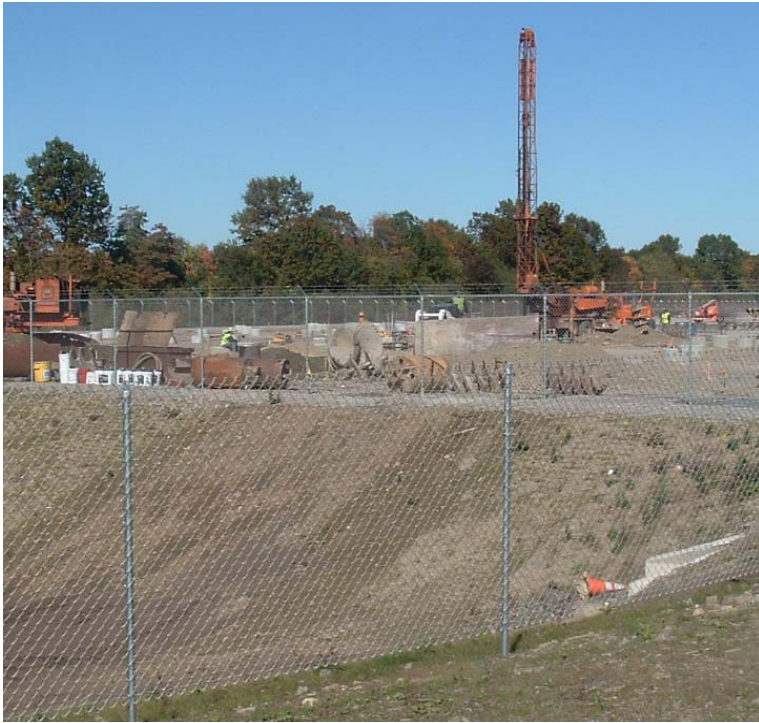
East Devon Substation: A view of the substation from the southern site boundary.

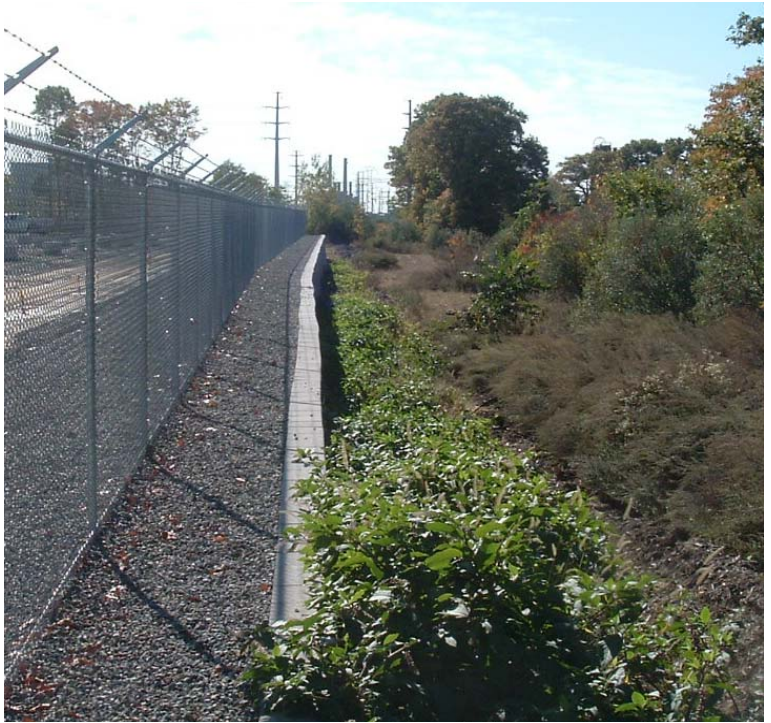
Foundation and site construction	Foundation work continues. Foundation drilling was noted during the inspection. 11/2/07	None at this time. 11/2/07	NA
Erosion and Sediment Controls	The retaining wall and mulch berm continue to contain soils and prevent off site sedimentation.	Continue to monitor and improve controls as necessary. 11/2/07	NA at this time

East Devon Substation: A view of the retaining wall located along the western site boundary.

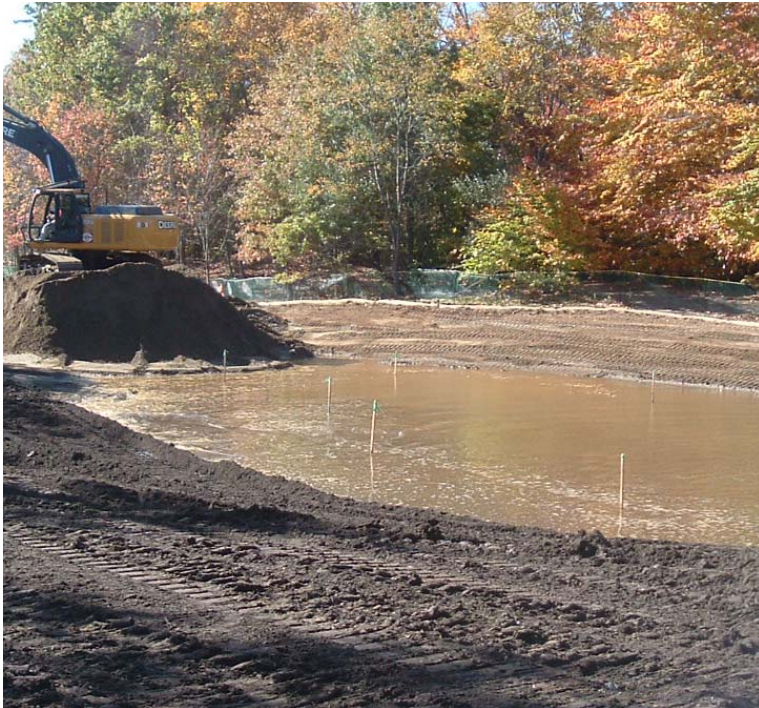
Eisenhower Park (Milford): Construction of the wetland mitigation area continues.

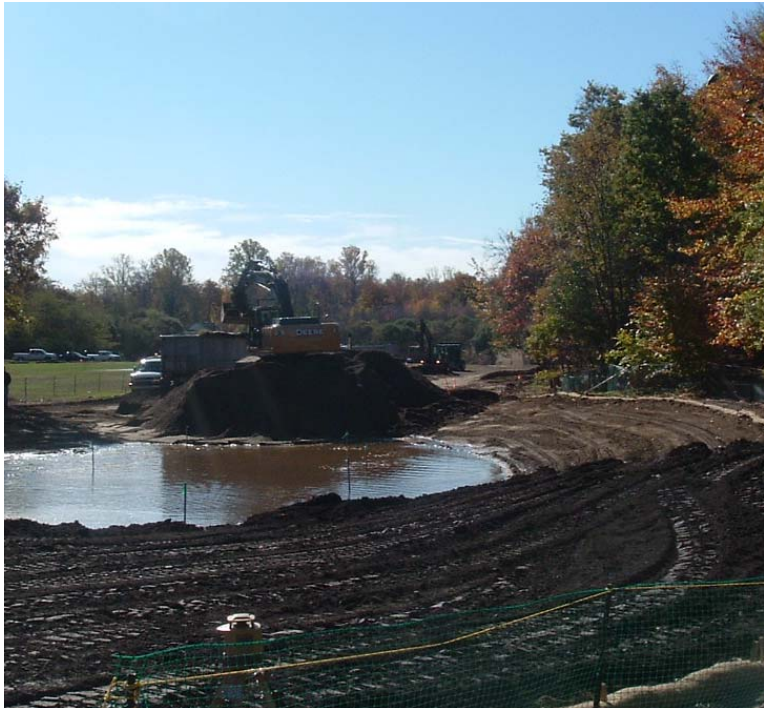
Eisenhower Park: Additional view of the wetland mitigation area.
