**Docket No. 272 – Development and Management Plan Inspection**

**East Devon Substation Inspection**

**Date:** November 8, 2007

**Location:** East Devon Substation

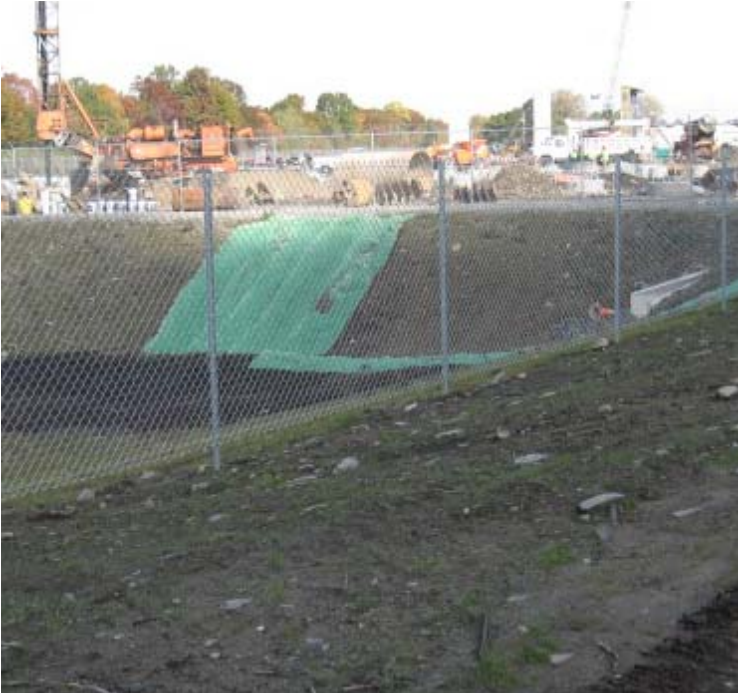
East Devon Substion (Milford): A general view of construction at the substation. Erosion control blankets were being installed along the detention basin slopes.

Areas of Inspection	Observation	Recommended Action	Corrected Action
	stabilize the exposed slopes of the detention basin. 11/8/07		installed to stabilize detention basin slopes
Dewatering	Dewatering is not being performed for substation work at this time. 11/8/07	None at this time. 11/8/07	NA
Blasting	No blasting is proposed at this time. 11/8/07	None at this time. 11/8/07	NA
Spills, Soils and Material Storage	Construction materials and equipment are kept on the substation site and at the receiving yard located to the east of Shelland Street. 11/8/07	In general, store materials and equipment appropriately. Ensure that vehicles are equipped with spill kits and maintain them when needed. All construction vehicles should be parked at least 100 feet from a wetland or waterbody when feasible. 11/8/07	NA
Additional Observations	NA	NA	NA

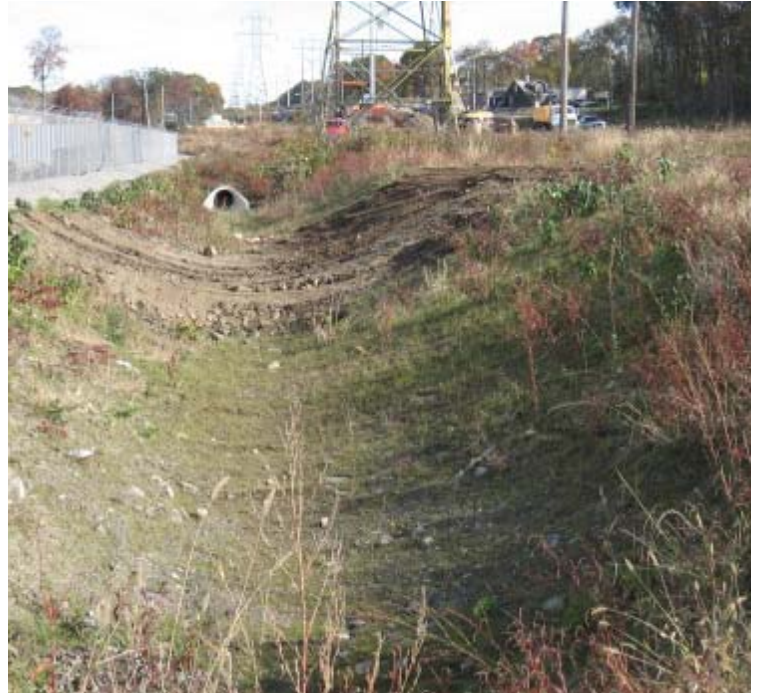
East Devon Substation: Exposed soils were observed within the drainage swale. Temporary stabilization is necessary here.

State species of concern, threatened and endangered species.	According to the D&M plan, state-listed species are not located in this work area. 11/8/07	None. 11/8/07	NA
Vegetative clearing or stabilization	<p>Vegetation has been cleared within the limits of the substation site and along the newly re-located Shelland Street. 11/8/07</p> <p>Stone has been spread throughout the site for stabilization. 11/8/07</p> <p>Exposed soils were observed in a portion of the vegetated swale. 11/8/07</p> <p>Erosion control blankets have been installed to</p>	<p>None at this time. 11/8/07</p> <p>Continue to monitor. 11/8/07</p> <p>Apply mulch or similar to temporarily stabilize soils over the winter. Erosion controls may be necessary at the outlet. 11/8/07</p> <p>Continue to monitor. 11/8/07</p>	<p>NA</p> <p>Stone has been spread throughout the site for stabilization</p> <p>Needs attention/ evaluation</p> <p>Erosion control blankets have been</p>

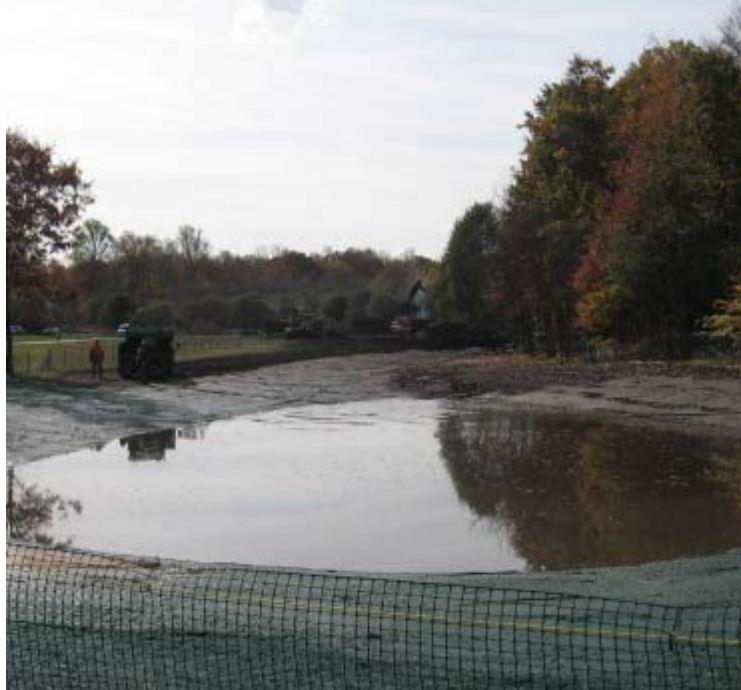
Eisenhower Park (Milford): A view of the wetland mitigation area.
