Docket No. 272 – Development and Management Plan Inspection

Segment 1a Inspection

Date: October 29, 2007

Location: Segment 1a – Scovill Rock Switching Station to Chestnut Junction, Oxbow Junction to Beseck Switching Station (excluding Royal Oak Bypass), and Black Pond Junction to Beseck Switching Station

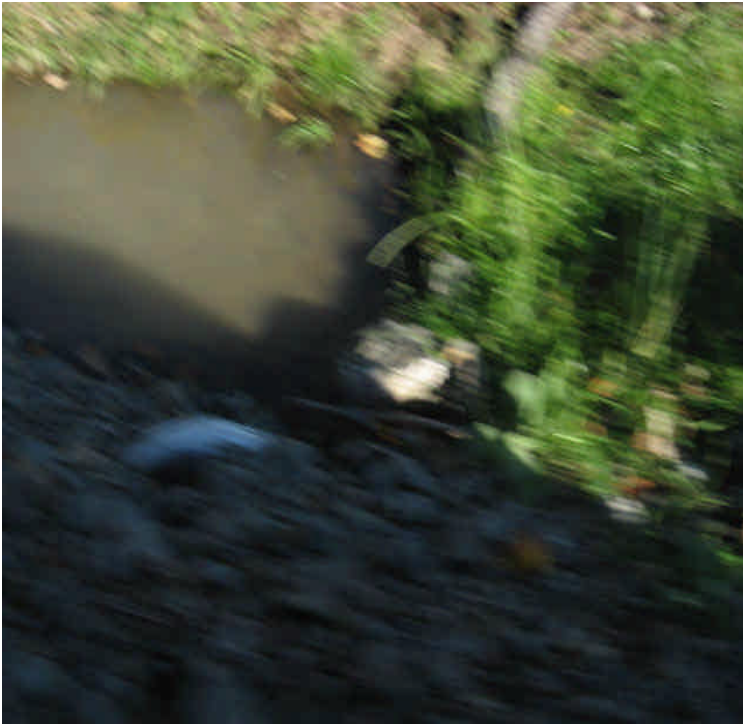
Scovill SS to Rte. 9 Rte. 9 to East Mount Rd.	Sediment from access road run-off noted at one culverted crossing off Shumpike. 10/29/07	Add controls along the access road as needed above wetlands. 10/29/07	Needs attention.
Oxbow Junction to Beseck SS	Access roads and pads are in place along the	Continue to add controls where needed, i.e. mulch,	NA

Shumpike Rd.: Turbid water noted at a culvert under the access road. Run-off from the sloped access road is resulting in the turbid water.

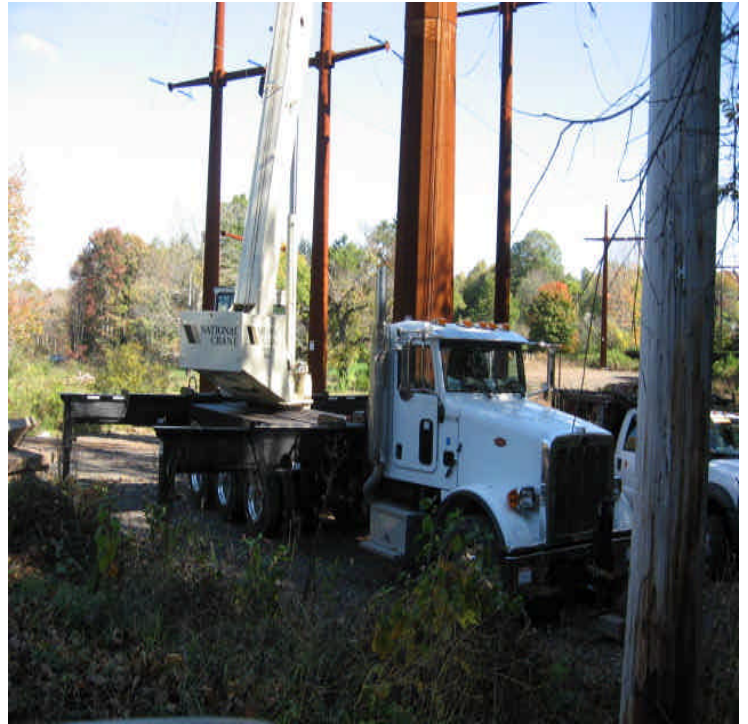
Oxbow Jct: Line work underway. Area is stable.

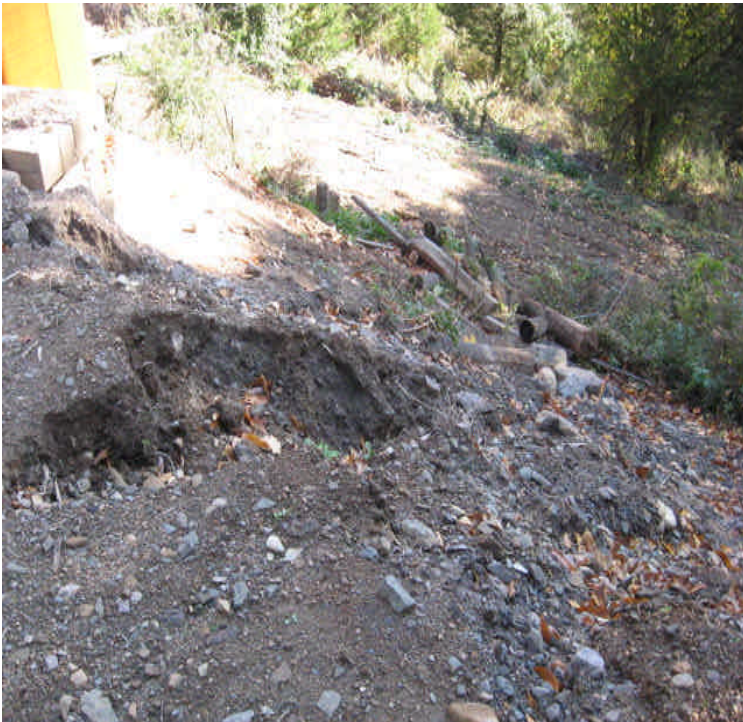
Black Walnut Dr: Ruts and erosion noted along a steep slope on the last pad site upgradient from Ball Brook. Regrade and stabilize; consider adding an erosion control blanket due to the grade.

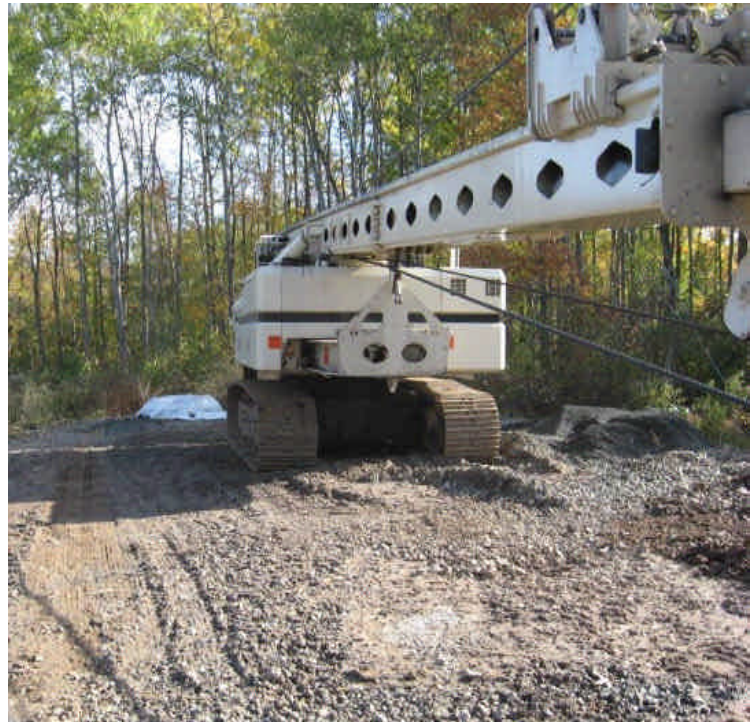
South of E. Main St.: Foundation installation is complete. Controls are needed as a large disturbed area is present upgradient from wetlands. Equipment is also parked upgradient from wetlands.

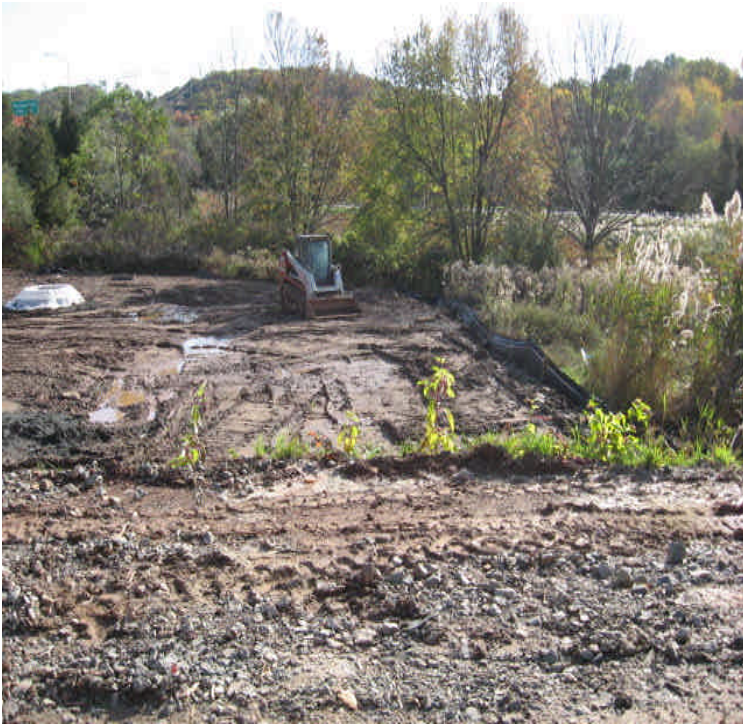
North of E. Main St: Foundation drilling is complete. Controls are in place. Continue to monitor carefully. Stabilize and restore disturbed areas as soon as possible, especially adjacent to the wetlands.

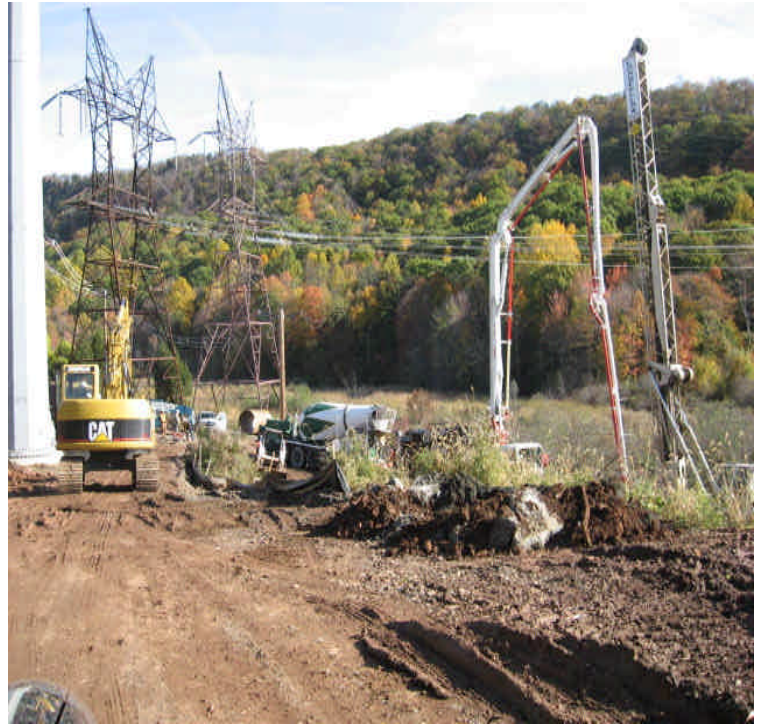
Black Pond Jct: Foundation installation underway. Pump truck and settling tanks were used for dewatering

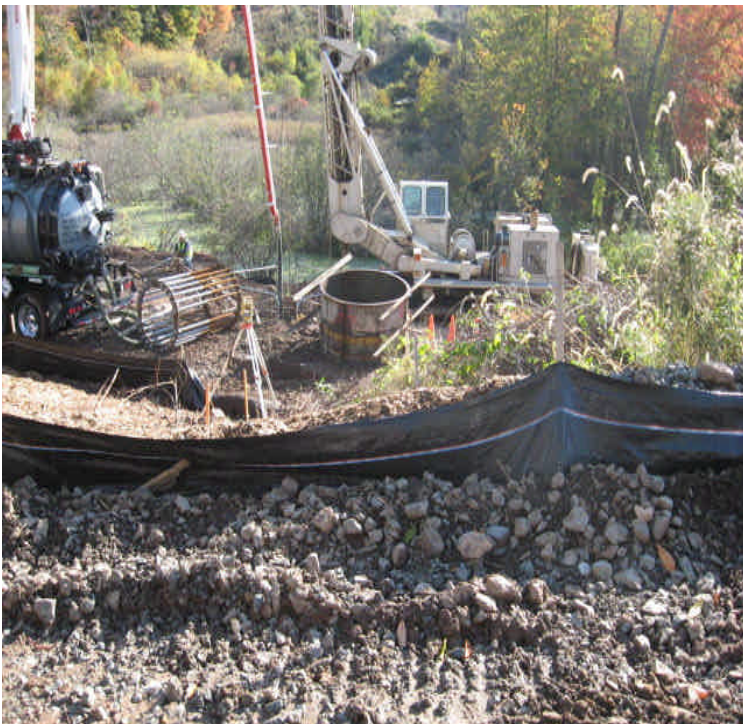
Black Pond Jct: Foundation installation is underway. Crews were pumping slurry into a settling tank onsite. Controls are in place. Continue to monitor carefully due to wetlands in the area.

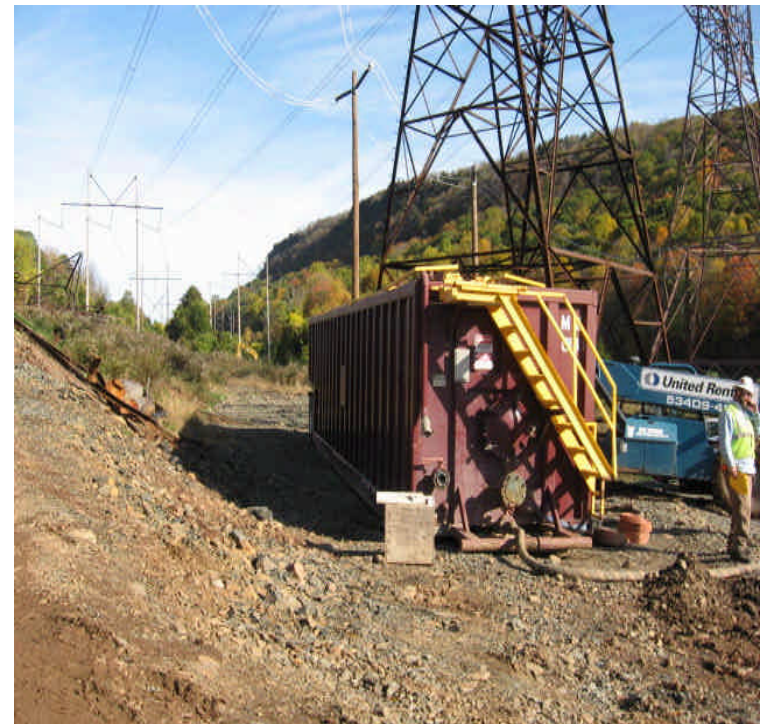
Black Pond Jct: Settling tanks were brought to the site for foundation installation and associated dewatering
