Docket No. 272 – Development and Management Plan Inspection

Segment 1a Inspection

Date: November 12, 2007

Location: Segment 1a – Scovill Rock Switching Station to Chestnut Junction, Oxbow Junction to Beseck Switching Station (excluding Royal Oak Bypass), and Black Pond Junction to Beseck Switching Station

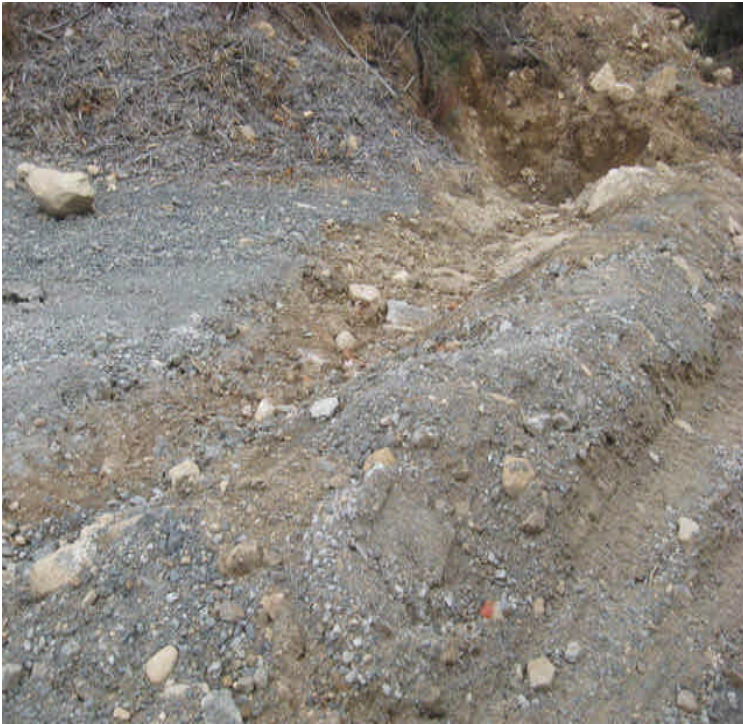
East of Rte. 9: Drainage ditches were installed along the access road. Ensure that run-off is directed to stabilized/vegetated areas and that the swale itself is stable.

Scovill SS to Rte. 9 Rte. 9 to East Mount Rd.	Water bars/drainage ditches are in place along the access road slope East of Rt 9. 11/12/07	Monitor for effectiveness of the diversions and add fiber rolls or controls along the access road as needed upgradient from wetland crossings. 11/12/07	NA at this time

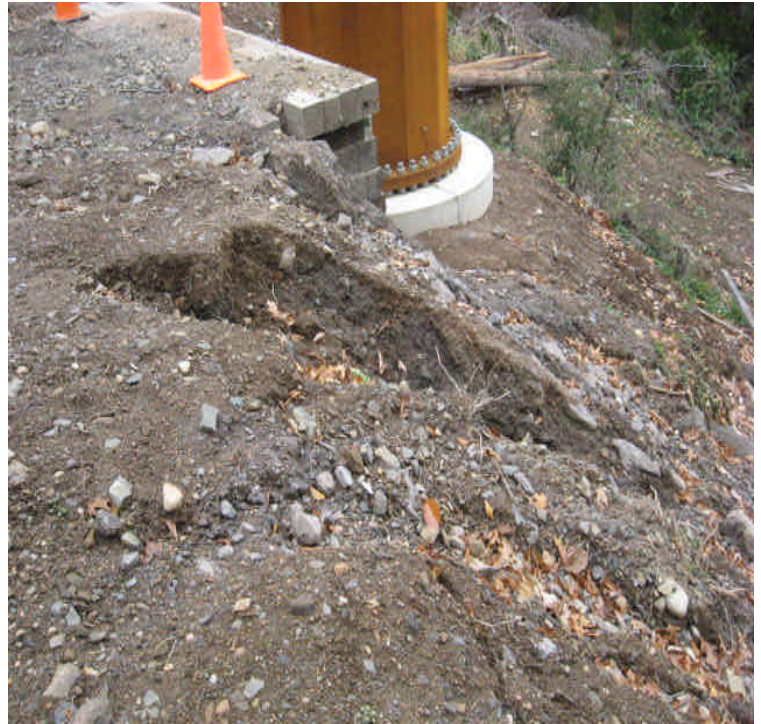
Black Walnut Dr: Ruts and erosion noted along a steep slope on the last pad site upgradient from Ball Brook. Regrade and stabilize; consider adding an erosion control blanket due to the slope grade.

Areas of Inspection	Observation	Recommended Action	Corrected Action
Black Walnut Dr.	An eroded washout was noted on the steep slope of the last pad site upgradient from Ball Brook despite past controls. 10/15-11/12/07	Adjust controls to protect the resource area downgradient. Consider an erosion control blanket if necessary to stabilize the slope and establish vegetative cover as soon as possible. 10/15-11/12/07	Needs attention
Contractor Receiving Yard and Storage Area	Silt fence and fiber rolls are in place at the perimeter of the yard and drainage areas/swales but several areas need repair. 4/23-11/12/07	Continue to add, maintain, and monitor controls as necessary. Repair deteriorating controls. 4/23-11/12/07	Needs repair when feasible. Existing vegetation helps contain/filter the area.
South of Contractor Yard Along Rte. 17 and Little Lane	Silt fence typically filters turbid run-off here before it leaves site. Timber mats are in place at the crossing and areas remain seeded. 11/12/07	Monitor and reinforce controls to ensure they adequately filter run-off. Monitor for stabilization. 11/12/07	NA

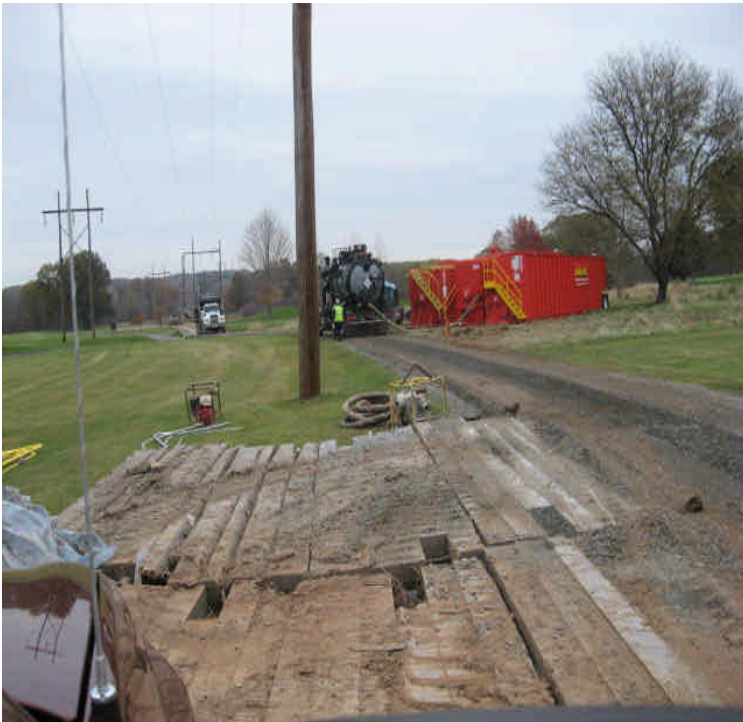
Durham Rd Golf Course: Dewatering during foundation drilling. Frac tanks were being used.

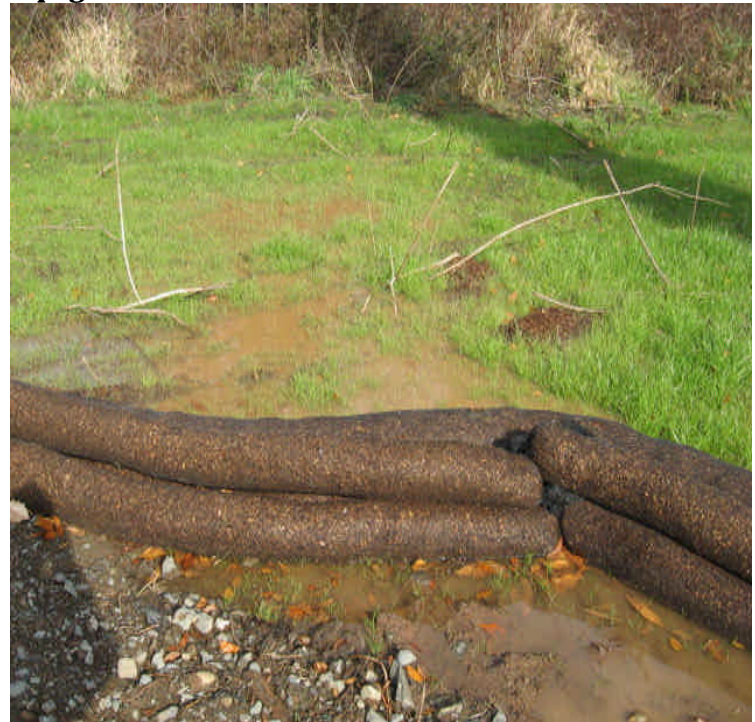
East of Besock SS: Following a rain event, turbid water was flowing from the access road and pad site, into the wetland here. Determine how to reinforce controls and make them more effective.

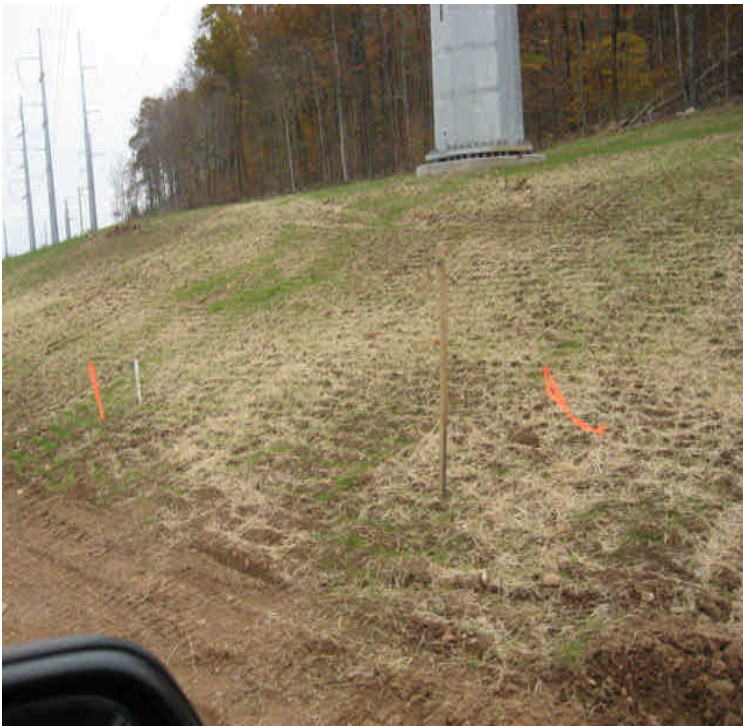
N. Beseck SS: Mulched and seeded areas located at recent pad sites are growing some grass cover. Continue to monitor into the winter for stabilization.

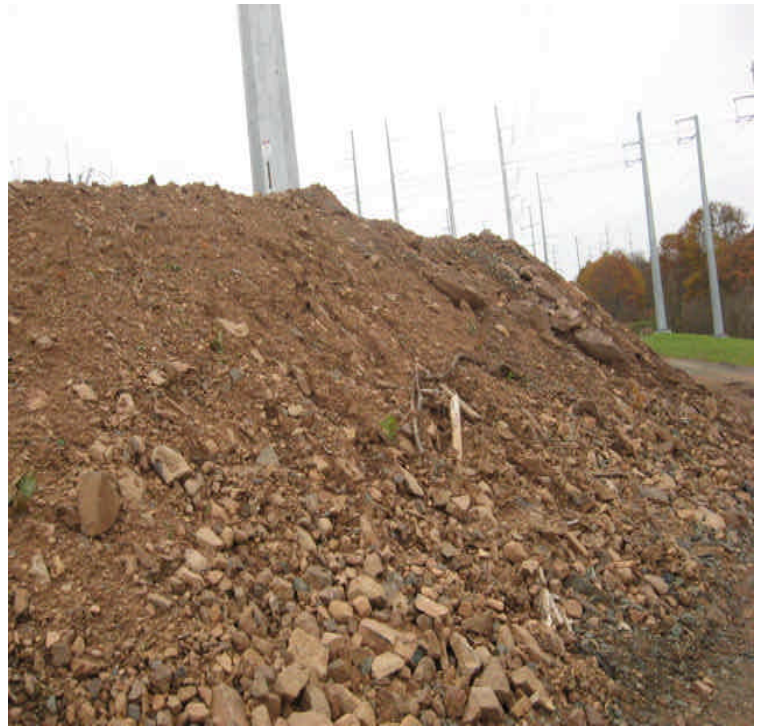
<p>South of High Hill Rd. (vicinity of East Meriden Substation)</p>	<p>The pad at structure #24462 contains a steep slope with exposed soils.</p>	<p>Stabilize the slope with seed/mulch and add controls as necessary to</p>	<p>Needs attention.</p>

East Meriden SS: The steeply sloped edge of a pad site needs controls/stabilization.

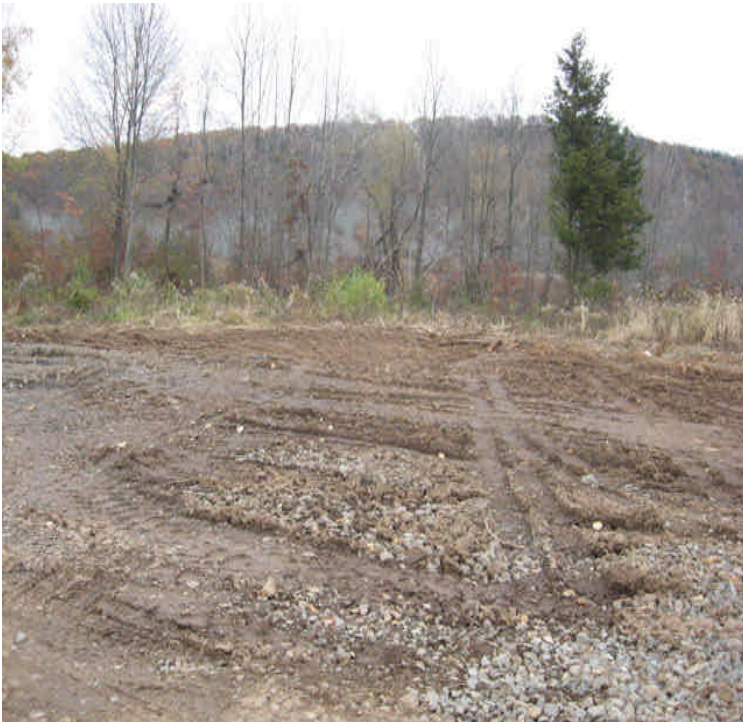
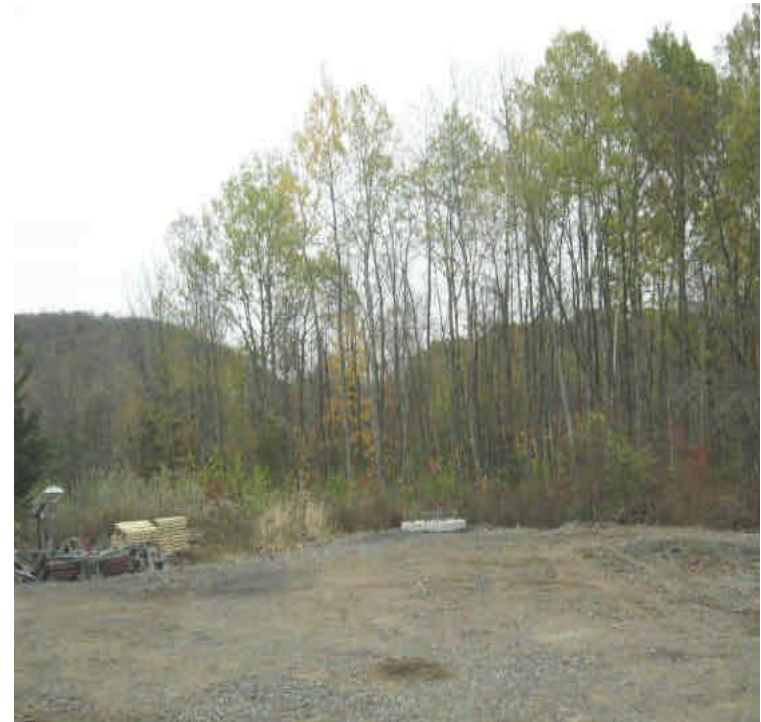
South of East Main St: (Both photos) Large, disturbed soil area located upgradient from wetlands. Controls are needed here. Grade, remove stone, and temporarily stabilize the soils if work will not return in 21 days.
