**Docket No. 272 – Development and Management Plan Inspection**

**Segment 1a Inspection**

**Date:** November 19, 2007

**Location:** Segment 1a – Scovill Rock Switching Station to Chestnut Junction, Oxbow Junction to Beseck Switching Station (excluding Royal Oak Bypass), and Black Pond Junction to Beseck Switching Station

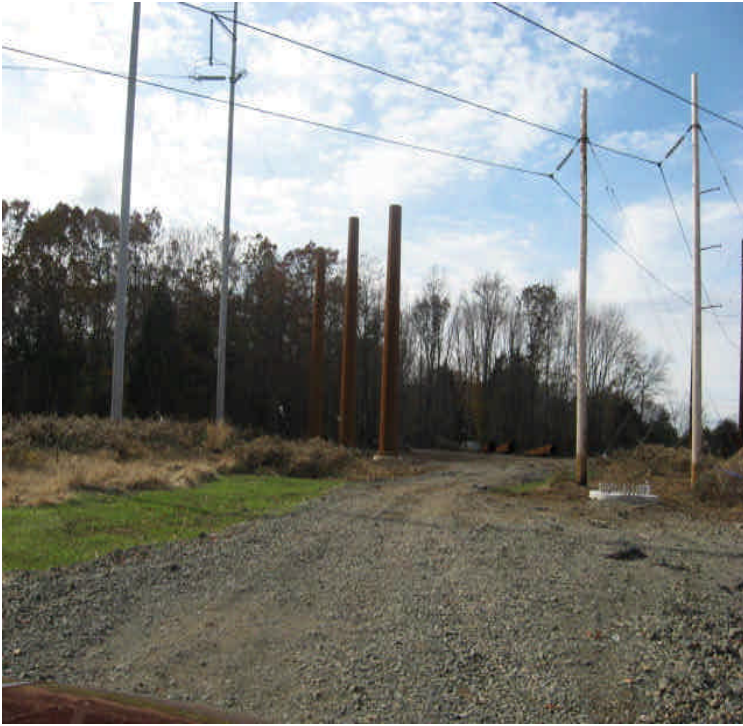
**Oxbow Jct: Partially completed structures waiting for final line transfer.**

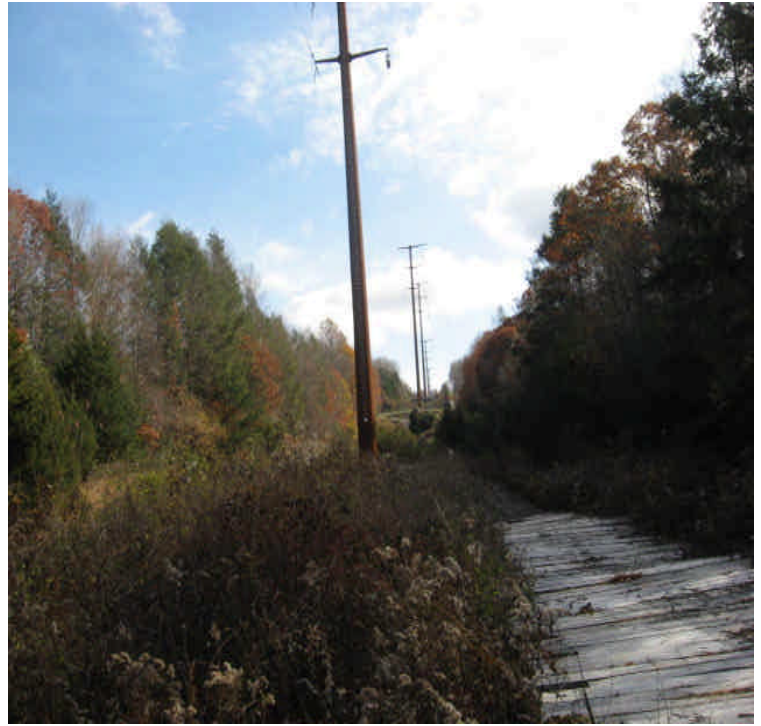
**Haddam Quarter Rd: Timber mat crossing. Vegetated cover has established and stabilized the adjacent wetlands.**

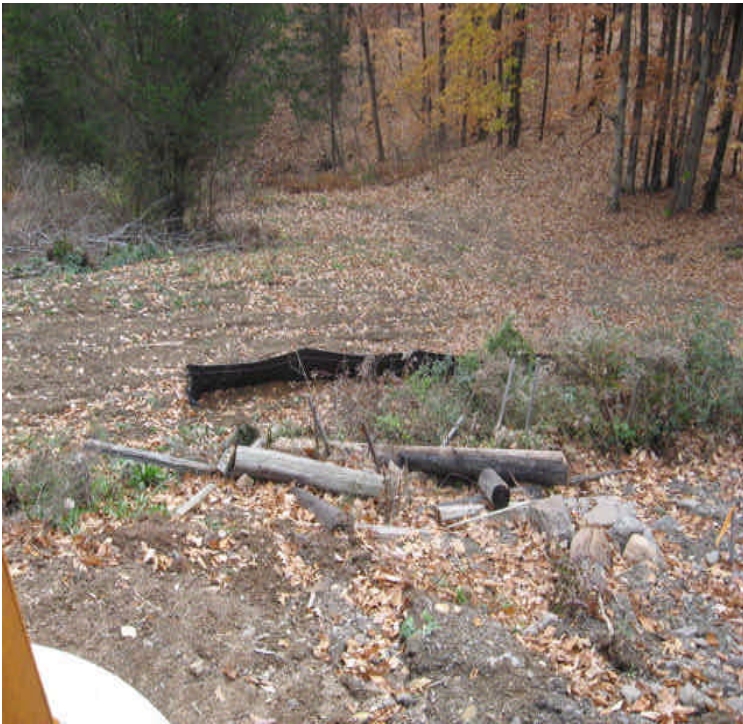
**Black Walnut Dr: Silt fence installed upgradient from Ball Brook at the base of the washouts. Monitor silt fence but ultimately address the problem at the source. Repair the gullies and re-stabilize the slope, especially as work activities are not returning.**

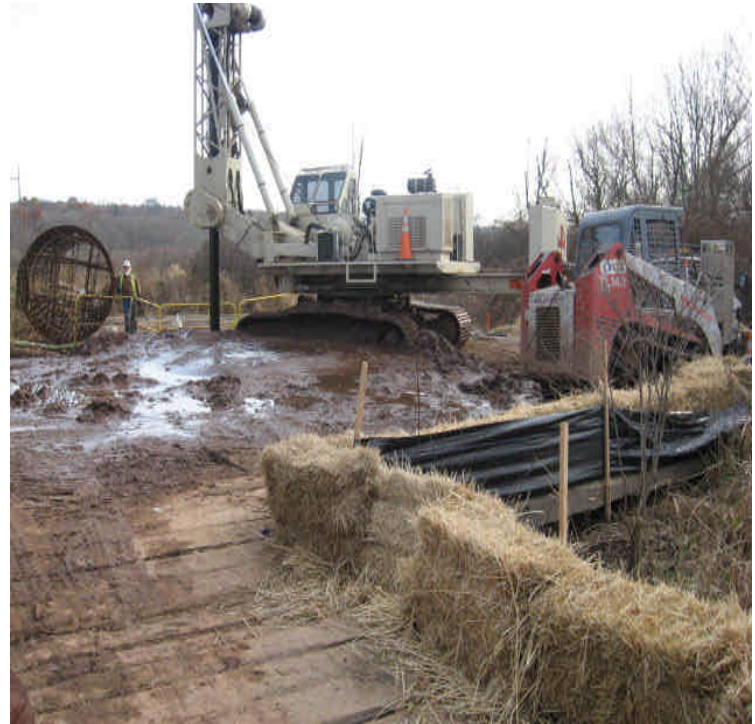
**Durham Rd Golf Course: Sediment pile noted on timber mats from foundation drilling. Controls are in place and should be monitored.**

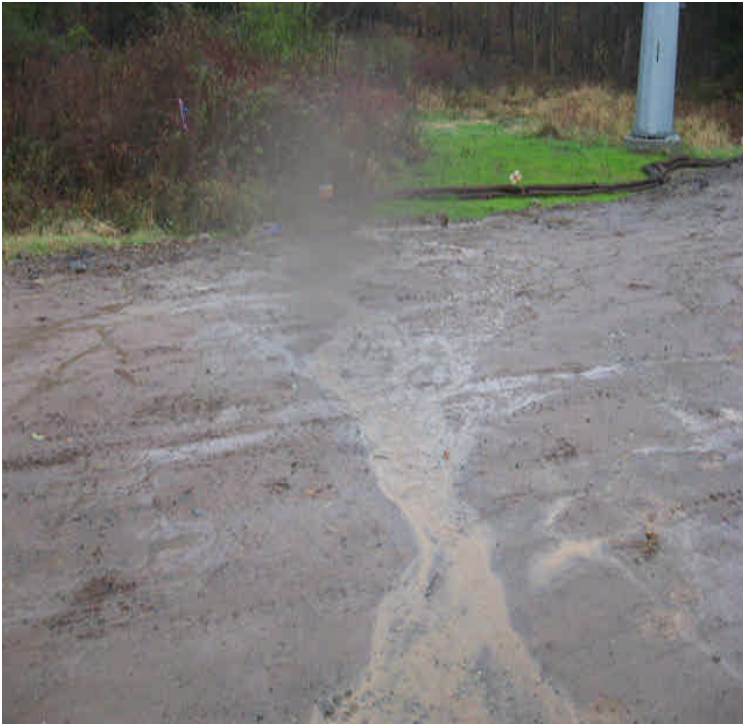
**N.E. Beseck SS: Turbid water flowing into wetlands from the access road. Reinforce controls as needed.**

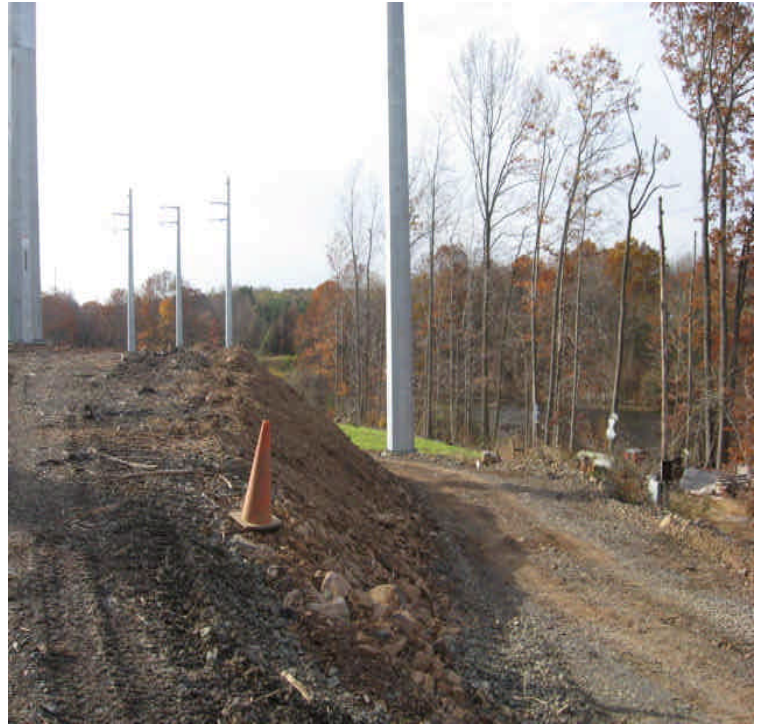
**East Meriden SS: The steeply sloped edge of a pad site in this area has been mulched.**

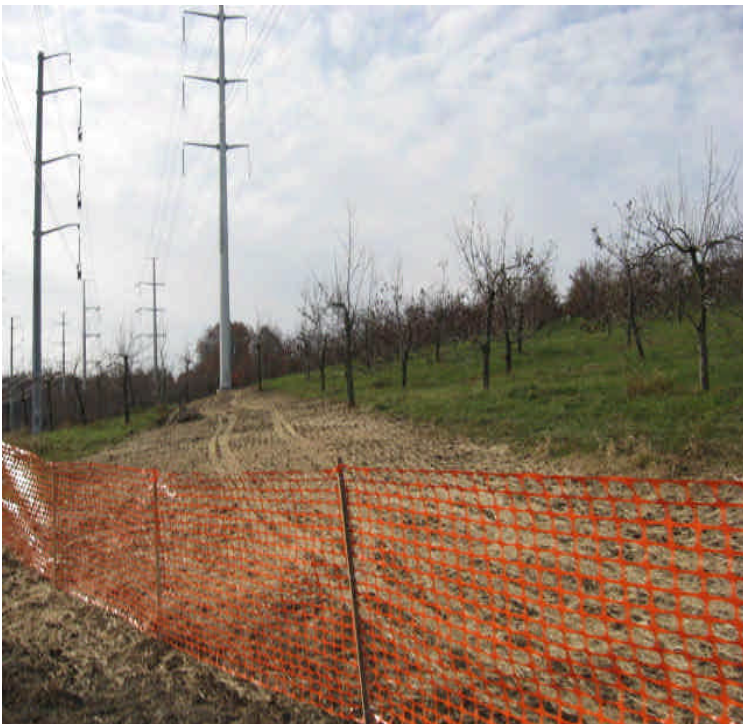
**East Meriden SS: Several exposed areas have been mulched and seeded and cordoned off from vehicle access.**

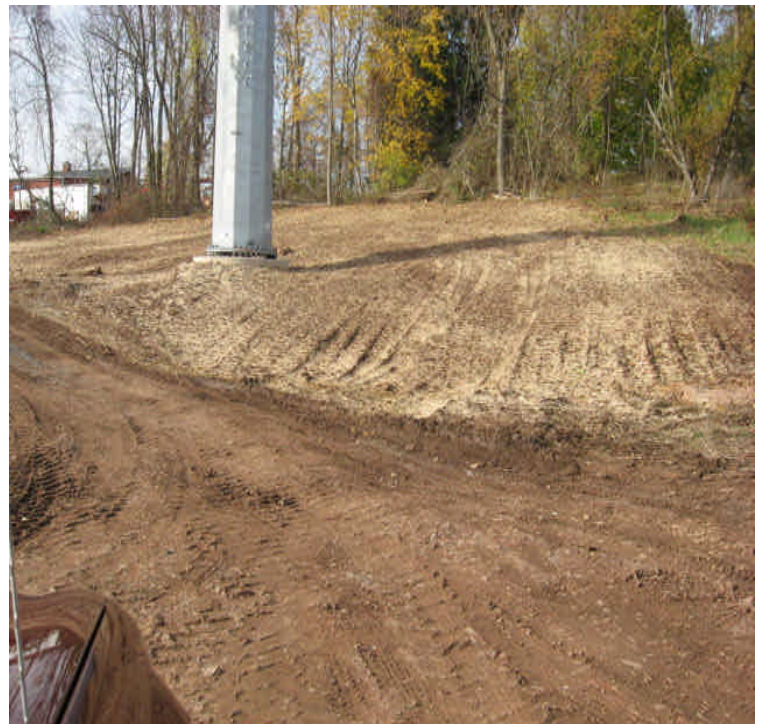
**North of East Main St: Exposed area located upgradient from the wetlands has been mulched and seeded. Monitor to ensure that the amount of mulch cover is appropriate for stabilization throughout the winter.**
