Docket No. 272 – Development and Management Plan Inspection

Segment 1a Inspection

Date: November 26, 2007

Location: Segment 1a – Scovill Rock Switching Station to Chestnut Junction, Oxbow Junction to Beseck Switching Station (excluding Royal Oak Bypass), and Black Pond Junction to Beseck Switching Station

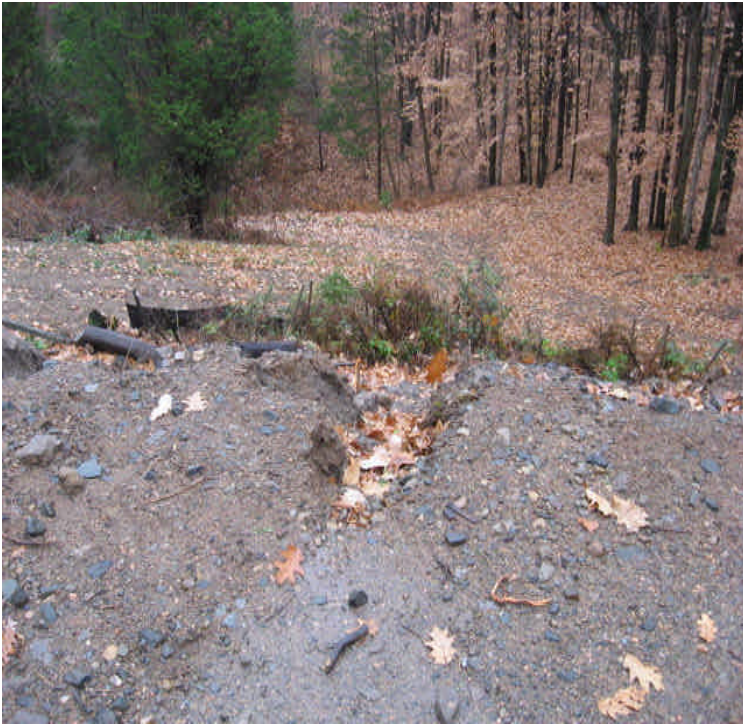
Areas of Inspection	Observation	Recommended Action	Corrected Action
Street	water as it leaves the site, including at the turn onto the ROW and along the pond. 11/26/07	controls as needed upgradient from wetlands. 11/26/07	
Black Walnut Dr.	An eroded washout was noted (since 10/15) on the steep slope of the last pad site upgradient from Ball Brook despite past controls. Silt fence was added down slope (on 11/19) to prevent sediment from reaching wetlands but the source is not controlled. 11/26/07	Consider an erosion control blanket if necessary to stabilize the slope. 10/15-11/19/07 Monitor controls for effectiveness but address the erosion at the source and stabilize for the winter. 11/19-11/26/07	Silt fence was added but the washout itself should be addressed.
Contractor Receiving Yard and Storage Area	Silt fence and fiber rolls are in place at the perimeter of the yard and drainage areas/swales but several areas need repair. 4/23-11/26/07	Continue to add, maintain, and monitor controls as necessary. Repair deteriorating controls. 4/23-11/26/07	Needs repair when feasible. Existing vegetation helps contain/filter the area.

Black Walnut Dr: Silt fence remains in place upgradient from Ball Brook at the base of the washouts. Monitor silt fence but address the problem at the source. Repair the gullies and re-stabilize the slope, especially as work activities are not returning

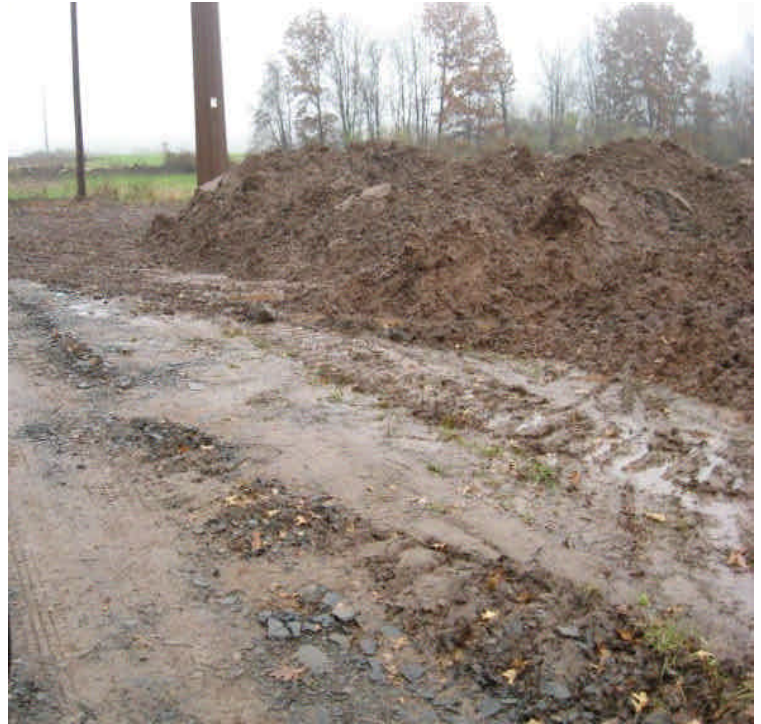
Little Lane	Stockpiles from other sites were being stored here. 11/26/07	Add controls if soil is to remain here. 11/26/07	Needs attention if soil remains.
Black Pond Junction to Beseck SS	Some equipment and supplies are being stored here. A large spill kit is stored onsite. 11/26/07	Always store equipment and supplies away from sensitive areas. Monitor and maintain equipment as needed and provide housekeeping on a regular basis. 11/26/07	NA at this time
Additional Observations	None. 11/26/07	None. 11/26/07	NA

Little Lane: Stockpiles from other sites are being stored in the uplands. A slurry pit has been filled in. Add controls as needed around the stockpile if it is to remain.

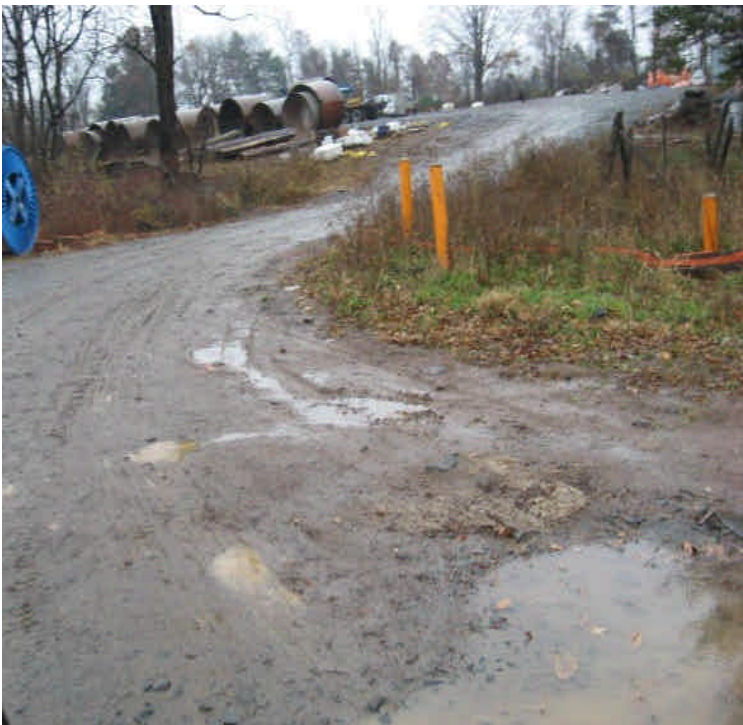
Contractor Receiving Yard: Deteriorated controls remain along the access drive, upgradient from the wetland.

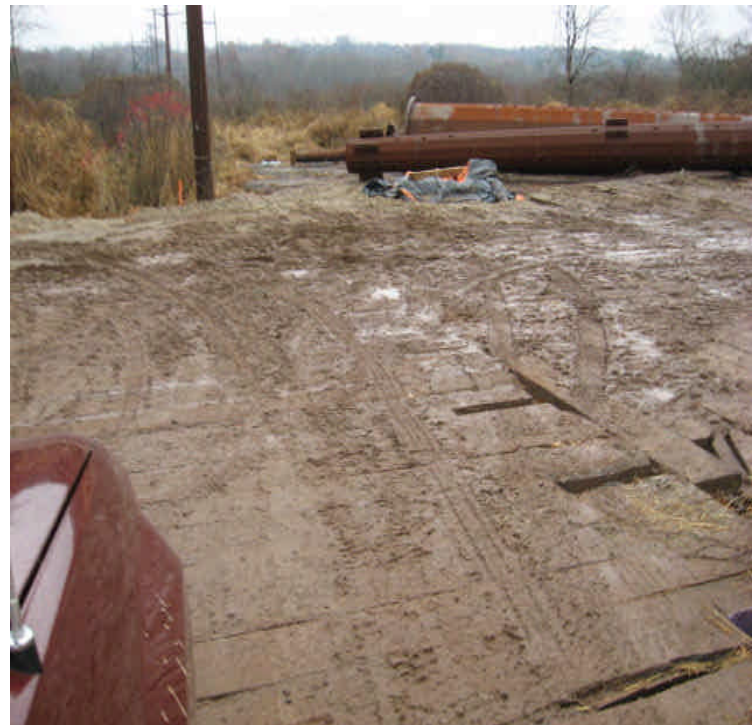
Durham Rd Golf Course: Foundation drilling complete. Sediment from the drilling has been removed from the timber mats.

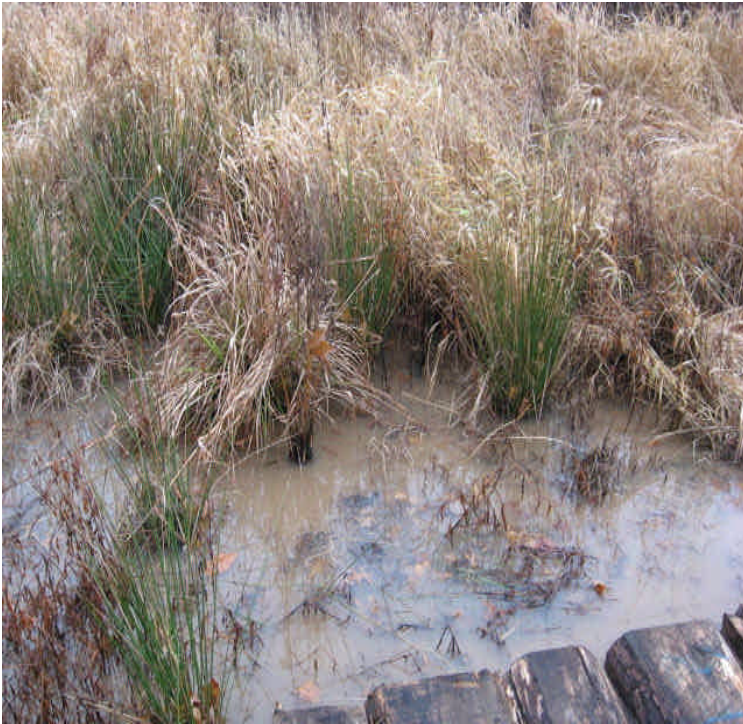
Areas of Inspection	Observation	Recommended Action	Corrected Action
Powder Hill Rd.	<p>Foundation installation at the edge of wetlands is complete within the golf course. The sediment pile was removed from the timber mats. Controls remain around the pad but turbid run-off is entering the wetlands from the access road. 11/26/07</p> <p>Several smaller streams remain culverted. Some accumulated sediment from past heavy rains has been noted in wetland areas however, vegetation was noted growing on top of the sediment. 11/26/07</p>	<p>Monitor this area closely and continue to add controls as needed. See access roads section. 11/26/07</p> <p>All crossings are temporary and will require restoration at the end of the work. Where exposed sediment is greater than 2", it should be removed carefully by hand from the wetland. 11/26/07</p>	<p>Needs attention.</p> <p>Needs evaluation/attention when access is complete.</p>

Durham Rd Golf Course: Turbid water was flowing into wetlands from the access road.

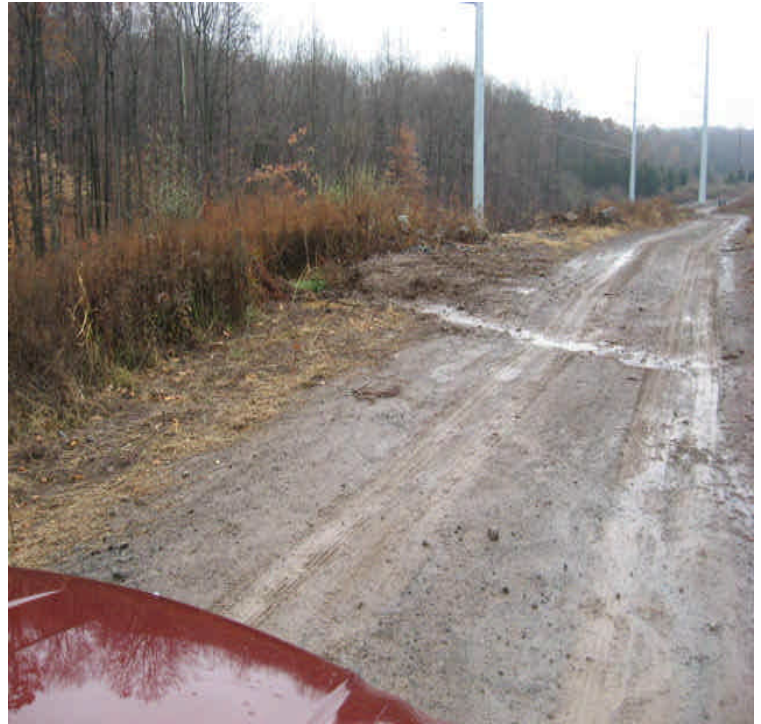
Beseck SS: Water bars have been installed to divert stormwater to stable areas.

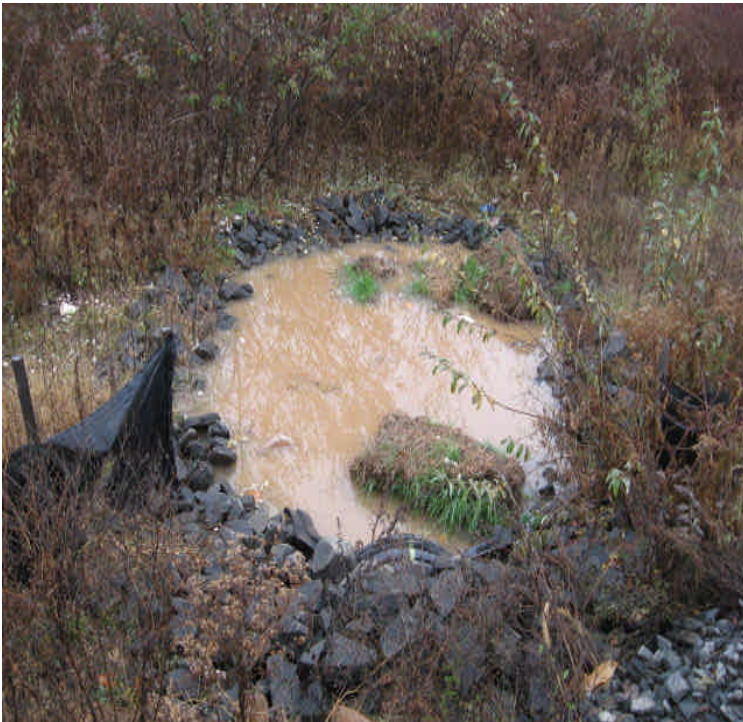
East of Beseck SS	<p>Turbid run-off from the pad and access road was noted under and beyond the fiber roll controls and within the wetland here. 11/12-11/26/07</p> <p>Silt fence was added near the riprap trap (11/19) but was not able to keep turbid water out of the wetland. 11/19-11/26/07</p>	<p>Either repair/reinforce controls north along the access road or determine how to make the controls at the wetland effective. Consider adding stone to the portion of access road adjacent to wetlands. 11/12-11/26/07</p>	<p>Silt fence was added but the area still Needs attention.</p>
West of Beseck SS	<p>New water bars have been installed along the slope of the access road to redirect stormwater. 11/26/07</p>	<p>Continue to monitor. Wetlands are still receiving turbid run-off from other areas. 11/26/07</p>	<p>Water bars added to the access road.</p>
Black Pond Junction to Beseck SS	<p>The area west of Beseck SS remains mulched and seeded. 11/26/07</p>	<p>Continue to monitor until final stabilization is achieved. Adjust controls as necessary. 11/26/07</p>	<p>NA at this time.</p>

Beseck SS: Turbid water from the access road was overflowing from the sediment trap. Wetlands are located to the east.

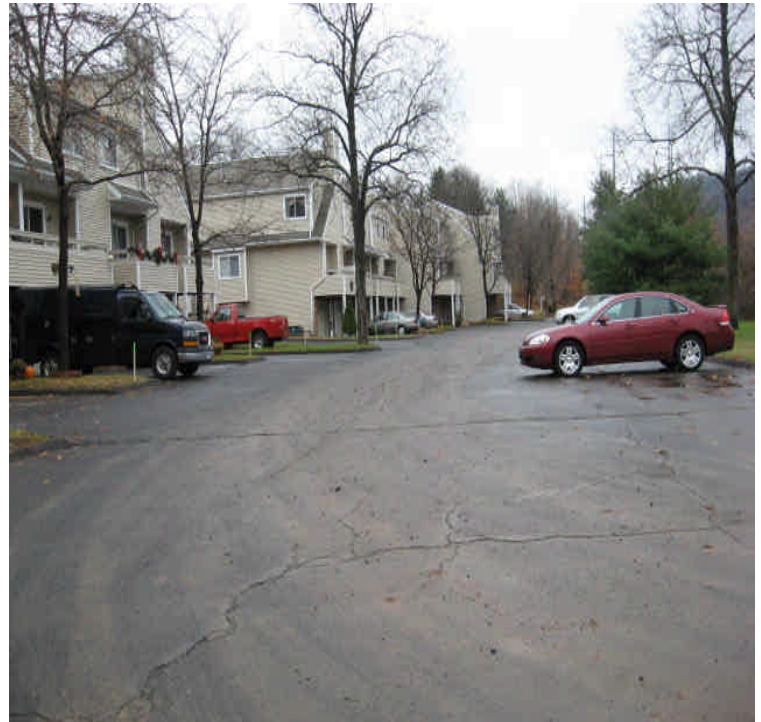
South of East Main St: Minor sediment tracking noted within the parking lot. Sweep as needed.
