**Docket No. 272 – Development and Management Plan Inspection**

**Segment 2a Inspection**

**Date:** November 6, 2007

**Location:** Segment 2a – Beseck Switching Station to Cheshire/Hamden Town Line

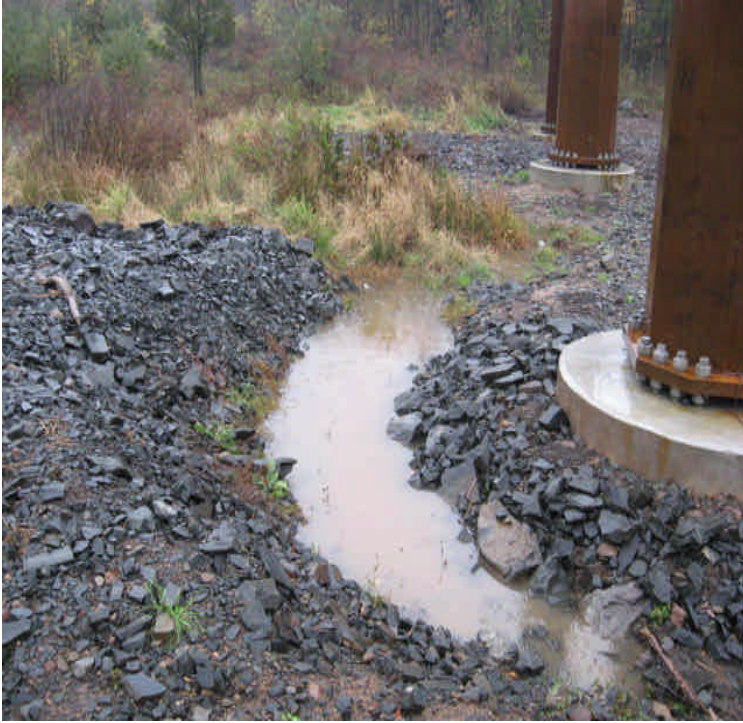
**Carpenter Ln:** Turbid water was observed within the wetlands during a rain event.

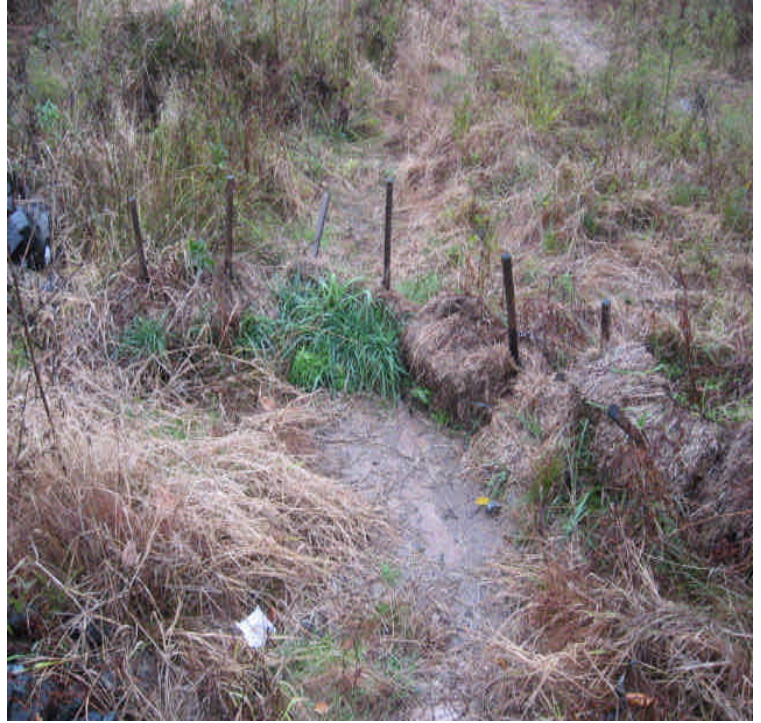
**Carpenter Ln:** Deteriorating controls and sediment accumulation was noted at the wetland outlet. This area still receives turbid run-off during rain events.

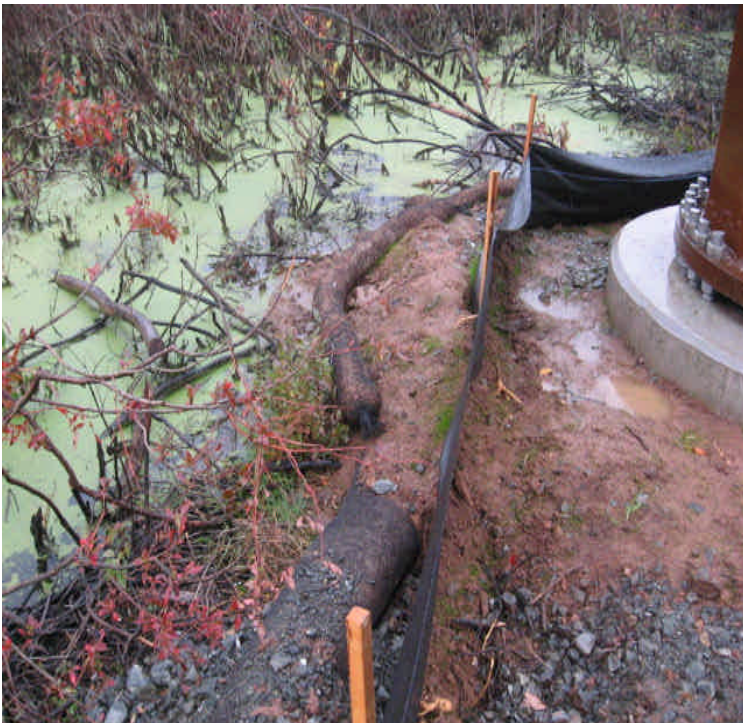
**Tamarack Swamp Rd:** The silt fence remains in place but the sediment that had been pushed beyond the original controls should be removed carefully.

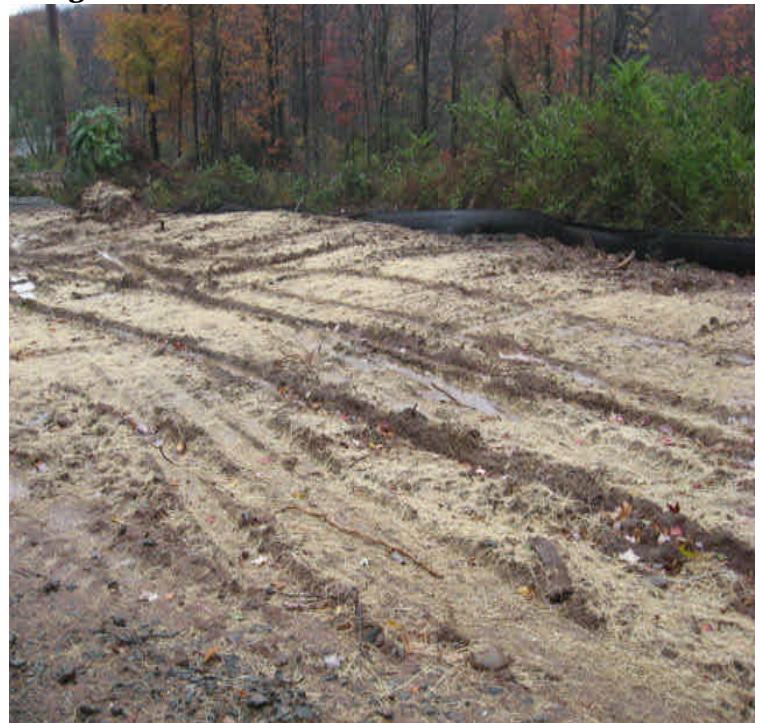
**Woodhouse Ave:** The stockpile was removed and the area remains mulched and seeded. Controls are in place and working well.

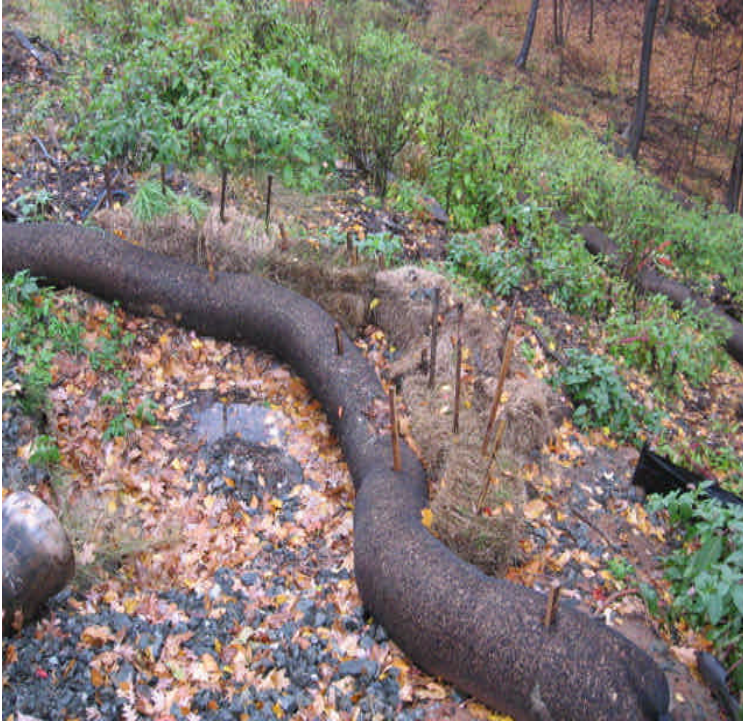
**Harrison:** Controls are in place across the eroded gully leading from the drainage basin. They are functioning well but the gully should still be repaired/restored.

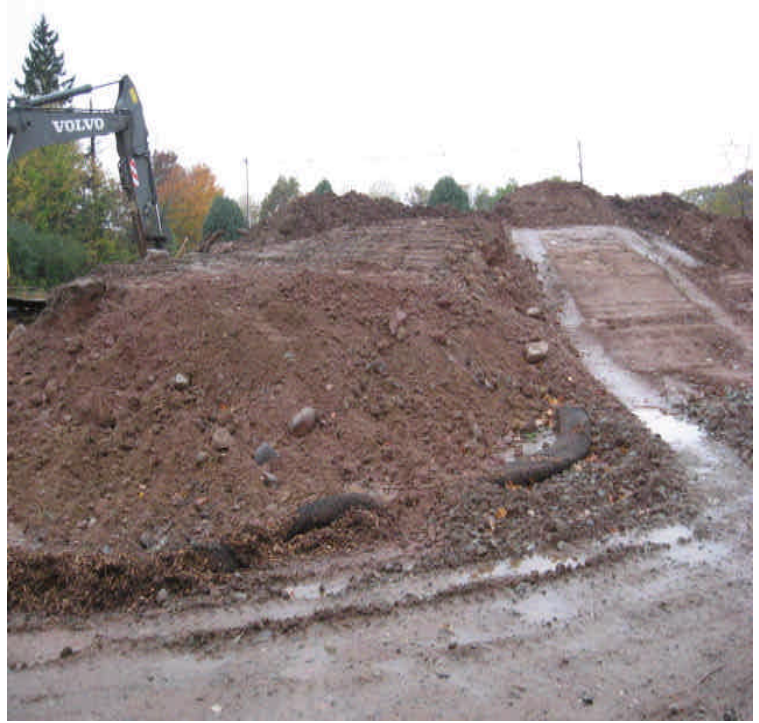
**Pond Hill Dr:** Soil stockpiles from other sites are being stored here. Controls have been overwhelmed by sediment and should be replaced or reinforced.

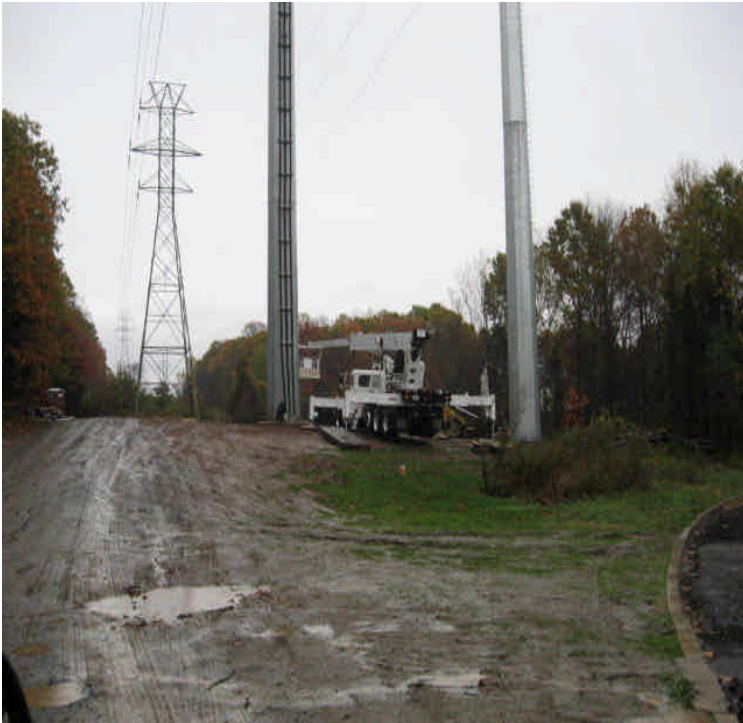
**Old Farms Road:** Turbid run-off was noted at a disturbed/exposed area during a rain event.

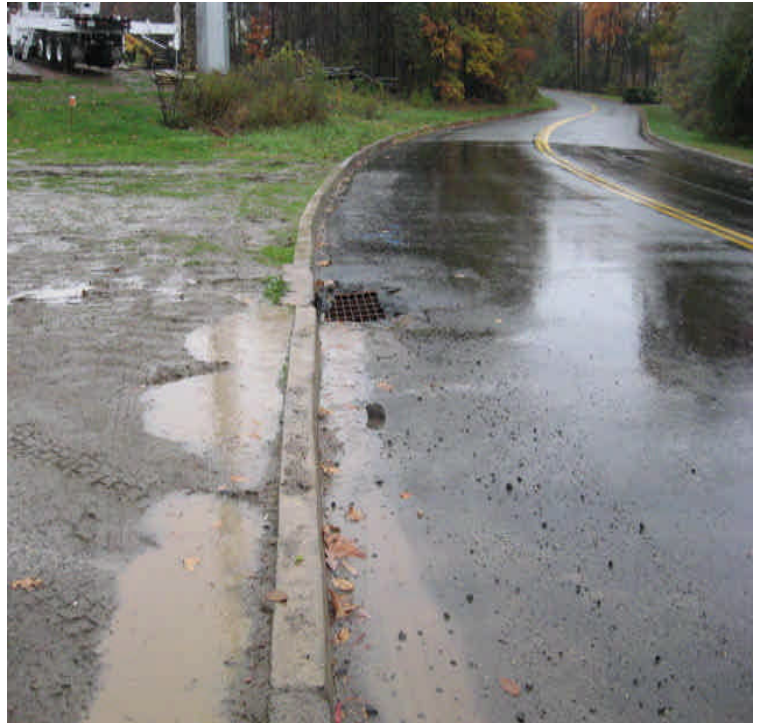
**Old Farms Rd:** Turbid run-off flowing from the ROW and into a catch basin in the roadway. This water then flows off-site into wetlands.
