Docket No. 272 – Development and Management Plan Inspection

Segment 3 Underground Line

Date: November 1, 2007

Location: East Devon Substation to the Housatonic River Crossing

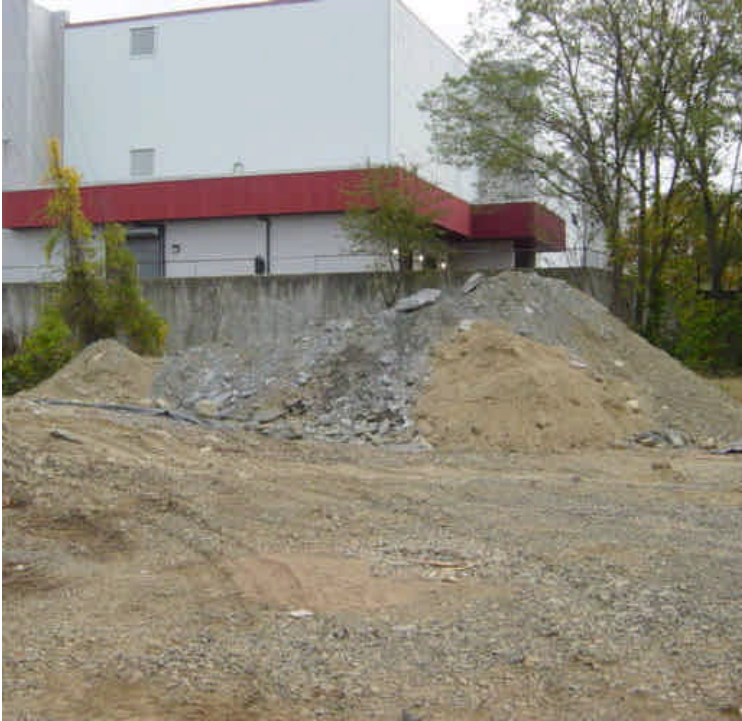
Work noted on the overhead lines along the cross country section between sta. #1051 to #1080 which overlaps the Segment 3 route. Several stockpiles were noted along the ROW, but erosion controls were not provided

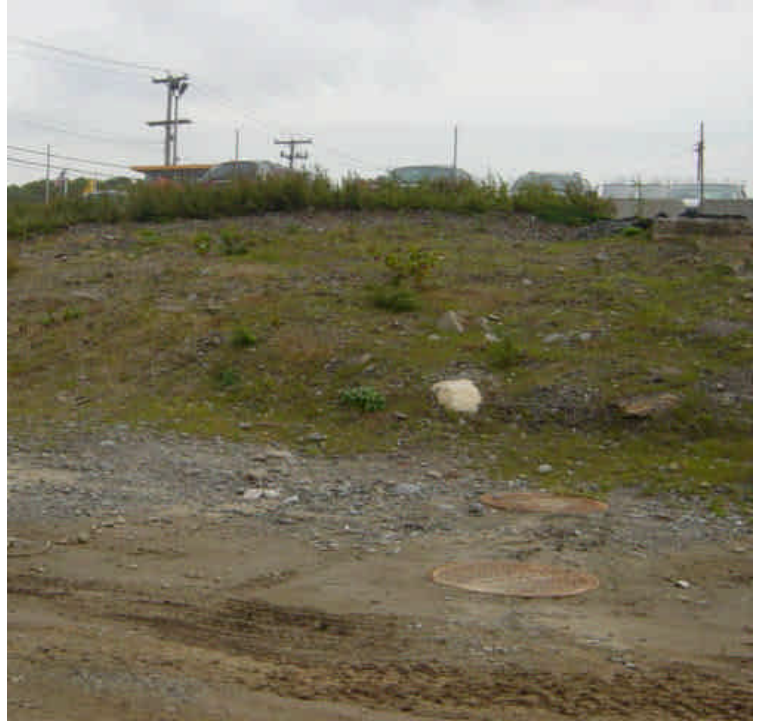
The exposed soil along the slope near sta. #1080 has re-vegetated naturally (approximately 75% coverage). The slope will be fully restored in the future. A plan is being worked out with the landowner.

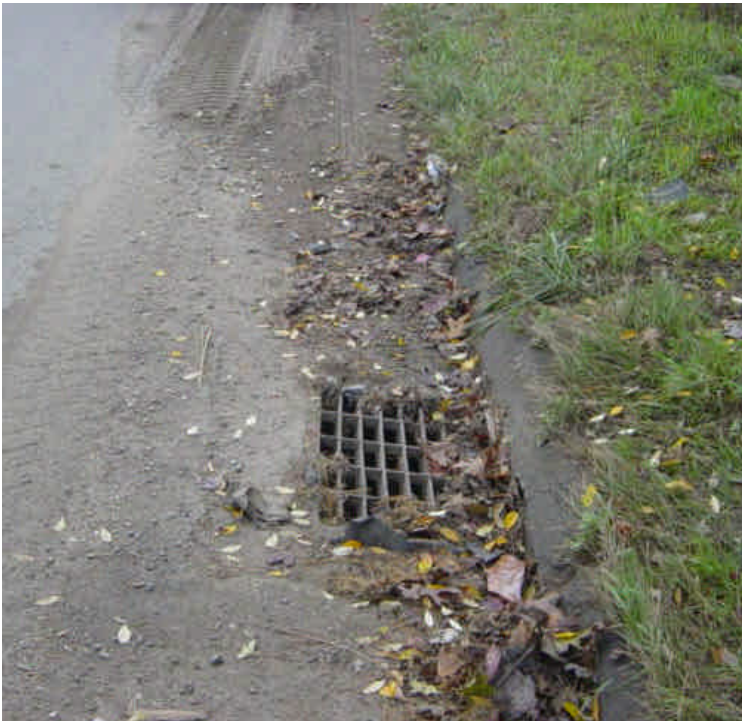
Tracking was evident along Caswell Street, but does not appear to be associated with this portion of the project. The catch basin was protected previously, but the silt sack is torn and in need of repair.

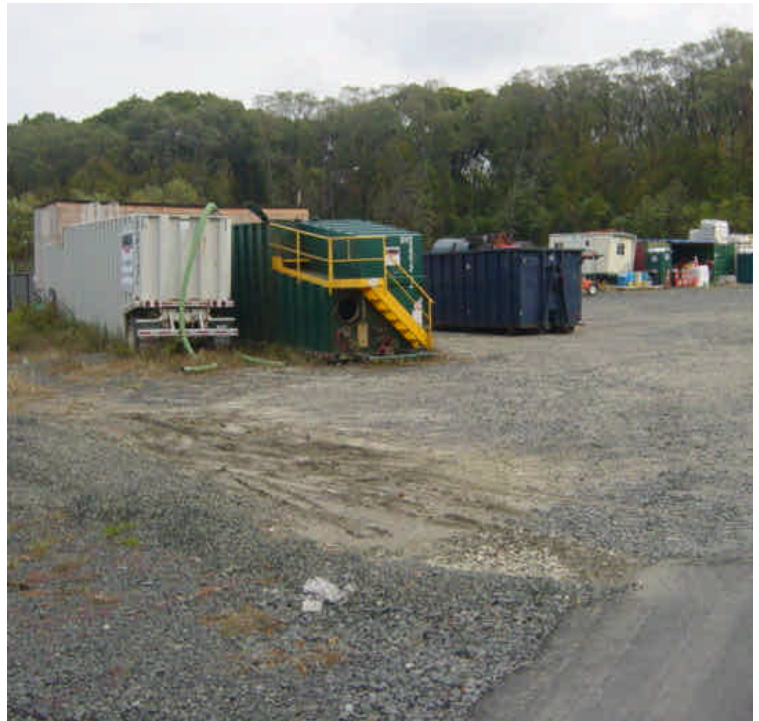
Shelland St. laydown yard remains inactive as work has shifted to other areas of the project. Perimeter controls continue to function, but require maintenance when work returns to this area.
