Docket No. 272 – Development and Management Plan Inspection

Segment 3 Underground Line

Date: November 21, 2007

Location: East Devon Substation to the Housatonic River Crossing

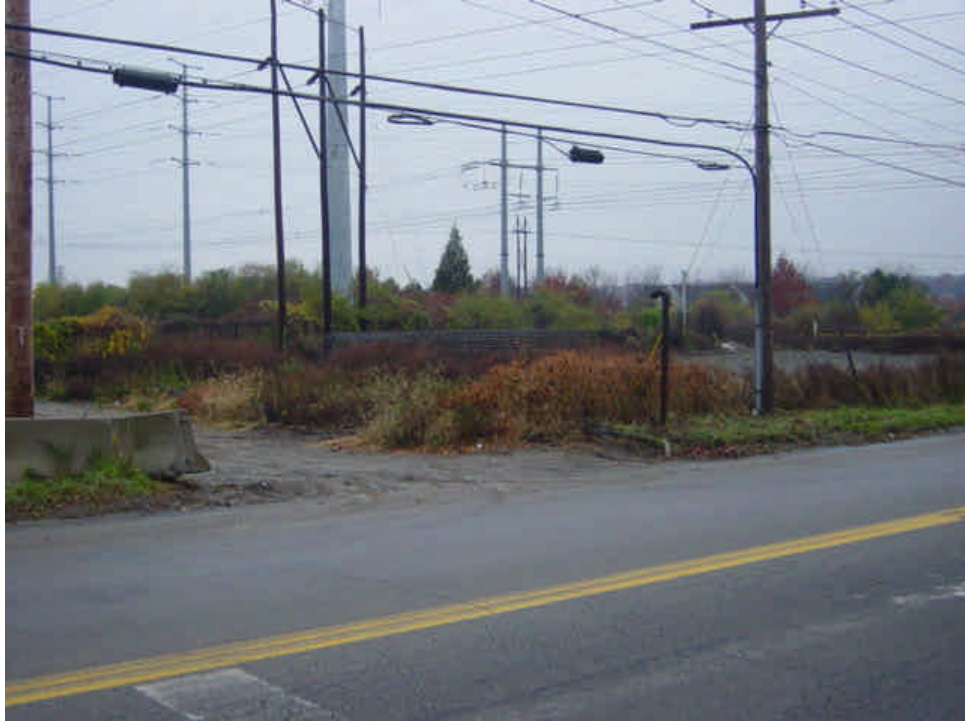
Sediment tracking continues near the entrance to the right-of-way near sta. #1080. Tracking does not appear to be associated with this portion of the project. The stone construction entrance has area has deteriorated and needs to be refreshed with new stone. This responsibility should be coordinated with overhead contractors. See the 2B report.

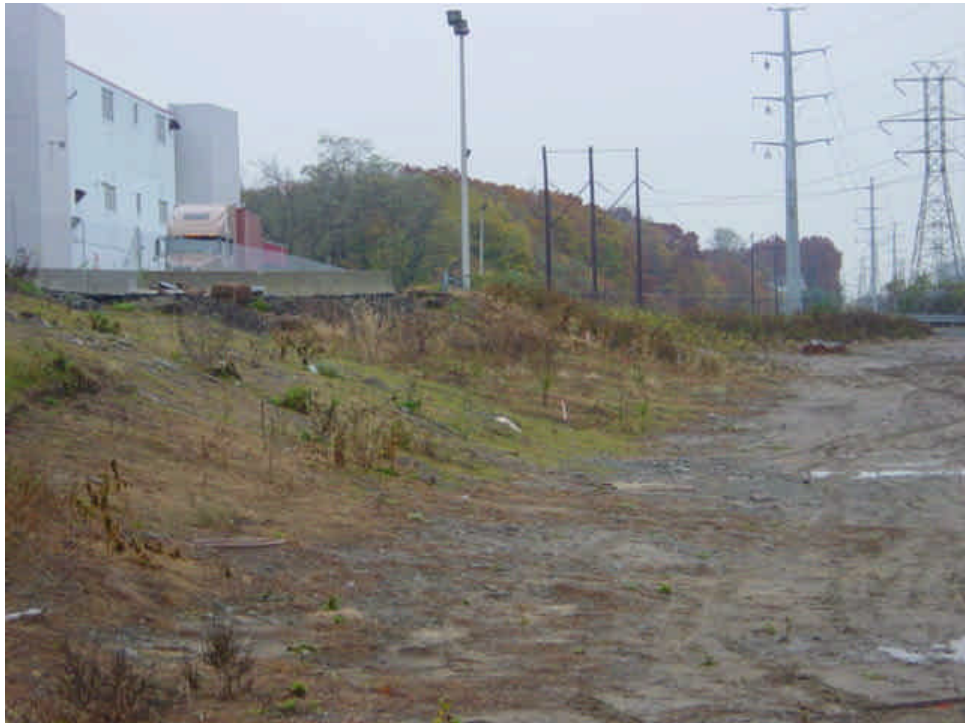
The slope near sta. #1080 is temporarily stabilized with vegetation. Final restoration is still required once an agreement is reached with the adjacent landowner.
