Docket No. 272 – Development and Management Plan Inspection

Segment 4a Underground Line

Date: November 21, 2007

Location: Singer Substation to Fairfield/Westport Town Line

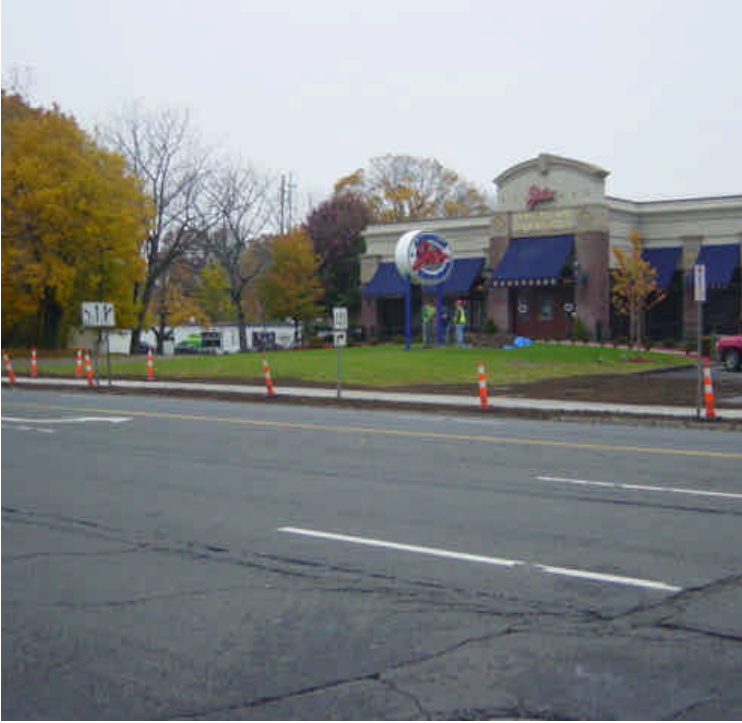
Permanent restoration work is underway near sta. #596 (vault #36) as a new sidewalk has been installed. Ensure that any landscaped areas are appropriately stabilized.

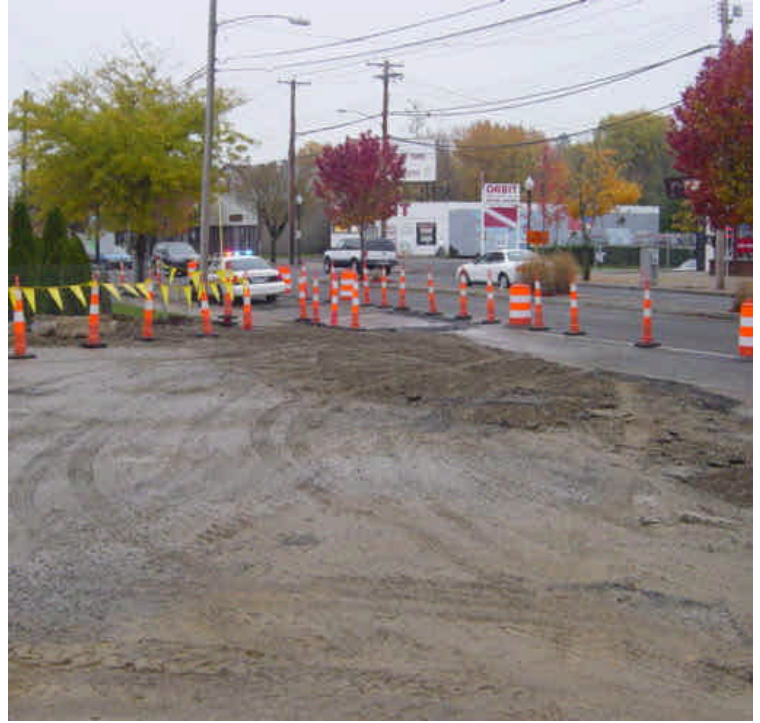
A large area of exposed soil is adjacent to the work area near sta. #649-650. Minor tracking was observed at the entrance/exit of the work area.

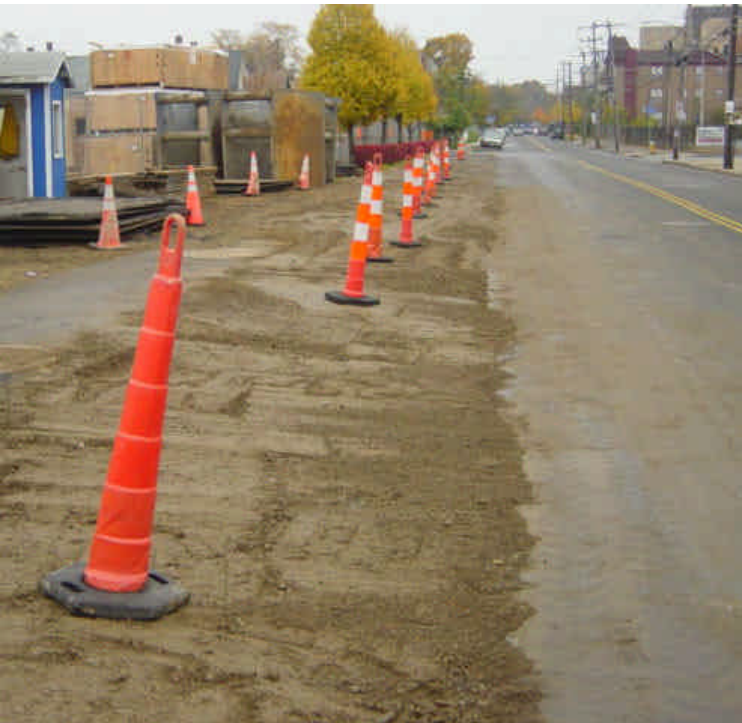
Kings Highway Lay-down Yard (Off Kings Highway, near Rt. 1 rotary)	<p>Minor sediment tracking (and potential for run-off) was observed along the shoulder of the roadway near sta. #801-803 (vault #49) where soils were recently backfilled and remain exposed. 11/21/07</p>	<p>Sweep roadway, stabilize exposed soils with hay mulch and provide restoration as soon as feasible. See soils section for more details. 11/21/07</p>	Needs attention.
Bostwick Ave. Lay-down Yard	<p>Perimeter controls remain in place. Neither sediment tracking nor dust migration were an issue this week. 11/21/07</p>	<p>Continue to monitor and maintain controls and sweep the roadway as necessary. 11/21/07</p>	No issues but needs regular attention.
	<p>Perimeter controls remain in place. Neither sediment tracking nor dust migration were an issue this week 11/21/07</p>	<p>Continue to monitor and maintain controls and sweep the roadway as necessary 11/21/07</p>	No issues but needs regular attention.

Area between sta. #801-803 has been backfilled. Exposed soils need to be stabilized. Minor sediment tracking was observed along the shoulder of the roadway.

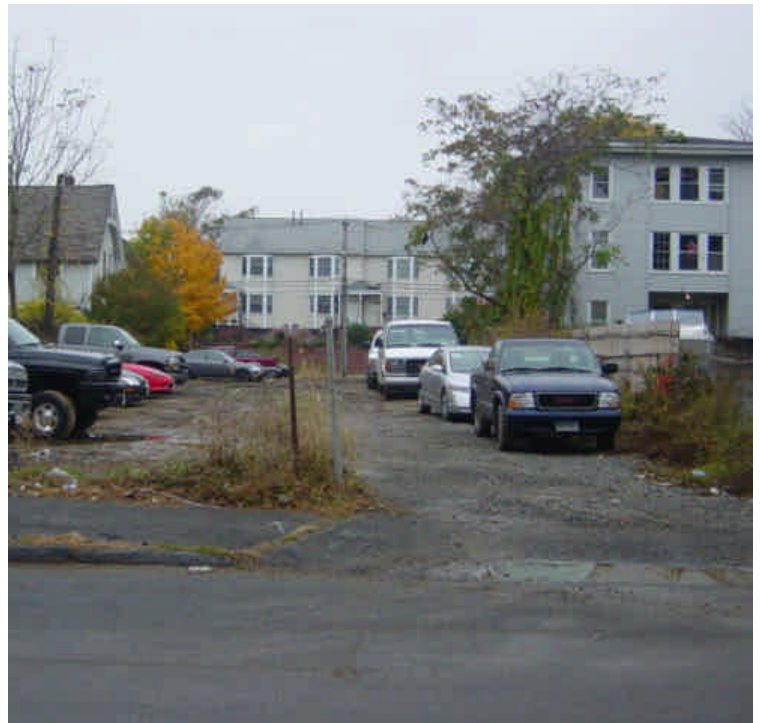
The area between Broad Street and Main Street was previously stabilized and vegetation had started to germinate but vehicles continue to park in this area, resulting in bare soil. Tracking was not observed.
