Docket No. 272 – Development and Management Plan Inspection

Segment 4b Underground Line

Date: November 1, 2007

Location: Fairfield/Westport Town Line to Westport Avenue in Norwalk

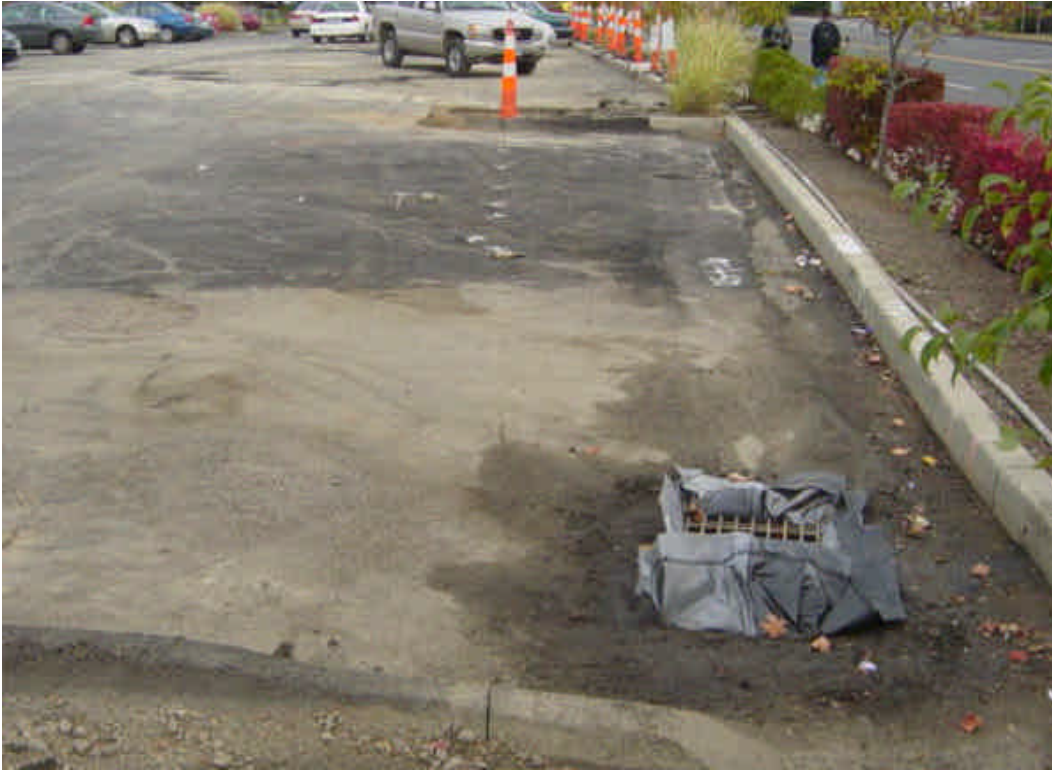
Steel plates are in place over the exposed trench near sta. #96, as tie-in work continues at vault #6. The silt sack in the catch basin has been replaced but heavy sediment remains in the parking lot area following the water ponding here last week.

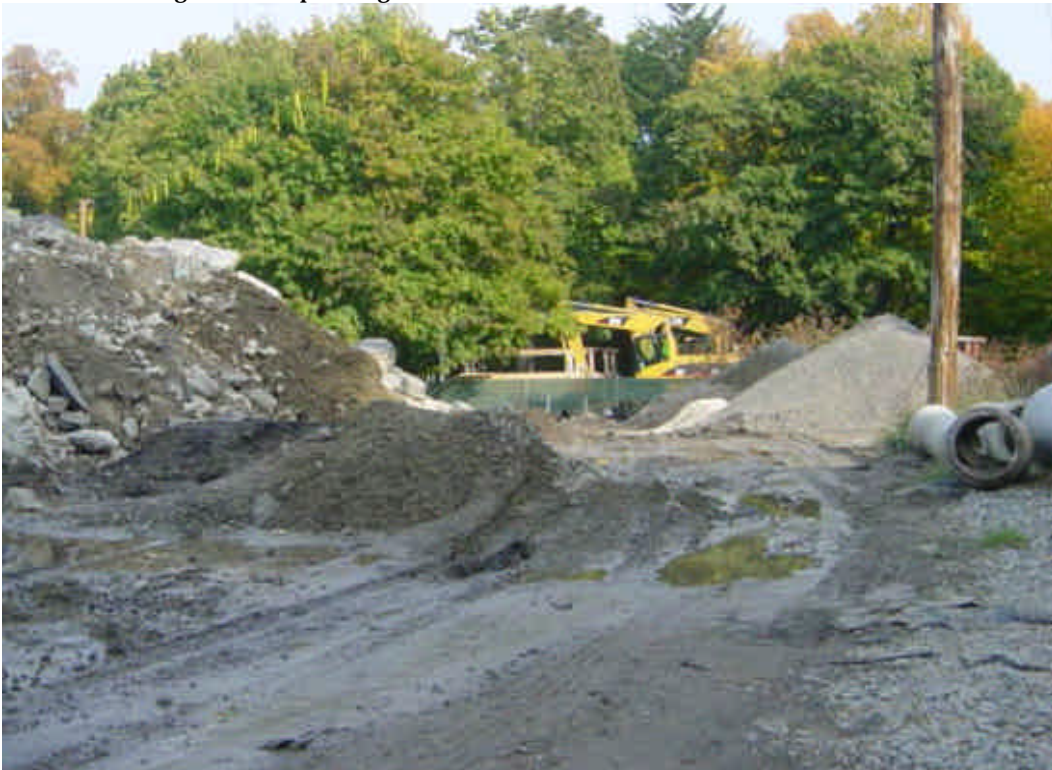
Stockpile of debris material in the Sherwood Island lay-down yard is growing very large. Saw cutting slurry was dumped near the edge of the debris pile on the access road within the yard, increasing the potential for tracking.
