Docket No. 272 – Development and Management Plan Inspection

Segment 4b Underground Line

Date: November 21, 2007

Location: Fairfield/Westport Town Line to Westport Avenue in Norwalk

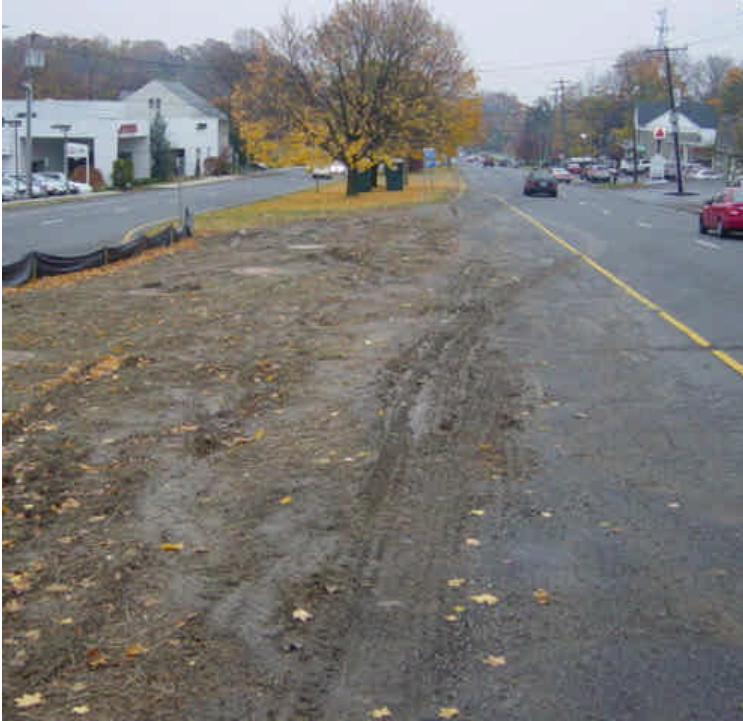
Minor tracking was observed near sta. #316-318. Hay mulch was previously applied over the exposed soils, but the area should be refreshed so there is a sufficient layer of cover for the winter months.

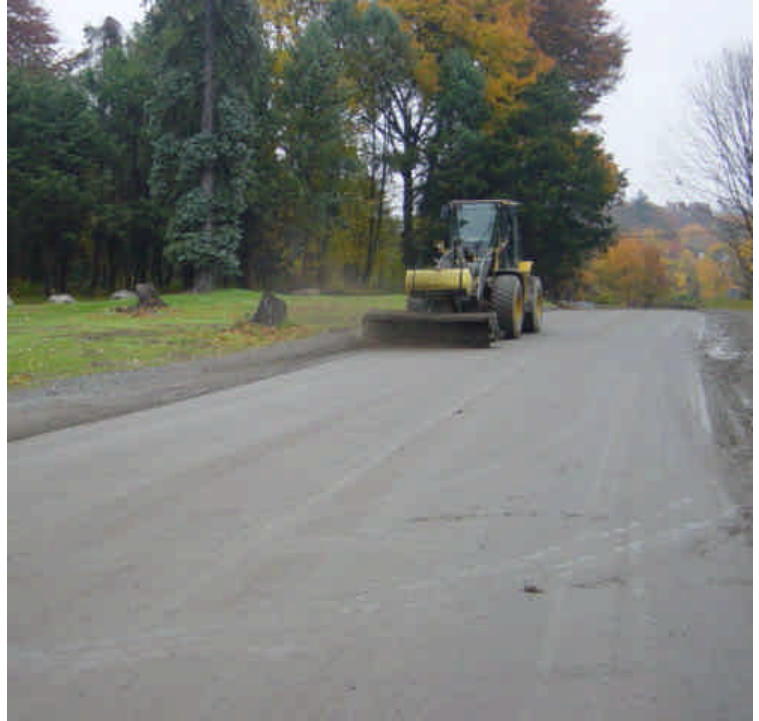
Minor tracking was observed along the access road to the Sherwood Island lay-down yard. Crews were observed sweeping the access road at the time of the inspection.

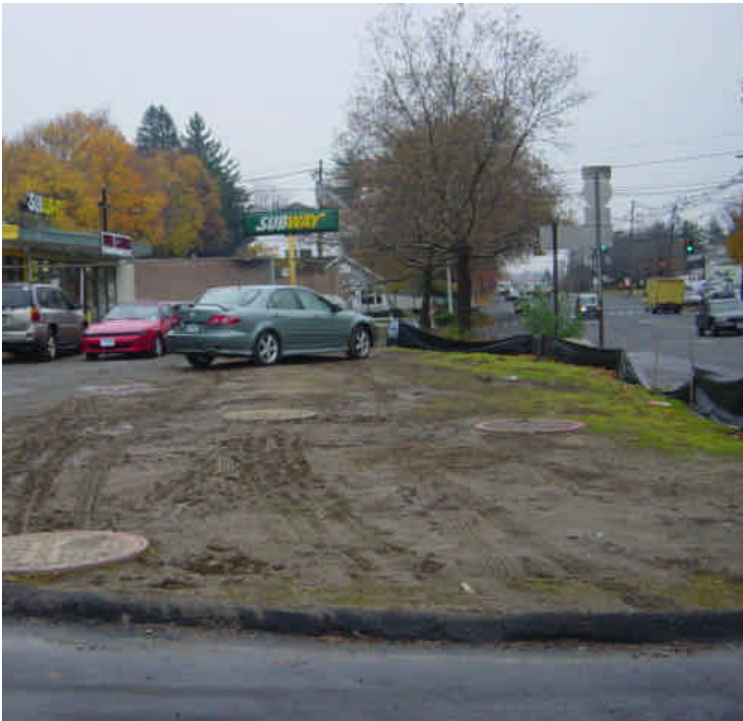
Vehicles continue to park on the seeded areas/exposed soils near sta. #334 (vault #20). Minor tracking was observed in the parking lot. Refresh with mulch cover sufficient for the winter months. Work out a parking plan with the landowner.

Vehicles continue to park on the seeded areas/ exposed soils near sta. #334 (vault #20). 11/15-11/21/07	Apply additional mulch in the area so that there is cover sufficient for the winter months. Work out the parking situation with the landowner. 11/21/07	Needs attention when feasible.
	Minor sediment tracking was observed along the shoulder near sta. #316-318. Hay mulch was previously applied to stabilize the exposed soils, but the area needs to be refreshed. 11/21/07	Sweep roadway as necessary. Apply additional mulch in the area so that there is cover sufficient for the winter months 11/21/07	Needs attention.
	A minor amount of sediment eroded near sta. #382 (vault #23), in areas where the curb has deteriorated. The area was previously backfilled w/ hard-pack and stabilized with hay mulch. 11/15-11/21/07 Hay bales placed	Sweep roadway as necessary. Improve restoration/ stabilization efforts and monitor until area is permanently stabilized. 11/15-11/21/07 Replace haybales if needed. 11/21/07	Needs attention.

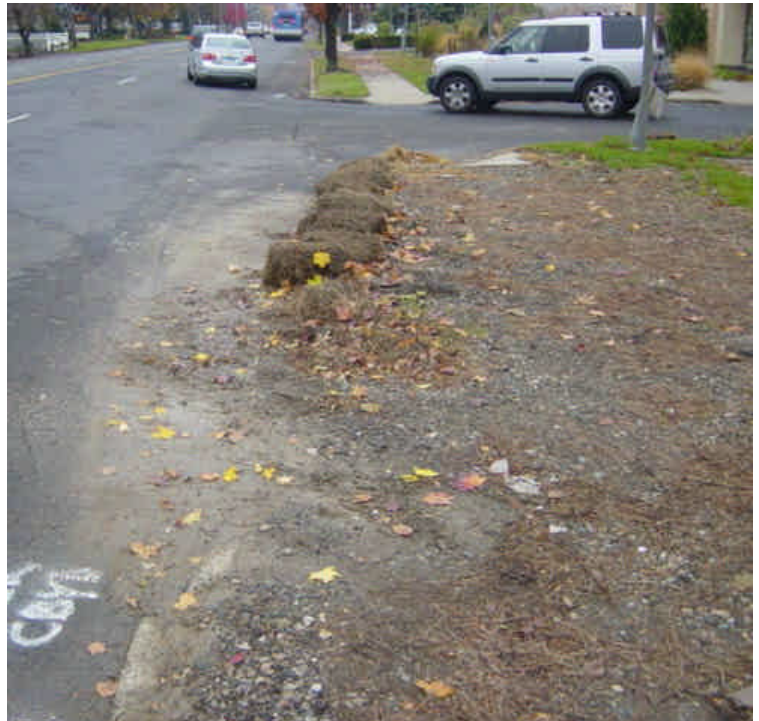
Minor sediment accumulation was observed along the shoulder of the roadway near sta. #381-383 (vault #23). The accumulation was heavier in areas where the curbing has deteriorated. Hay bales are providing some control, but the bales are also deteriorating.
